Transitional to What?

Prepared as a technical document to assess a portion of the transitional shelters dispersed and discuss proposed methods for extending their expected lifespan if applicable to the shelter & site.

Architecture for Humanity / Habitat for Humanity

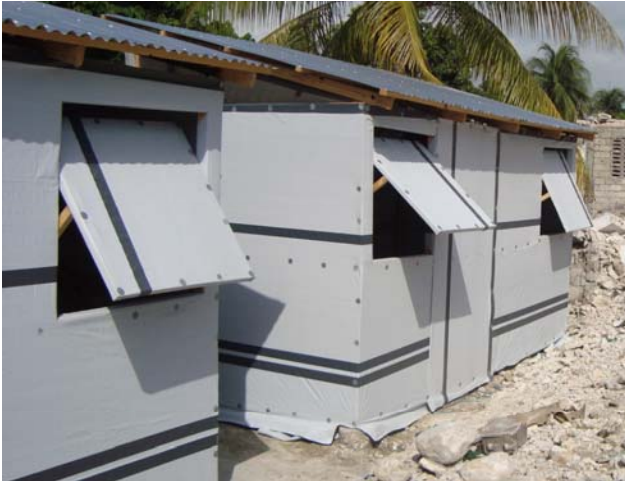
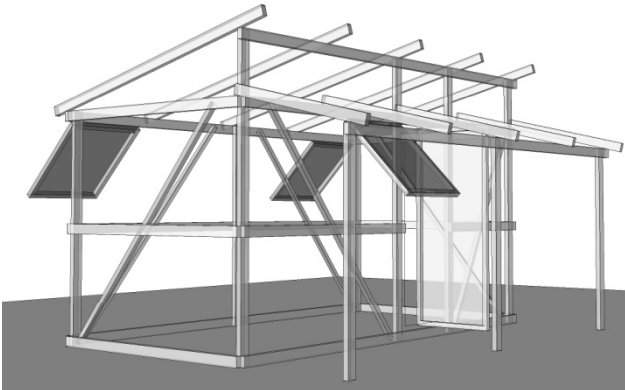
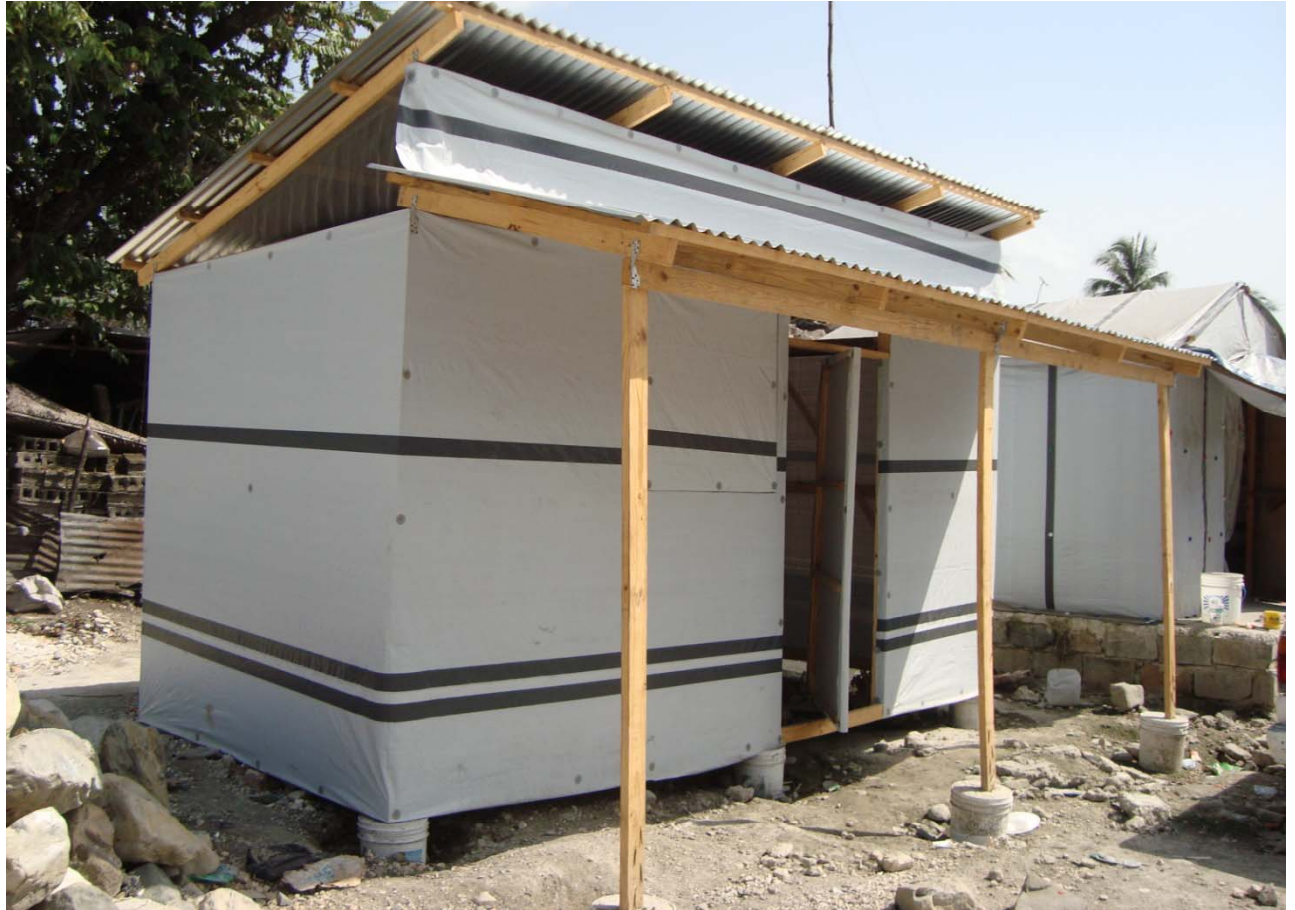
Site Survey-Habitat for Humanity

- Lack of Security with Tarp, Adding piece-meal siding
- Second Door Preferred
- Additional Covered Outdoor Area Needed
- Rain Blows in Gable End

- Safety/Siding
- Size
- Flooding Hazard; Water Infiltration @ Base
- Hurricane Hazard; Metal Roofing Nailed

- 1-3 years Extended Lifespan Potential

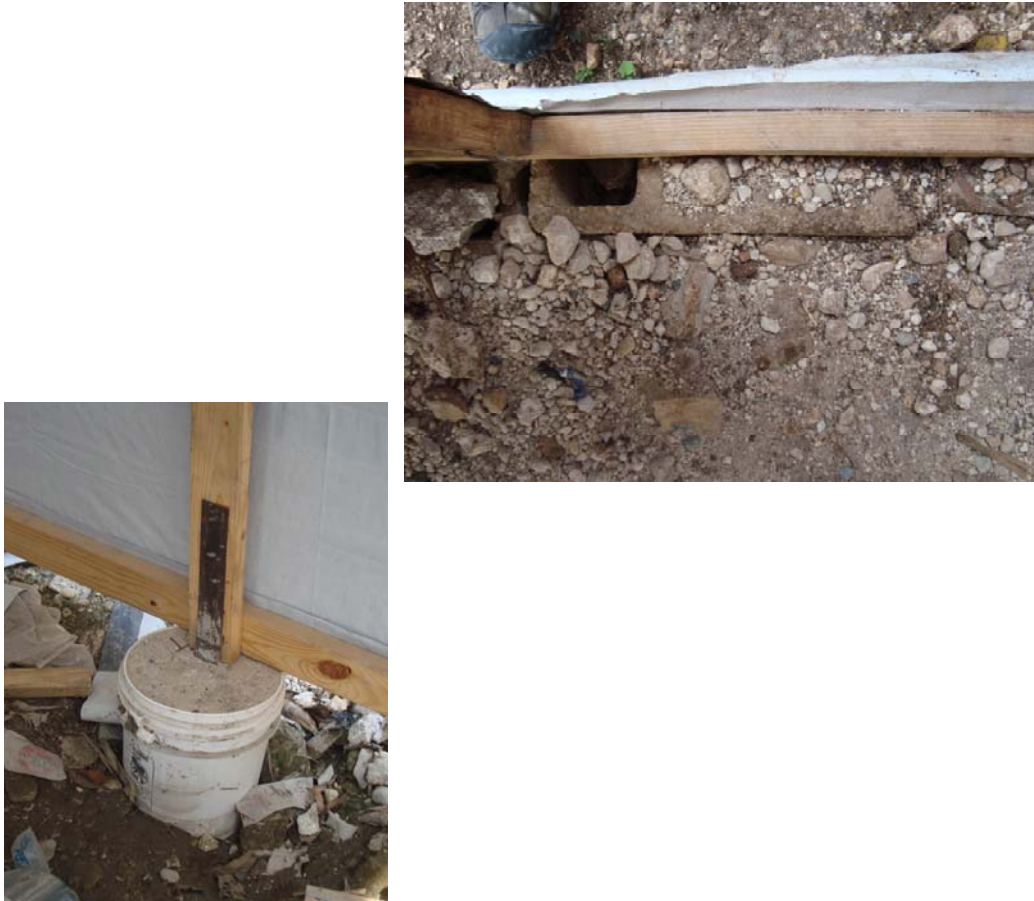
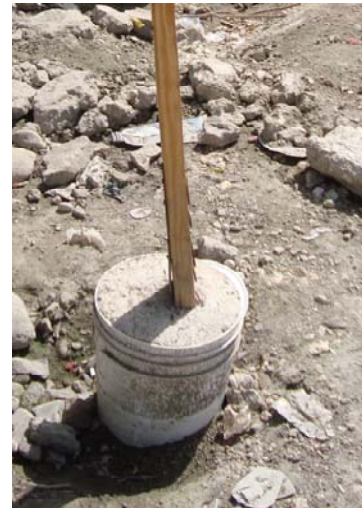
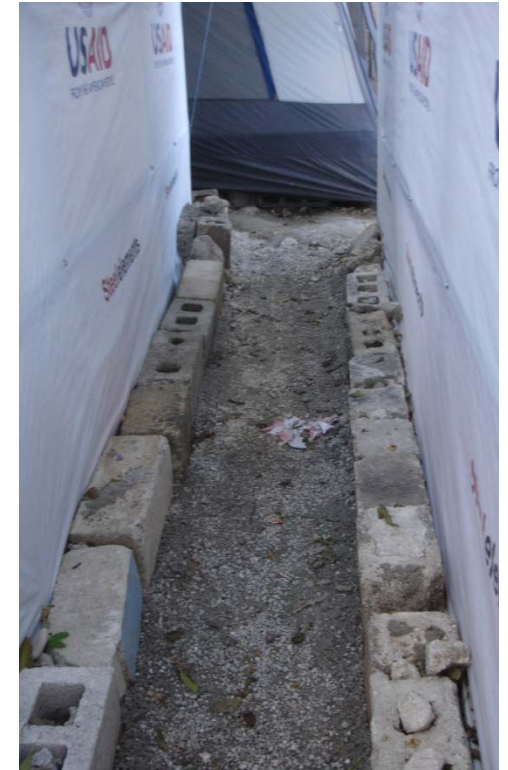
(Owner Modified)

- Water Hazard
 - Ground Water Infiltration at Base
 - Wash out potential at shallow Footings
- Hurricane Hazard
 - Inconsistent methods w/ Hurricane Tie-Down / Strength of Footings

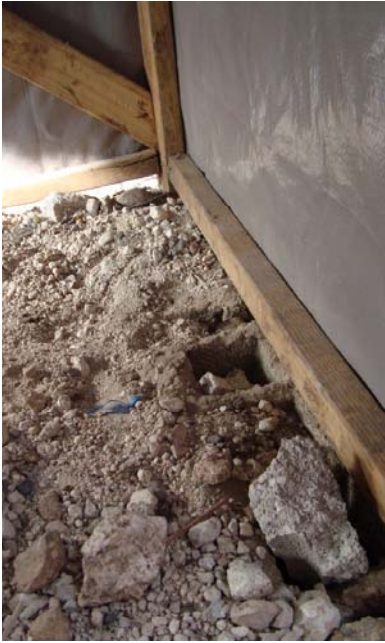
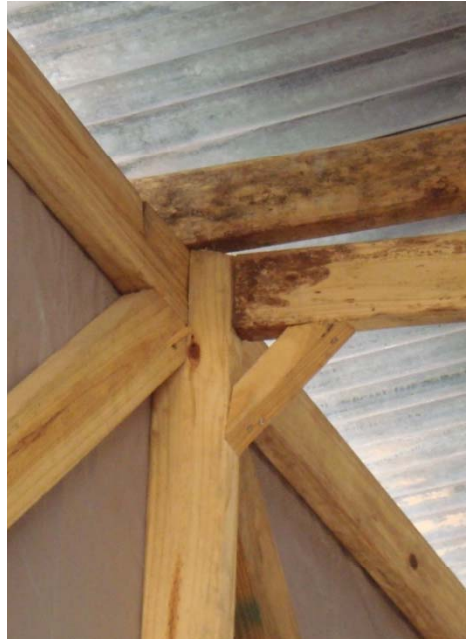
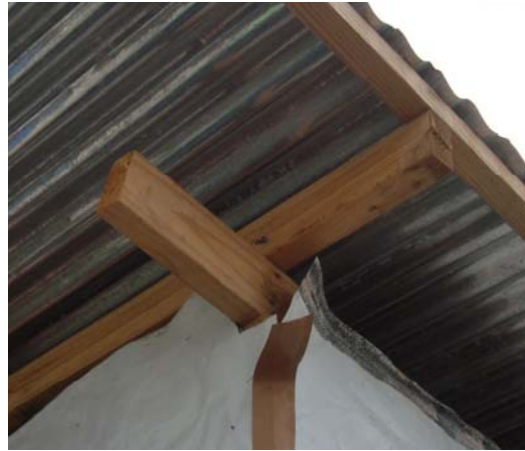
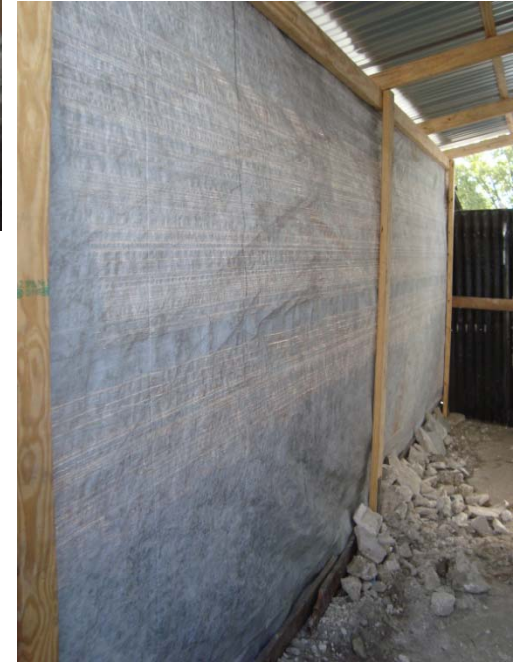
- Water Hazard - Contact with Moisture/Ground
- Hurricane Hazard - Inconsistent installation of Hurricane Straps (with-in companies & types)

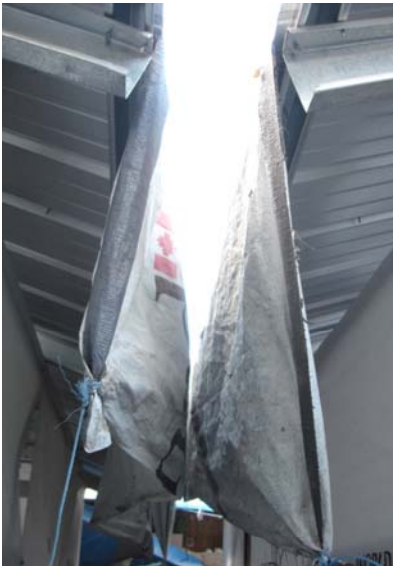
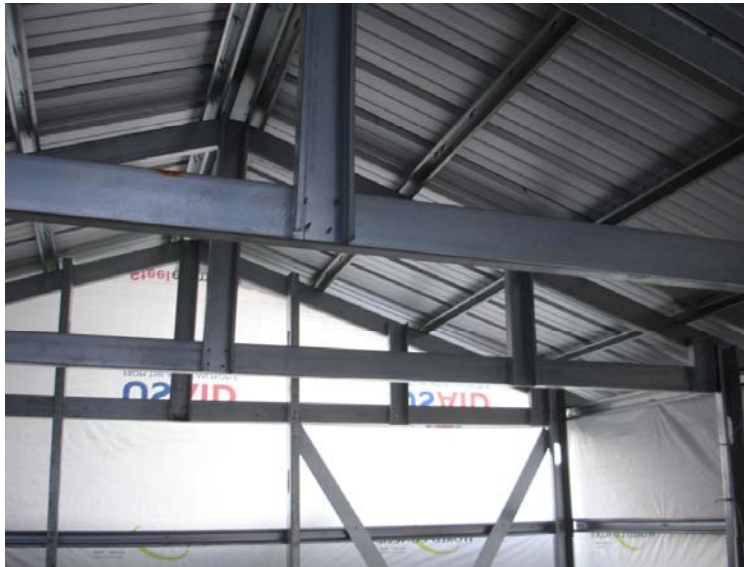
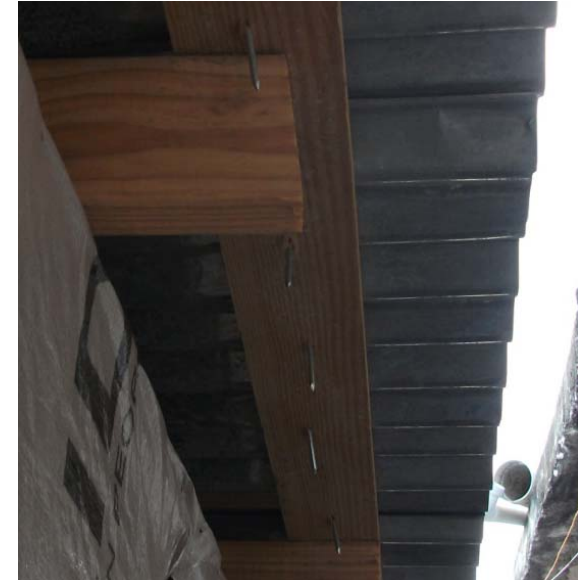
- Water Hazard
 - Roofing Leaks w/ Metal Frame
 - Durability of Tarp Siding, Tearing through at conn.
- Hurricane Hazard
 - Low Durability to High Winds w/ Tarps & Metal Roofing Installation Methods (nails not bent over, no screws)
- Other Concerns
 - Heat / Lack of Ventilation
 - Safety / Security of Tarps

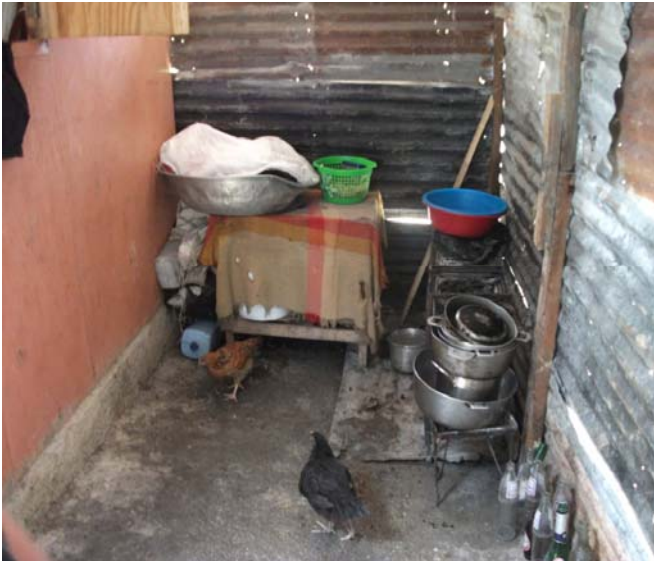
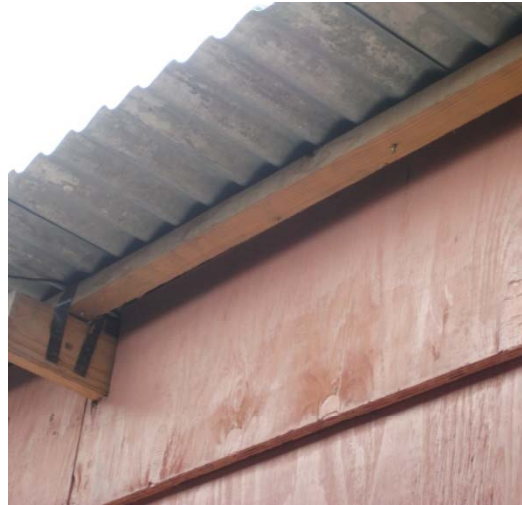
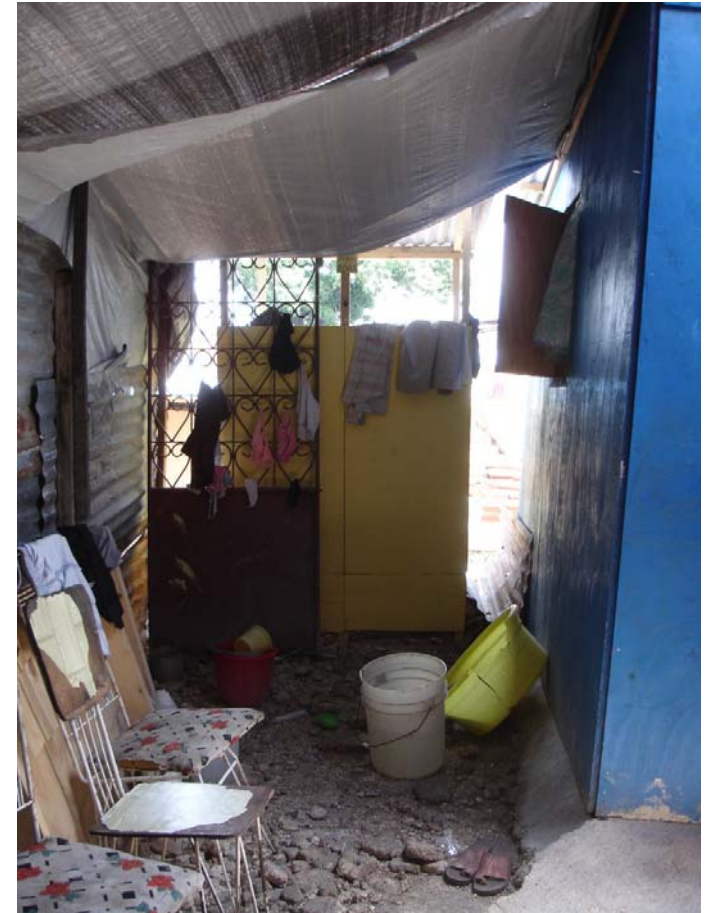
ADRA

- Poor Ventilation / low ceiling
- Additional Windows /Secure Venting Needed
- Second Door Preferred
- Additional Covered Outdoor Area Needed
- No flooding or water penetration issues

- Heat/Ventilation
- Hurricane Winds; Metal Roofing Nailed straight through, no Screws
- Size / Add. Covered Outdoor Area

- 2-8 years, Extended Lifespan Potential

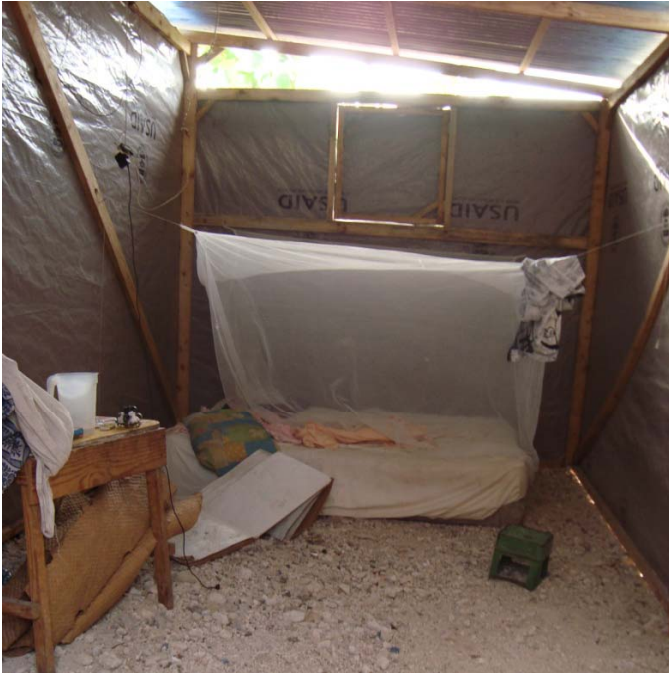
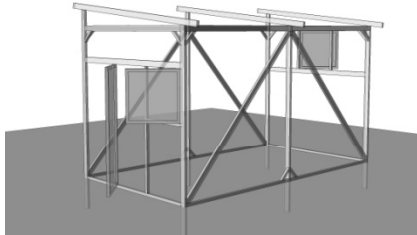
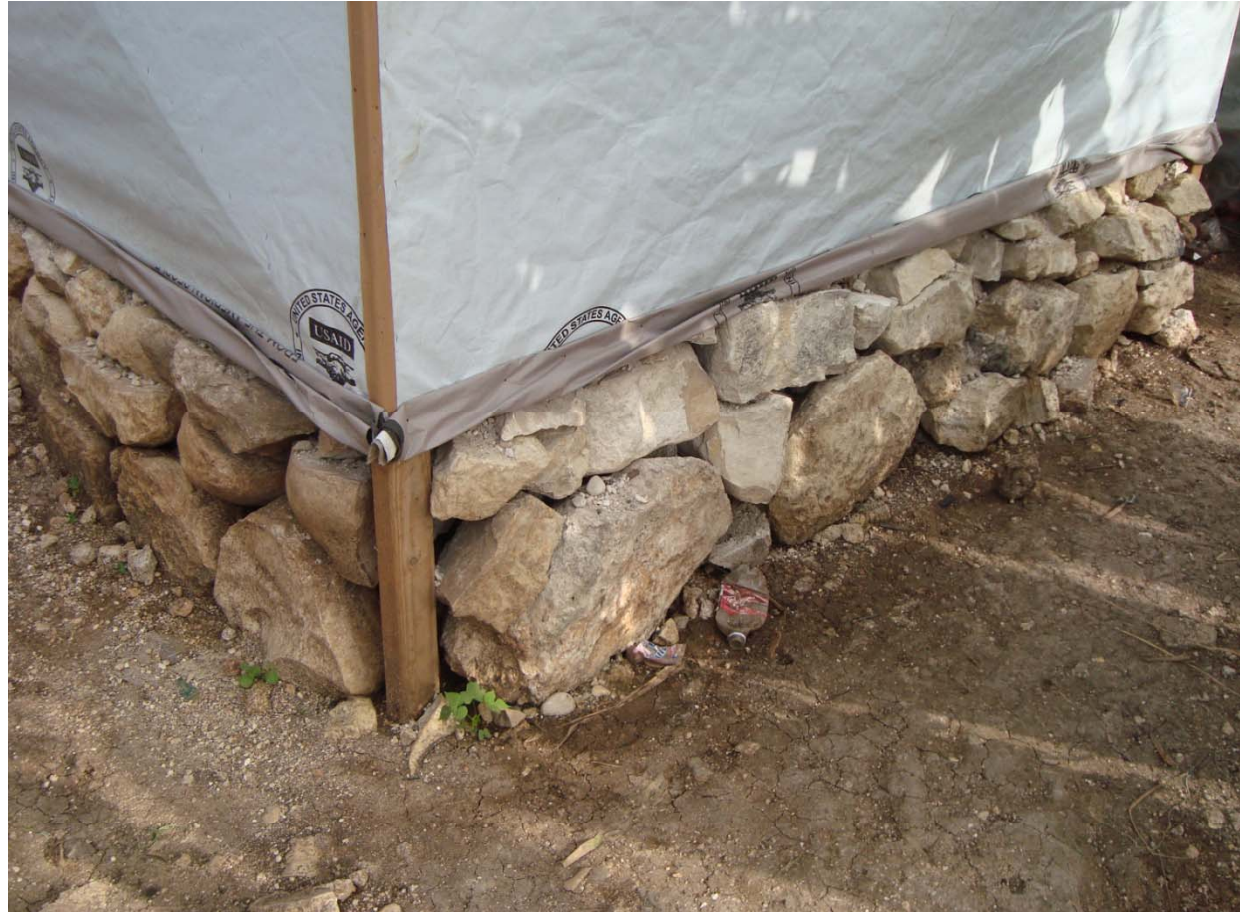
ADRA

- Lack of Security -Tarp
- Poor Ventilation
- Second Door Preferred
- Additional Covered Outdoor Area Needed
- Rain Blows in Gable End

- Security
- Heat/Ventilation
- Flooding Hazard; Water Infiltration @ Base
- Hurricane Hazard; Metal Roofing Nailed, no straps at roof/wall or posts/foundation

- 1-3 years

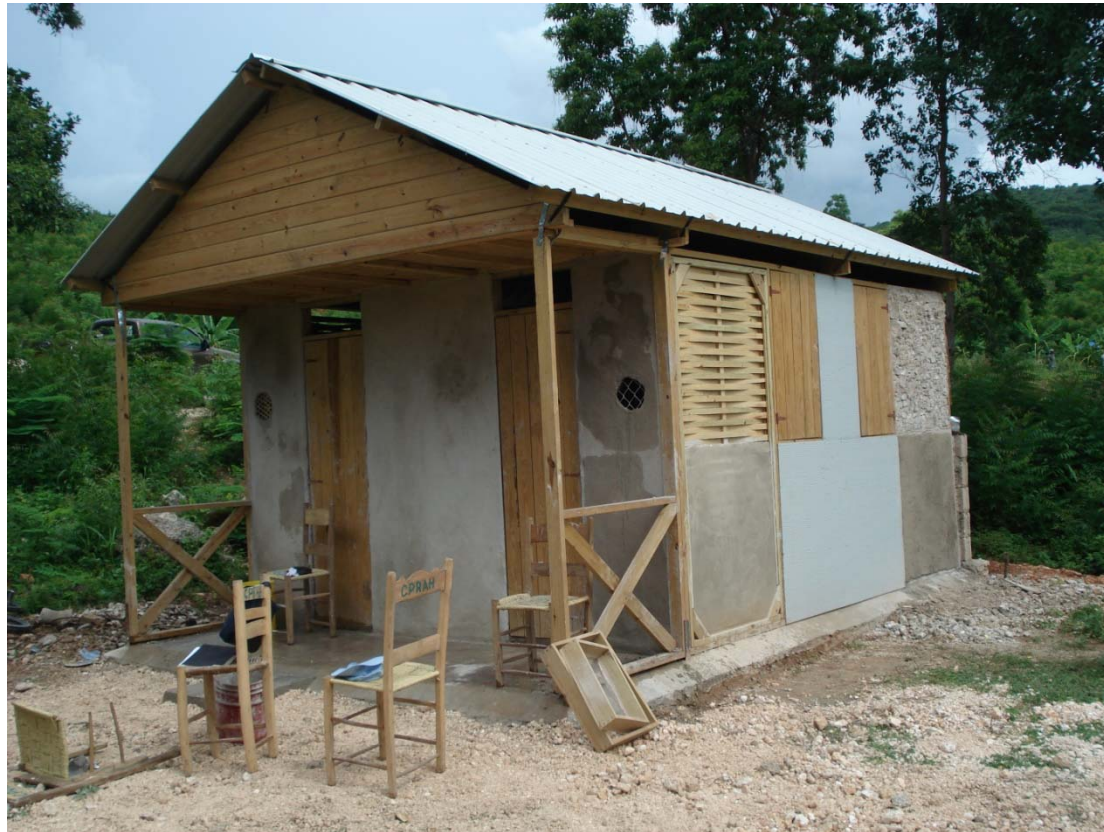
CORTAID 1850

- Additional Covered Outdoor Area Needed
- Water Collection System Needed
- Latrine & Wash Facility Needed

- Additional Covered Space
- Infrastructure Requirements

- 8 years min.

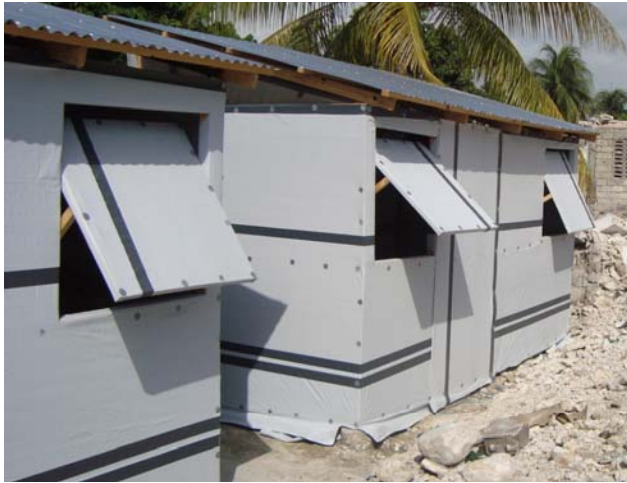
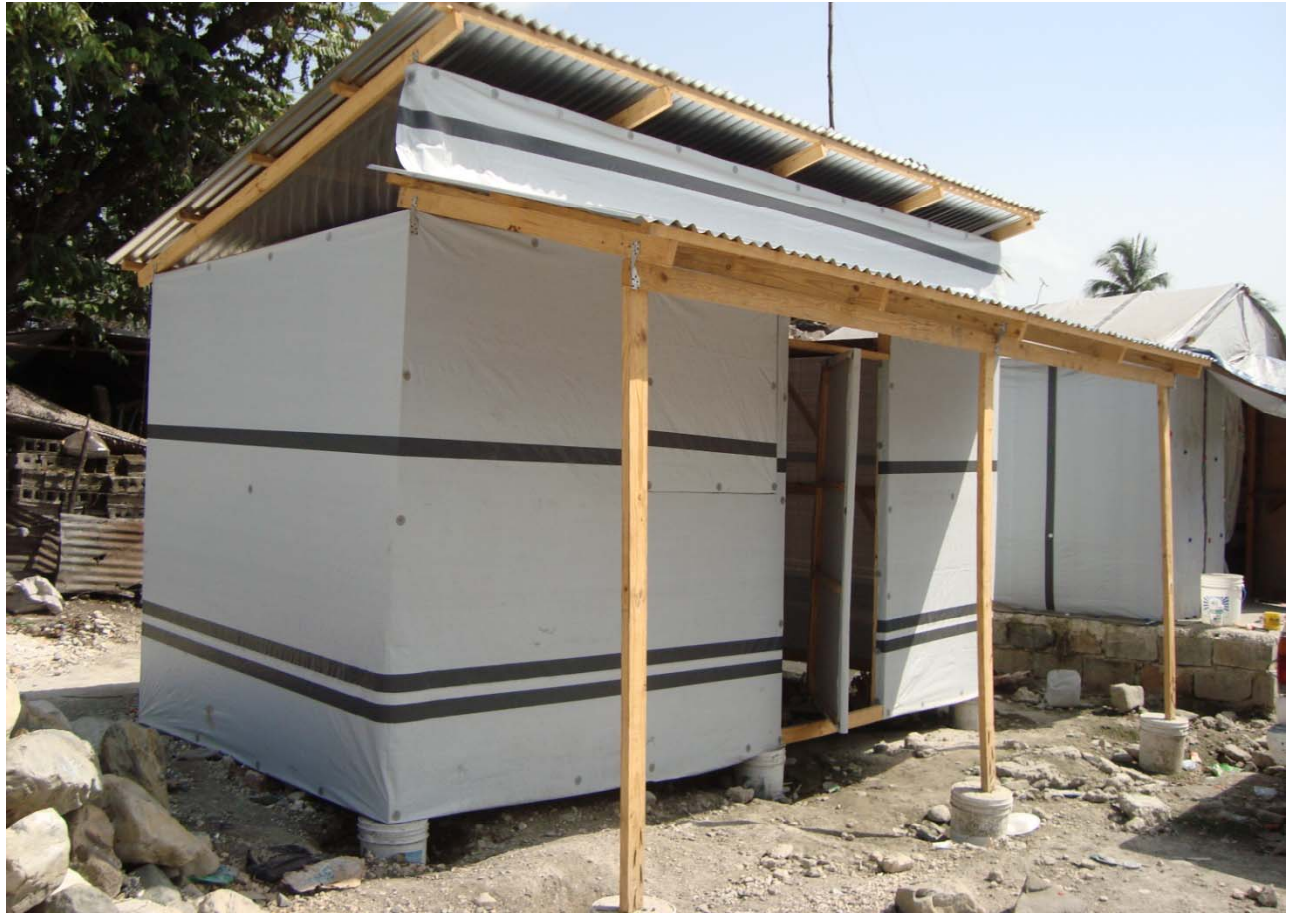
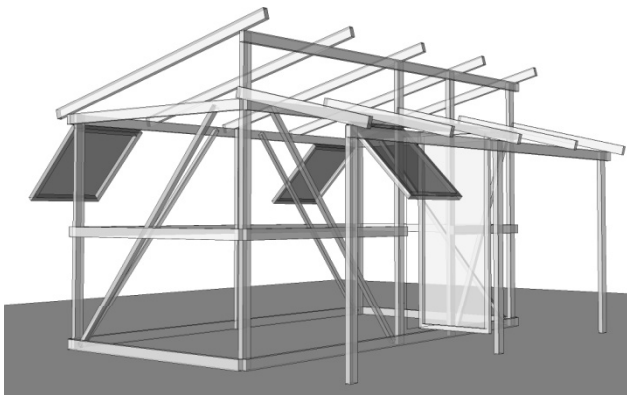
Habitat for Humanity

- Lack of Security with Tarp, Adding piece-meal siding
- Second Door Preferred
- Additional Covered Outdoor Area Needed
- Rain Blows in Gable End

- Safety/Siding
- Size
- Flooding Hazard; Water Infiltration @ Base
- Hurricane Hazard; Metal Roofing Nailed

- 1-3 years Extended Lifespan Potential

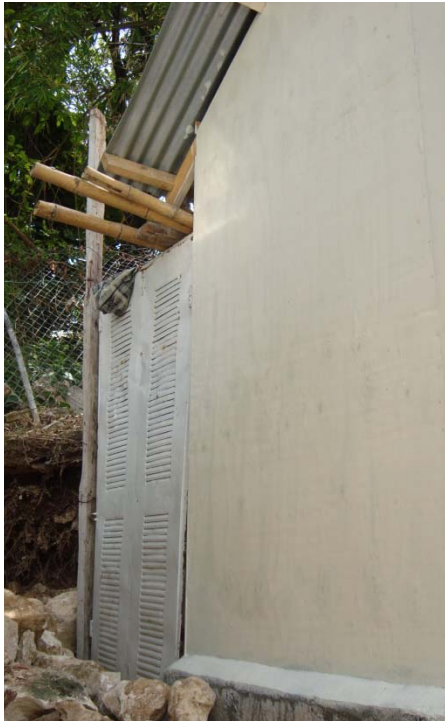
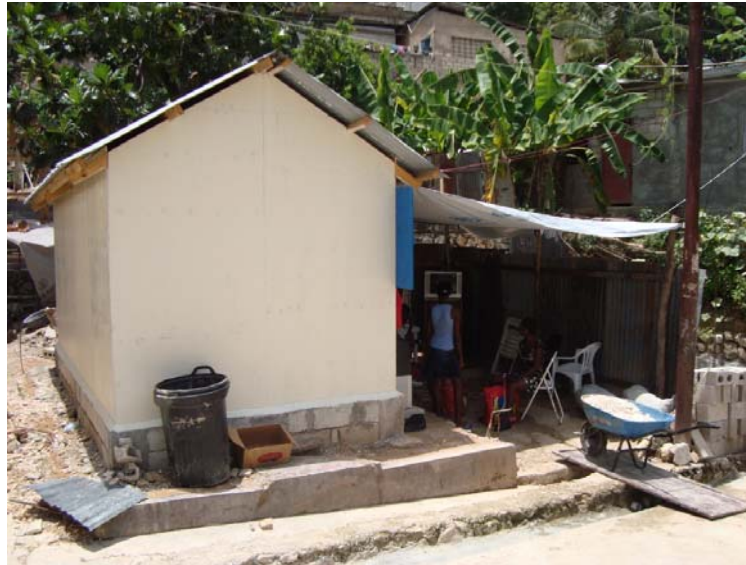
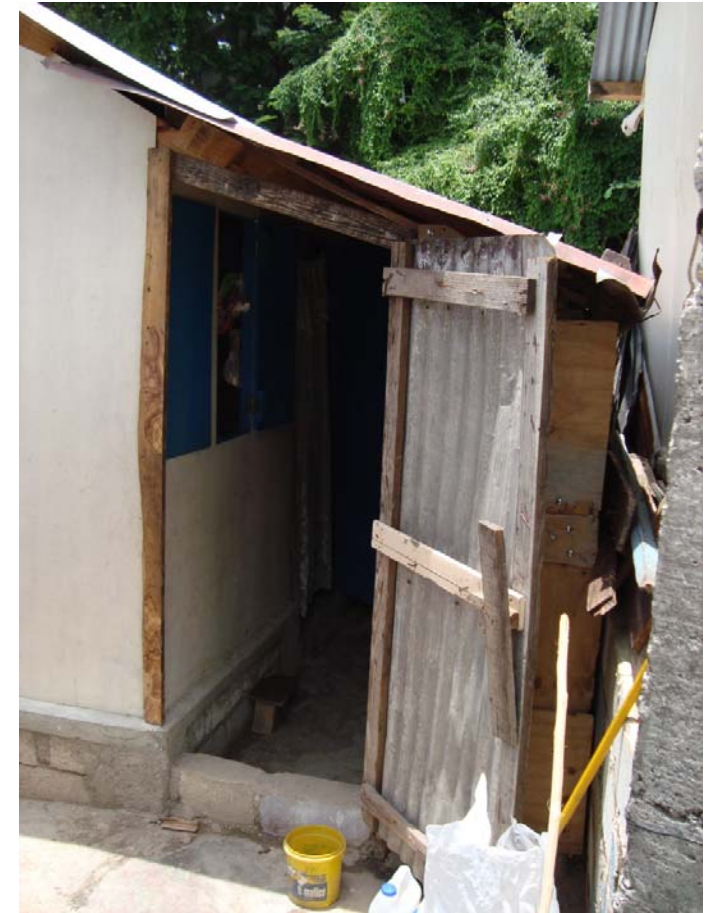
- Poor Ventilation, minimal Windows
- Second Door Preferred
- Additional Covered Outdoor Area Needed

- Heat/Ventilation
- Size -Additional Covered Area
- Hurricane Hazard; Metal Roofing Nailed, hurricane straps not consistently installed

- 3-8 years Extended Lifespan Potential

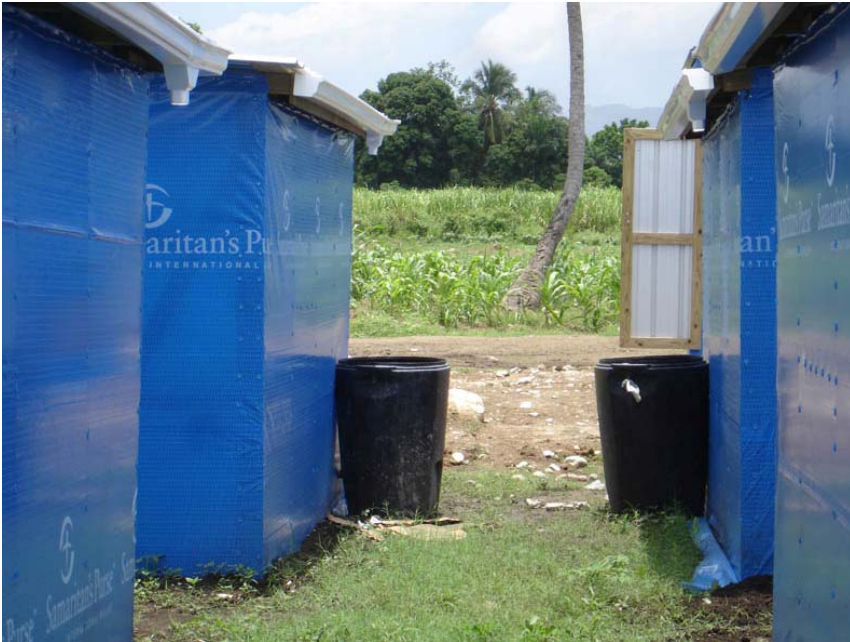
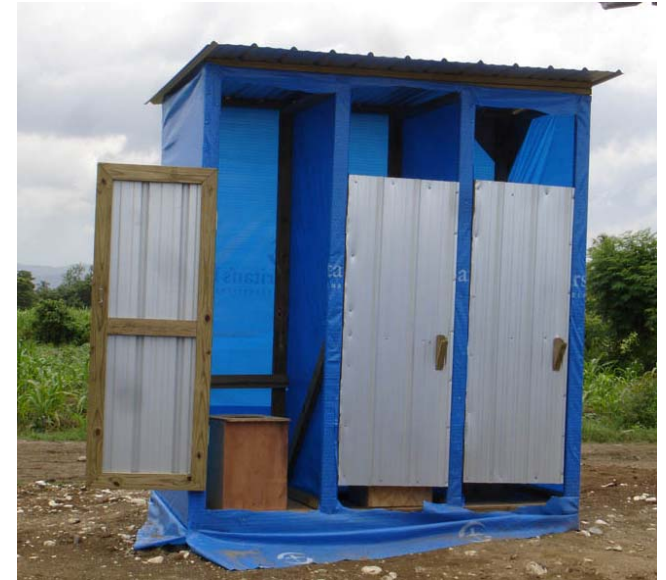
Samaritan's Purse

- Lack of Security -Tarp
- Poor Ventilation
- Second Door Preferred
- Additional Covered Outdoor Area Needed
- Ground Water Infiltration

- Security
- Heat/Ventilation Size - Add. Covered Area
- Flooding Hazard; Water Infiltration @ Base
- Hurricane Hazard; better tie to foundation

- 1-3 years

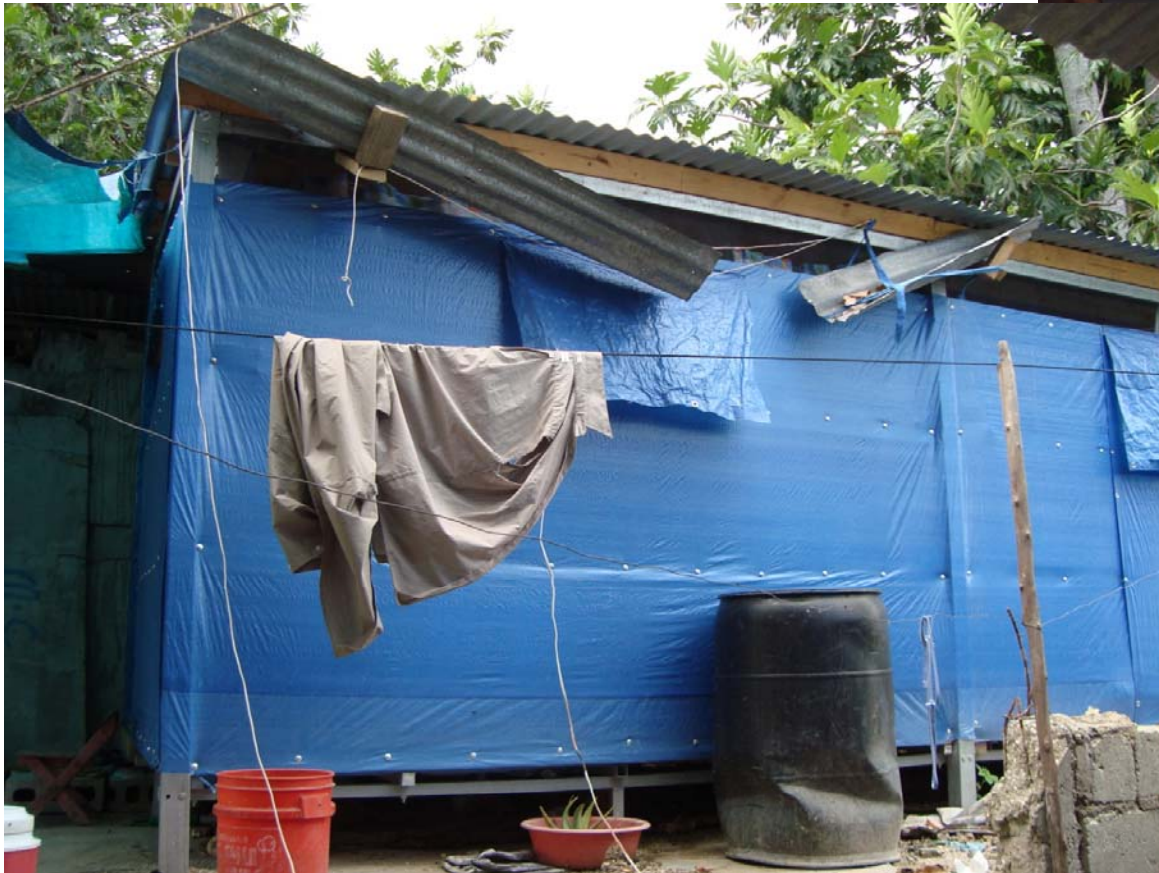
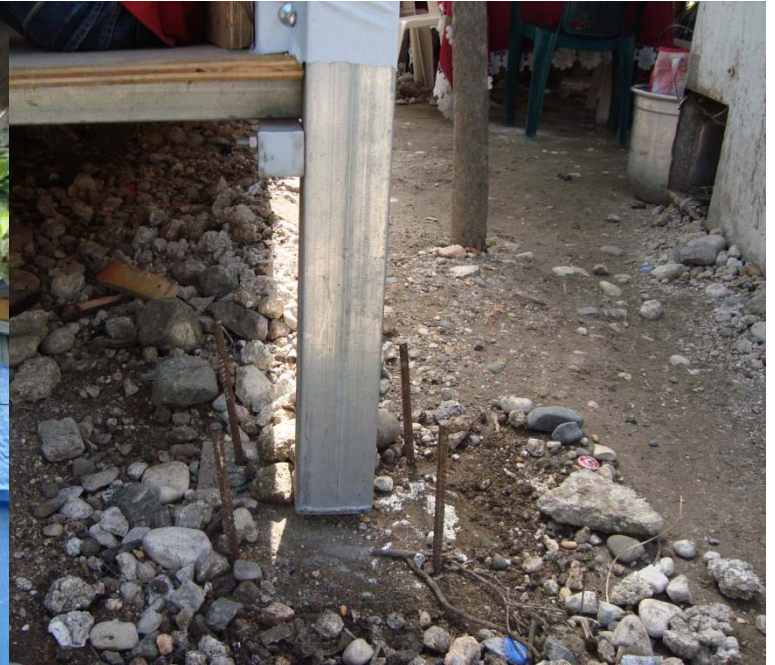
Spanish Red Cross

- Lack of Security -Tarp
- Poor Ventilation
- Second Door Preferred
- Additional Covered Outdoor Area Needed
- Rain Blows in Clearstory

- Security
- Heat/Ventilation
- Size -Additional Covered Area
- Hurricane Hazard; siding

- 1-8 years, Extended Lifespan Potential

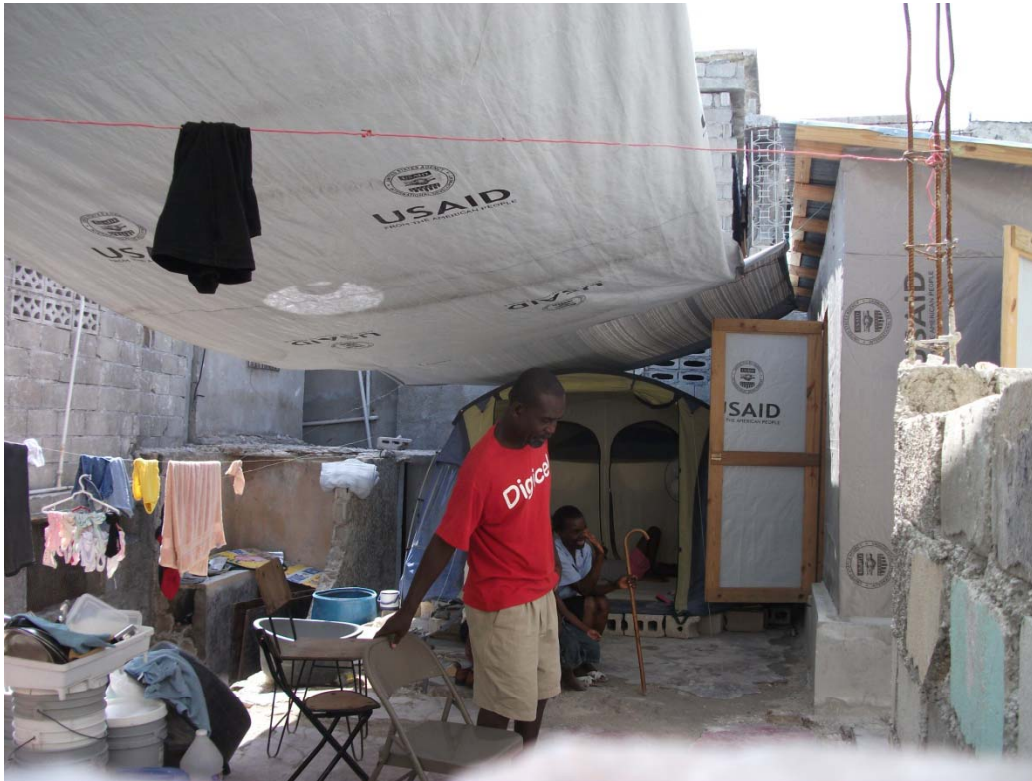
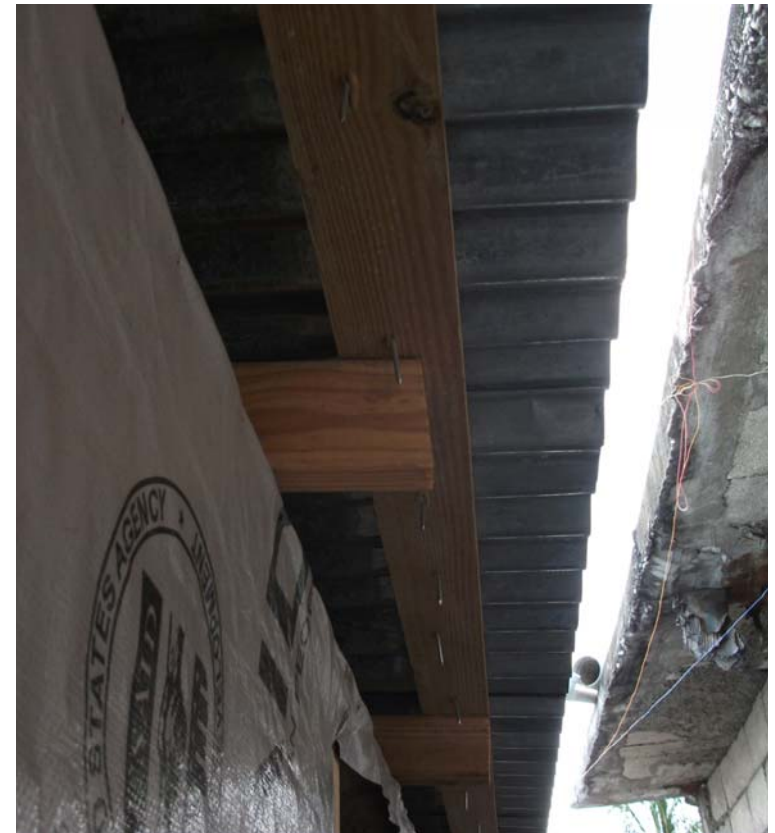
World Concern –Type 1

- Lack of Security -Tarp
- Poor Ventilation
- Second Door Preferred
- Additional Covered Outdoor Area Needed

- Security
- Size
- Heat/Ventilation
- Hurricane Hazard - Metal Roofing Nailed,
no straps @ roof/wall or foundation

- 1-5 years, Extended Lifespan Potential

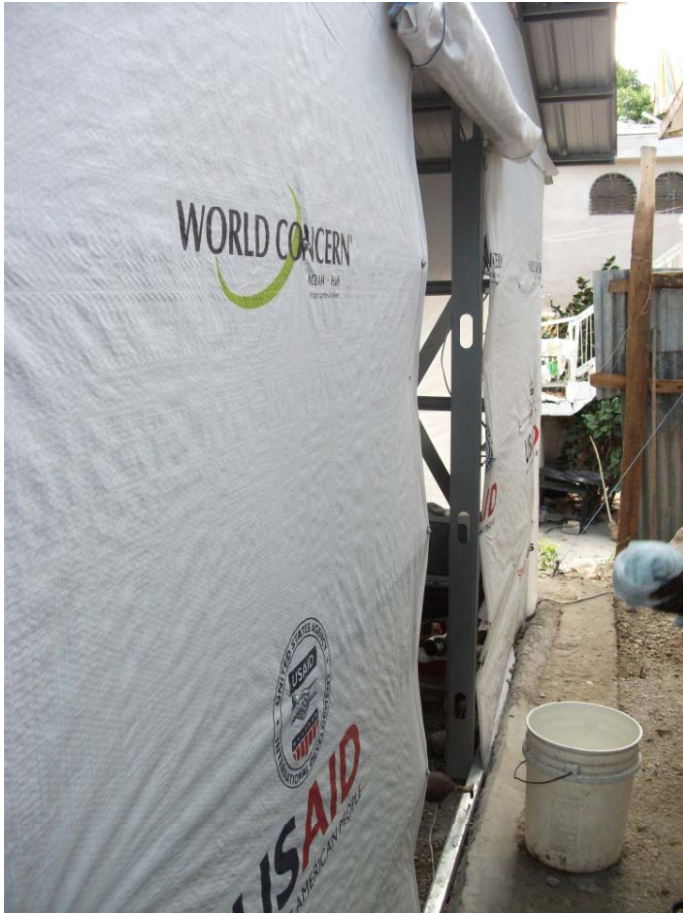
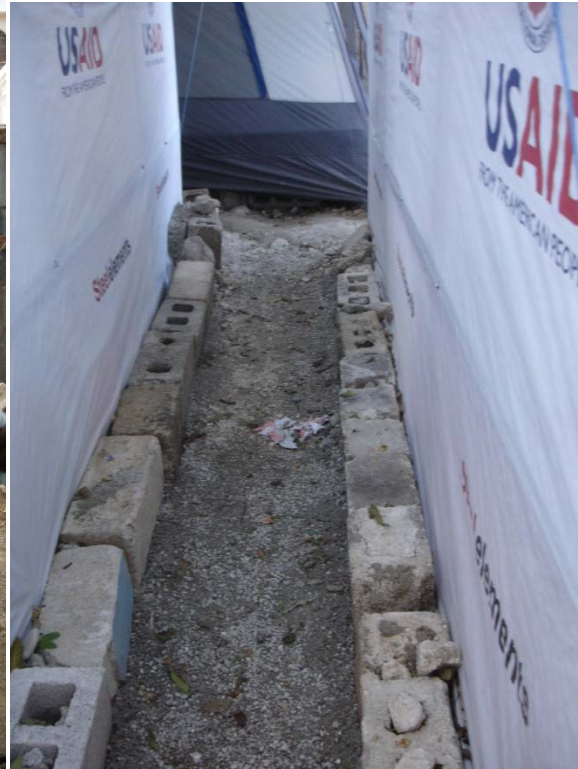
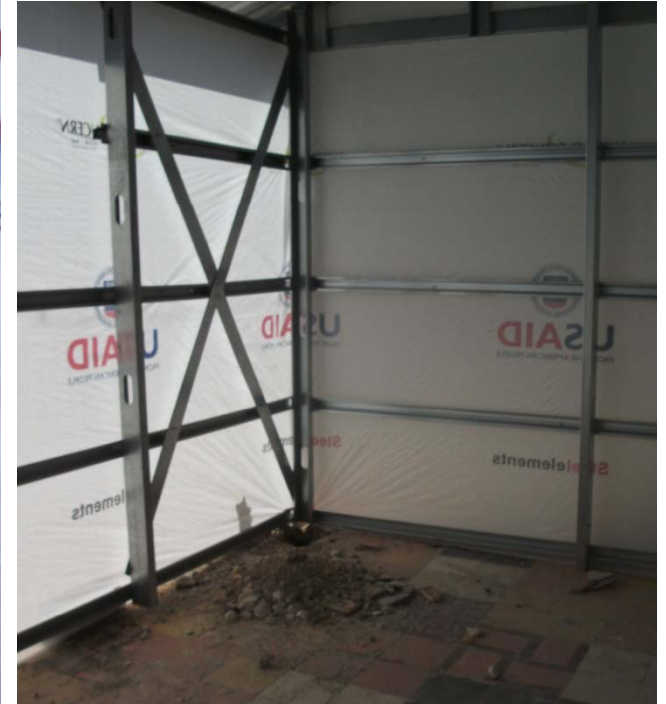
World Concern -Type 2

- Lack of Security -Tarp
- Poor Ventilation
- Second Door Preferred
- Additional Covered Outdoor Area Needed
- Roof Leaks at fastening points
- Water Infiltration @ Base

- Security & Durability of Tarp -pull through
- Heat/Ventilation
- Size
- Flooding Hazard - Water Infiltration @ Base
- Hurricane Hazard- Varying Found. Anchor Sys.

- 1-8 years, Extended Lifespan Potential
