**International
Hurricane Research
Center**

Shelter and Component Testing OFDA transitional shelters: materials, techniques and structures

Project Number: WOW12-2012-02

Shelter and Component Testing OFDA transitional shelters: materials, techniques and structures (Supplementary Test)

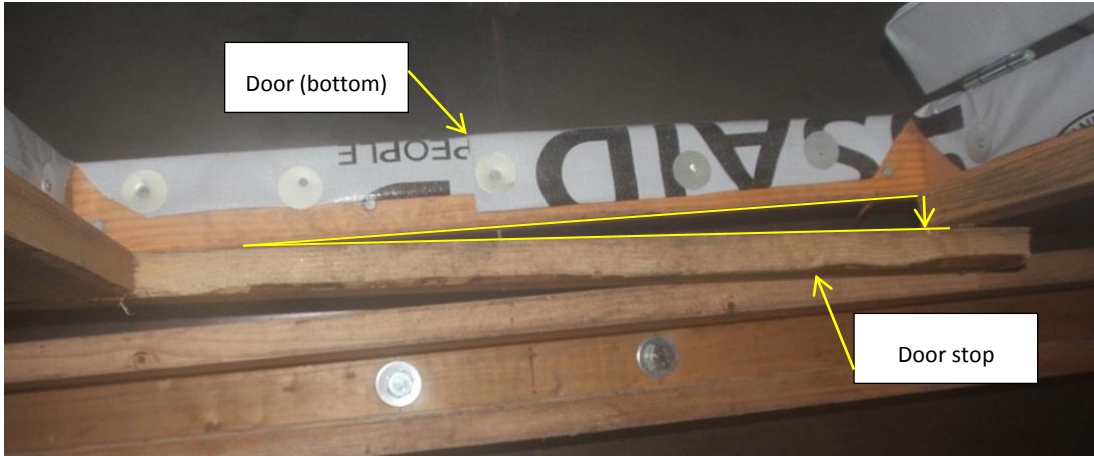
Furthermore, the increase in speed from 85 mph to 95 mph did not produce noticeable damage on the outside of the shelter. The additional lateral bracing seemed to be effective to transfer the forces and reduce the deflection at 90° angle of attack. The reinforced door hinges and door stop are believed to have provided additional support and strengthened the door system. No damage to the door was observed. While inspecting the inside of the shelter it was observed that the door stop did transfer the loads from the door to the frame. The bottom section of the door stop was partially pulled out from its attachment (Figure 6). This was a consequence of a construction flaw, where the nails were driven into the gap between the bottom plate and the platform.

Figure 6 - Bottom door stop pulled-out

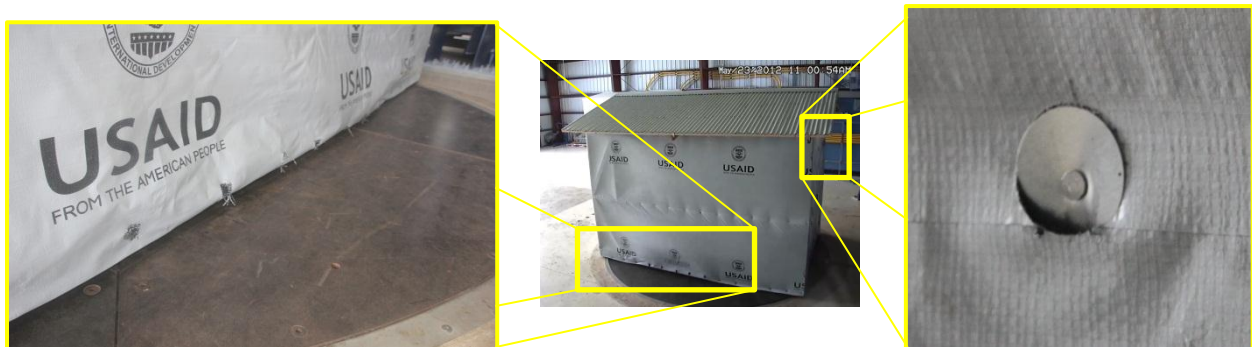
With the wind speed increased to 100 mph, sections of the OFDA plastic sheeting were pushed harder into the sharp edges of the tin caps. It is presumed that either the internal pressure build-up from air leaking through the shelter openings or the aerodynamic forces (suction) created on the wall surfaces, or a combination of both, caused the tin caps to start cutting through the plastic (Figure 7). It demonstrated that tin caps transfer the concentrated loads from the nail head to a bigger area on the plastic, but it's sharp edges can cut through it under repetitive loading. It is believed that a material with blunt edges (i.e. wood battens) might be a better option to enhance the durability of the USAID/OFDA plastic during repetitive loading and provide a surface to distribute the forces.

Figure 7 - Plastic puncture by tin cap discs

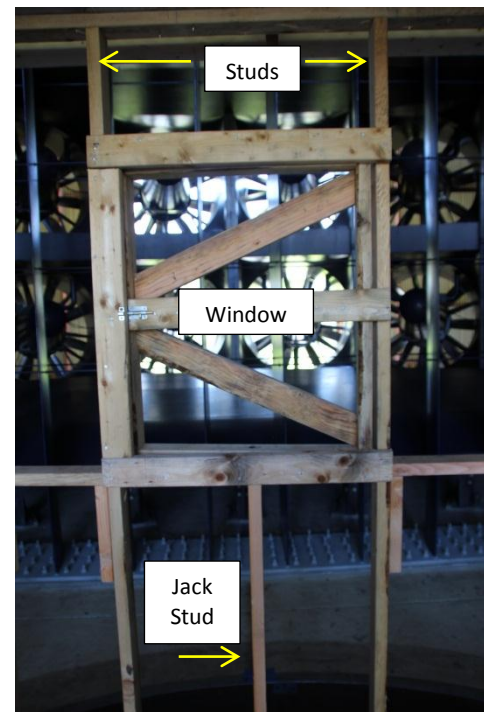
2. While reviewing the video it can be observed that there was a sudden deformation of the wall in its mid-section (close to 1 min into the test). The window section of the wall buckled inwards but did not detach from the rest of the frame (Figure 9). Until this moment the structure was still standing and the damage could have been repaired.

3. An inspection of the damaged wall after the test found that none of the studs around the window section fractured. Therefore, it is assumed that the wind-induced forces on the wall slowly pulled the nails out of the wood members that connected the studs to the top and bottom plates. There was no evidence of the nails failing from shear.

Figure 8 - Window framing

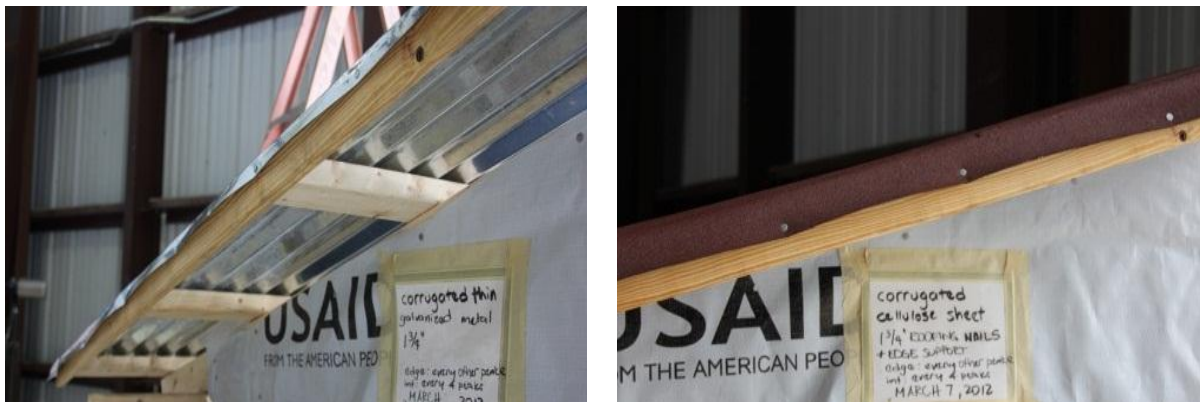
Figure 10 – Additional fascia board on purlin ends to provide additional fasteners on roof gable end

In both cases where the roof cladding became partially or totally detached from the purlins, a simple change to the structure and fastening method secured the cladding. A fascia board was nailed to the purlin free ends on the gable end. This additional board allowed fastening the sheets of roof cladding with a shorter spacing between fasteners: every 12-in instead of every 24-in. Retesting the retrofitted setup confirmed that none of the sheets were punctured and that all the cladding stayed attached to the roof structure (Figure 10).

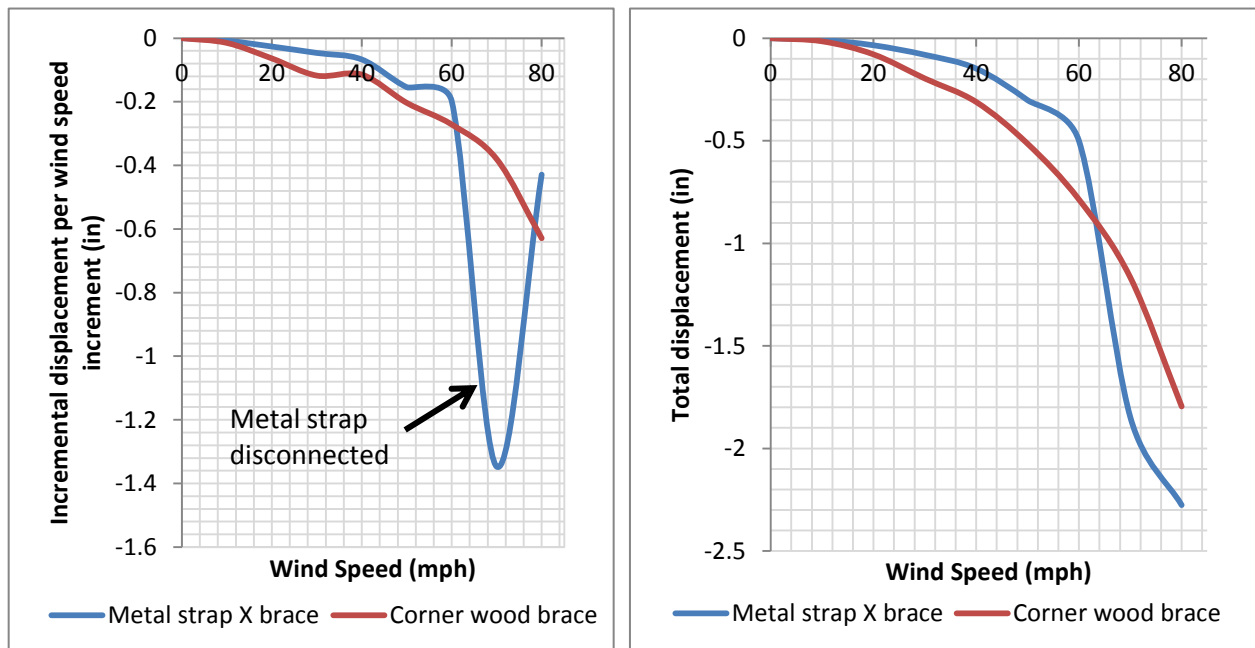
Both metal strap and wood braces performed well in avoiding big deformations on the wall panels when submitted to wind induced horizontal (shear) loads. The metal strap X brace did allow deformation approximately 0.6-in greater than with the wood braces. During the wind loading one of the metal X braces became loose when the fasteners were pulled out of the wood. This can be seen in Figure 19 where the incremental deformation measured between 60 to 70 mph was substantially bigger than the with the other speed increments. The displacement measured is approximately 1.30-in, when with the other speed increments the displacement ranged between 0.02 and 0.2-in.

Figure 19 - Wall bracing deformation under wind loads

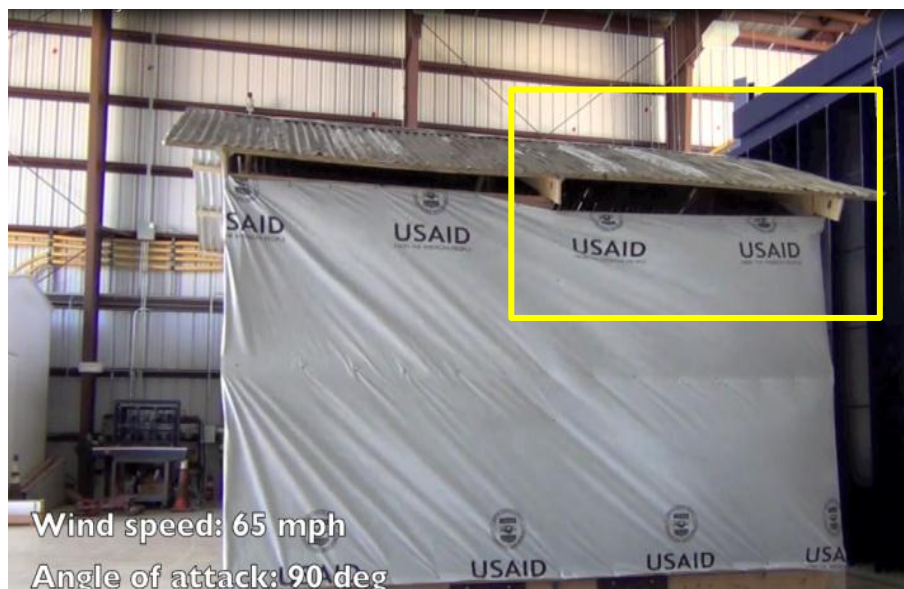
Figure 22 – T-Shelter 1 test at 65 mph and 0° and 90°; some of the wood boards part of the framing detached

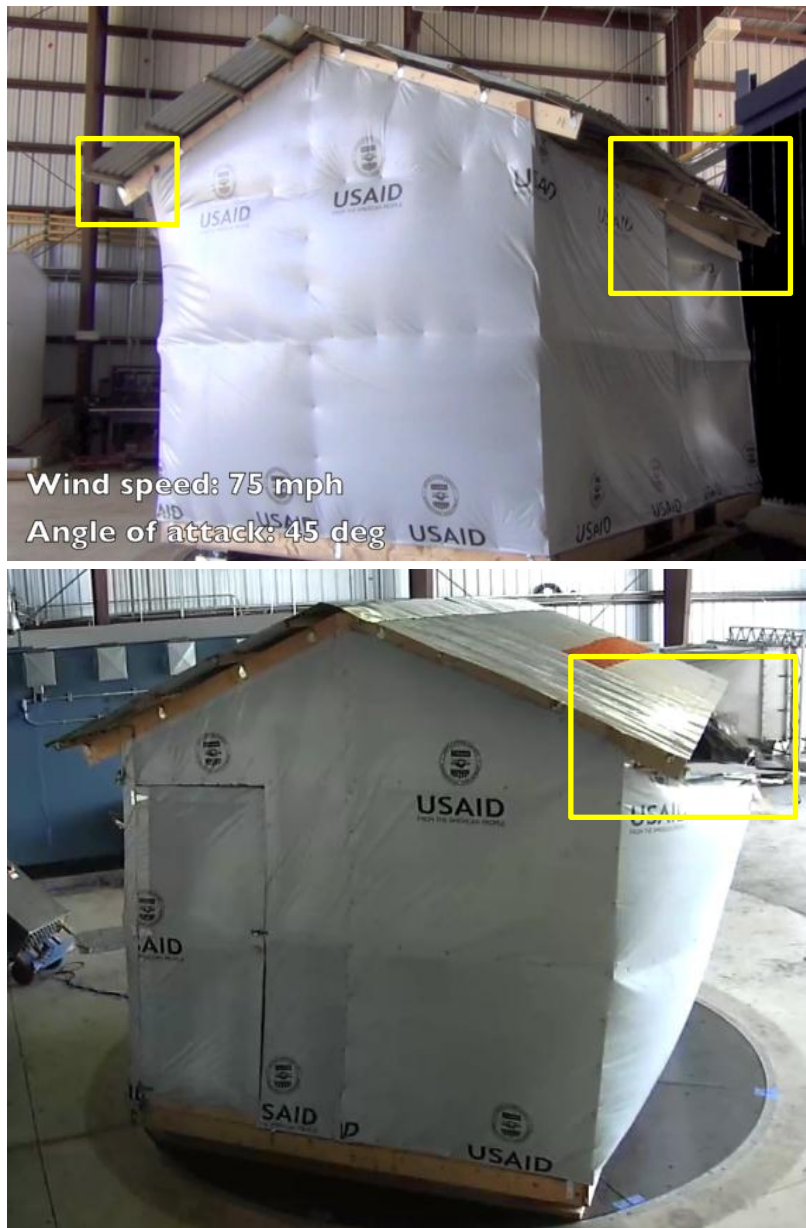
Figure 23 - Test at 75 mph and 45°; horizontal members detaching from framing

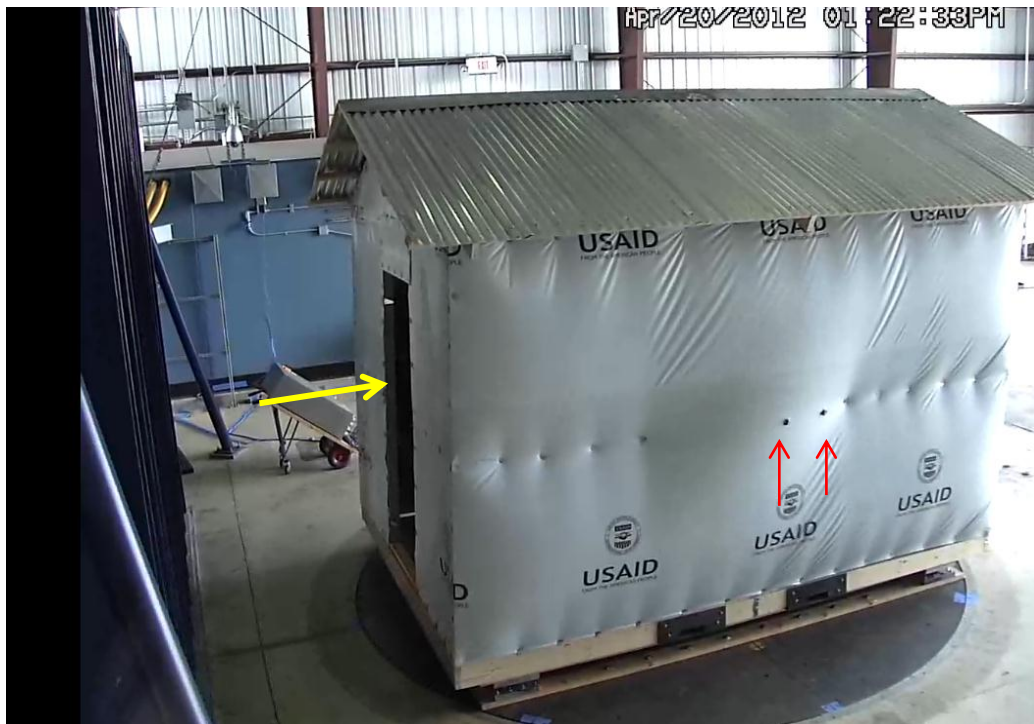
Figure 27 - T-Shelter 2 door failure at 85 mph and 90 degrees. Red arrows show OFDA plastic perforated by tin caps

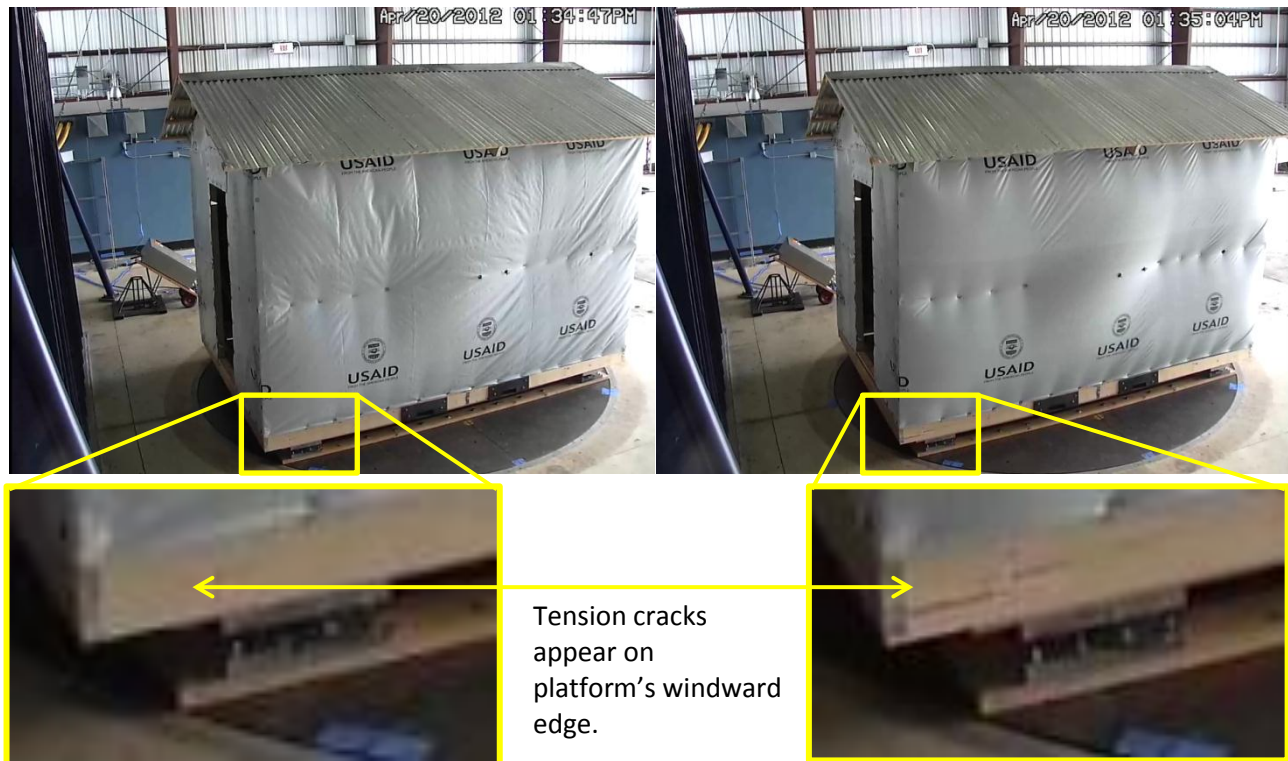
Figure 28 - Tension cracks on T-shelter base platform's windward edge
