# Remote Programming for Resilient Shelters

Case from Madagascar, 2012

Humanitarian  
Response  
Case Study

SHELTER AND  
SETTLEMENTS

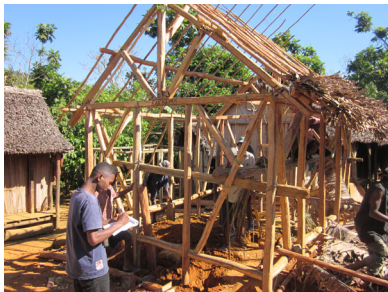
Trained members of community shelter committees assessing the quality of construction of shelters. Photo credit: CRS/J.E. Andrianambinina

- Targeting committees assessed quality of construction and provided additional support to community mobilizers. This system optimized CRS' technical specialists' time as well as strengthening the technical capacity of local staff, community and program participants.

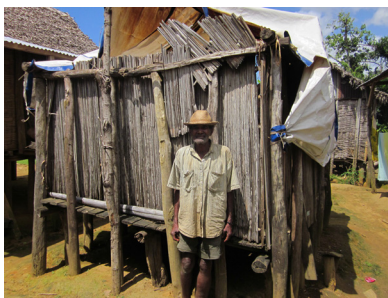
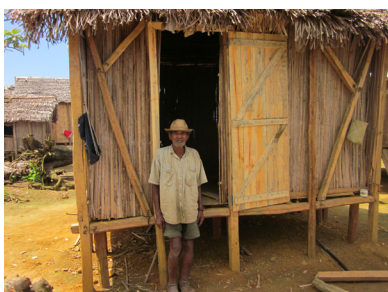
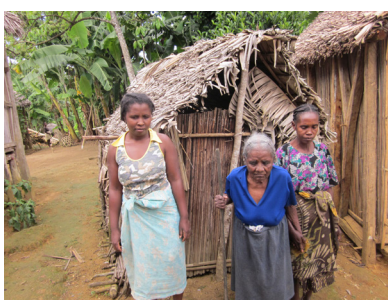
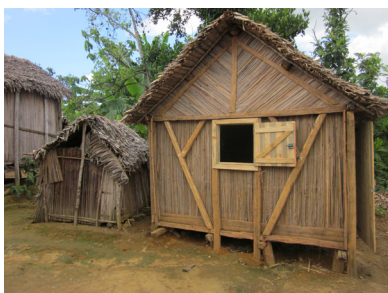
Shelters of the vulnerable (disabled/elderly) project participants before and after the implementation of the shelter program. Photo credit: CRS/J.E. Andrianambinina

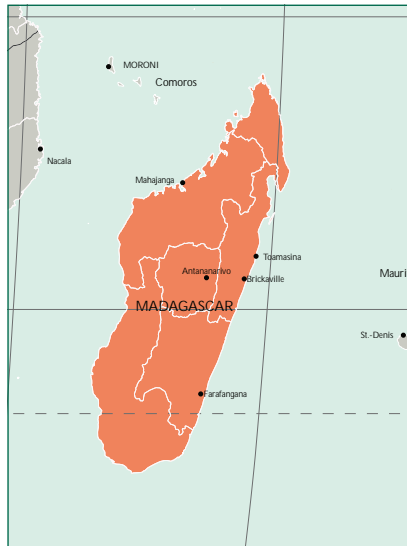
Cover: Tsaby, 79, stands between the home he was provided by Caritas Madagascar and CRS and his home that was flattened by Cyclone Giovanna. The new homes included modifications that help protect them against cyclone damage including ties on the support structure and the roof and y-shaped support beams. The homes are all made with different parts of the locally grown traveler's palm. Photo credit: CRS/ Sara A. Fajardo

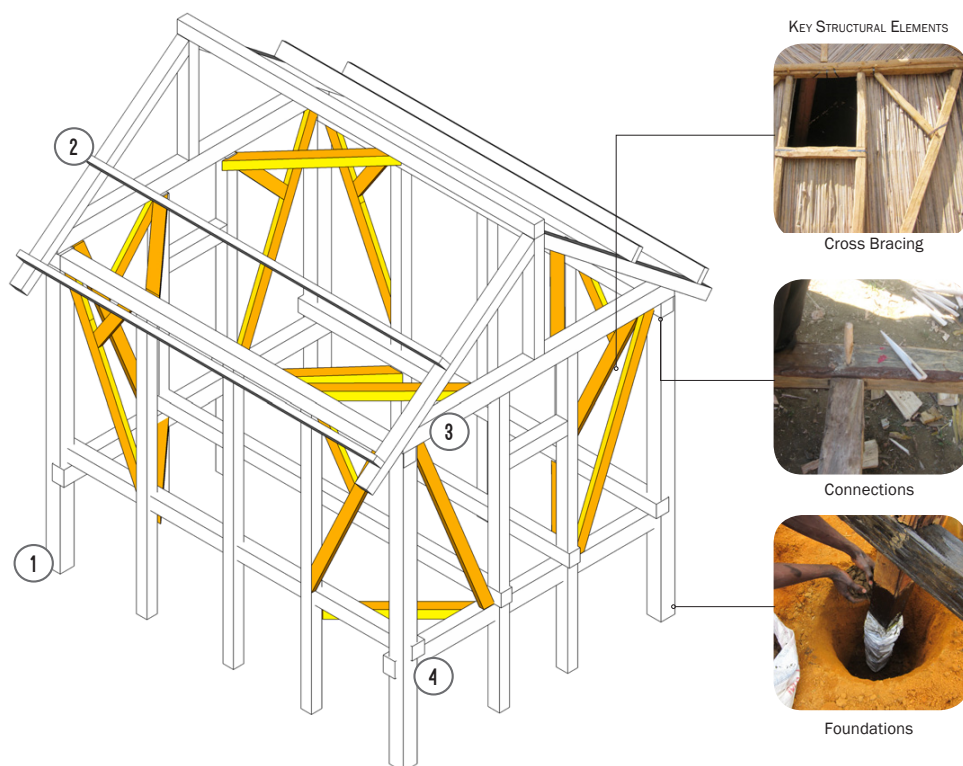
Axonometric 3D diagram showing improved structural components to shelter. Photo credit: CRS/Amanda Rashid

1 Columns Buried 100mm below grade in a gravel footing

2 Metal hurricane straps wrapped and nailed around connections for extra strength

3 Diagonal cross bracing in all planes

4 Mortise and tenon joints between members

Details of joints and connections, key to the structural integrity of the shelter. Photo credit: CRS/Amanda Rashid

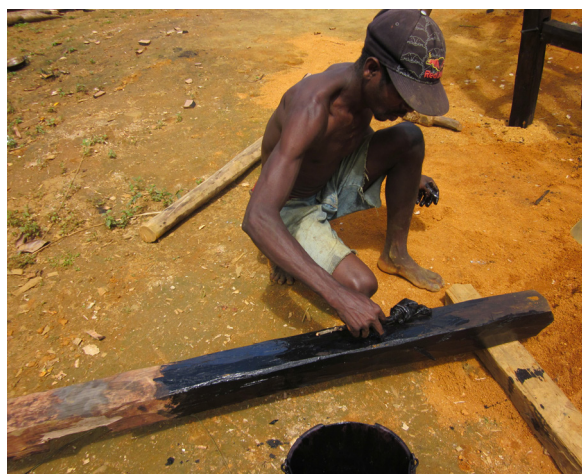
Structural members are treated with used engine oil, or similar to preserve and to prevent termite infestation. Photo credit: CRS/J.E. Andrianambinina

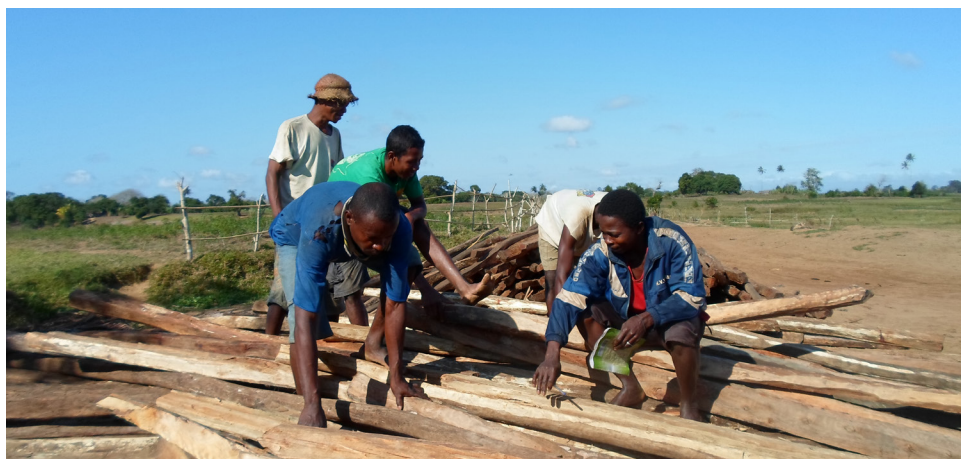
Shelter committee inspecting timber poles to ensure they are of a suitable quality. Photo credit: CRS/J.E. Andrianambinina
