## SITUATION OVERVIEW

### Location description

Haat Boma is in Korwai payam of Ayod county on the north west part of Ayod. It is bordered by Unity State on the west, Fangak County on the North and Canal/Pigi on the east.

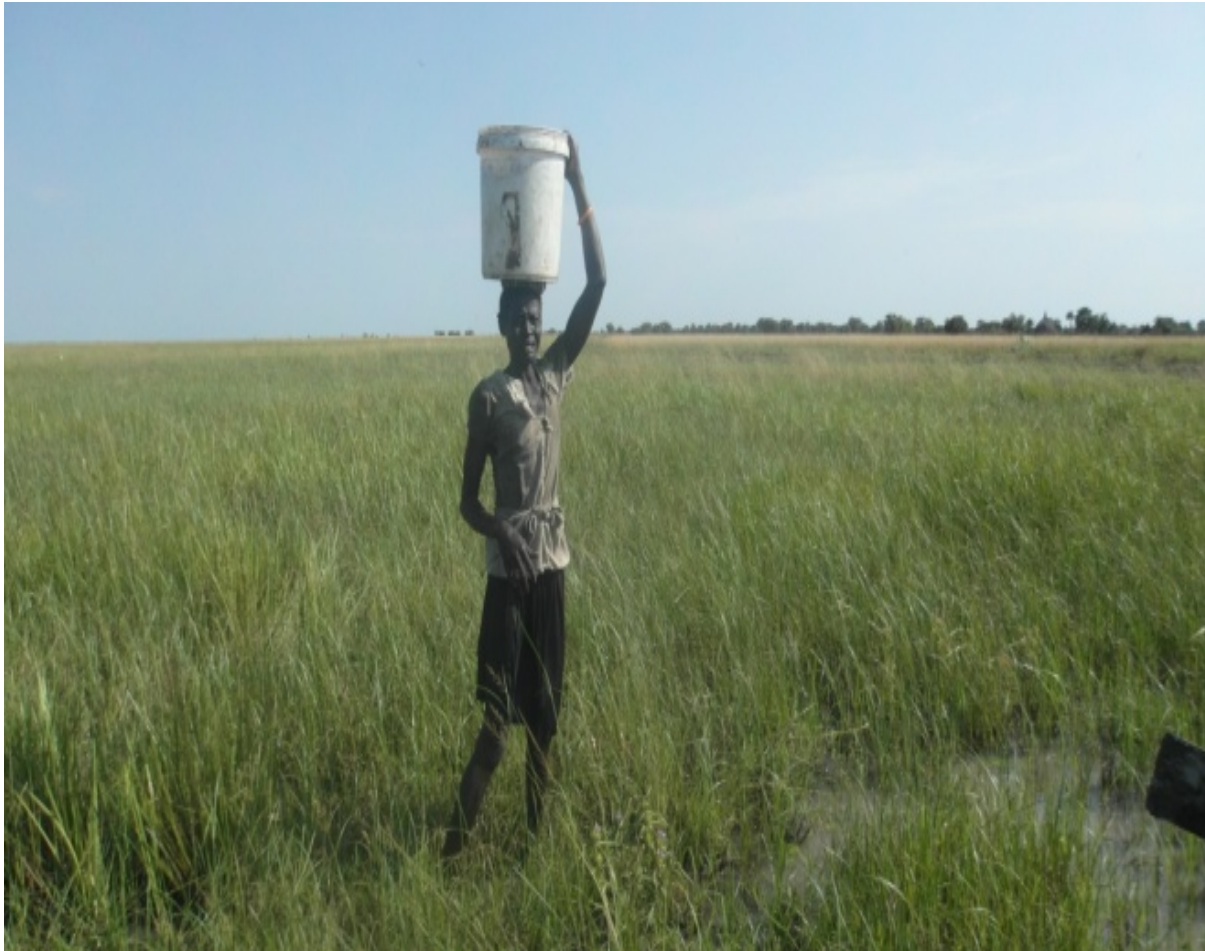
Figure 1 Woman from Collecting Water in White Nile in Haat

Currently there are no water sources in Haat, all the community is using water from the river, surface water and swamp with no treatment. Others collect water from Geraf -4km away and White Nile – 8Km away from our location depending on their proximity to the two locations.

- Distribution of water buckets and jerrycans for collection and storage of water.
- Distribution of Water Purifiers to purify the Nile water after collection

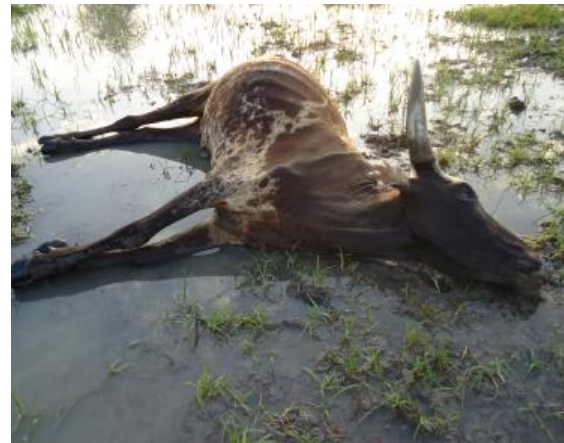
Figure 2 Dead Livestock

Though it should be noted that dead animals were often left where they had died without proper disposal due to lack of definite space for disposal due to flooding in most areas.

- Sensitization on proper disposal of carcass once an animal dies in the community.

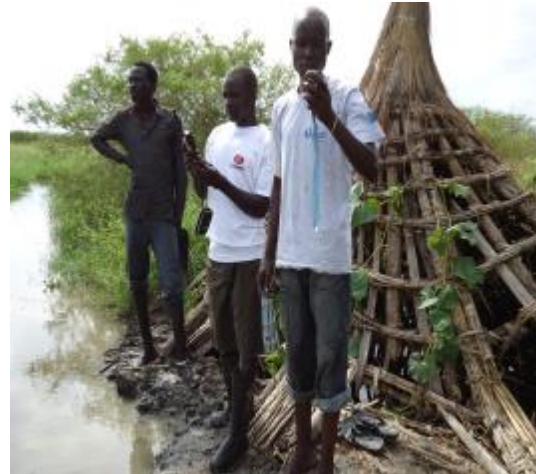
Figure 3 Haat Water Source

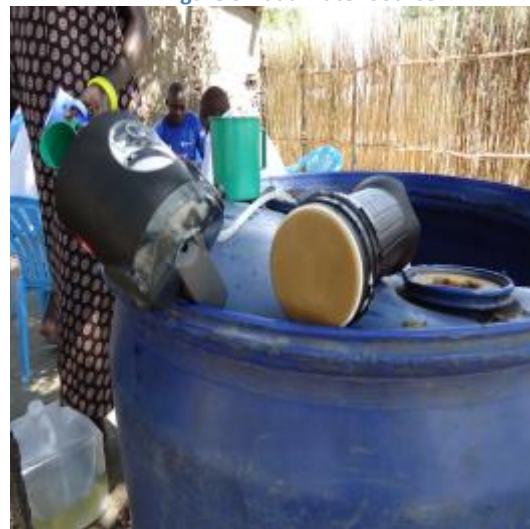
Figure 4 Ceramic filter after filtering 20l of water

- Sensitization on proper use of Pur if distributed

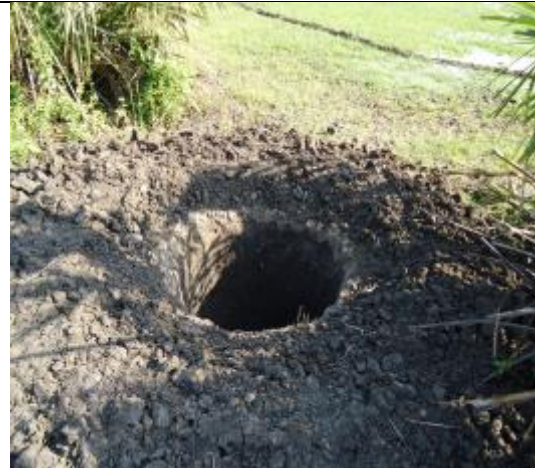
The only latrine was done by the team when they came on ground through hire of local labor and materials.

Figure 5 local latrine construction

- Sensitization should be prioritized for community to do HH latrines using local materials with little support to try end OD practice.
- Construction of latrines CFS for the children and teachers in Haat Primary school, PHCC should be considered.

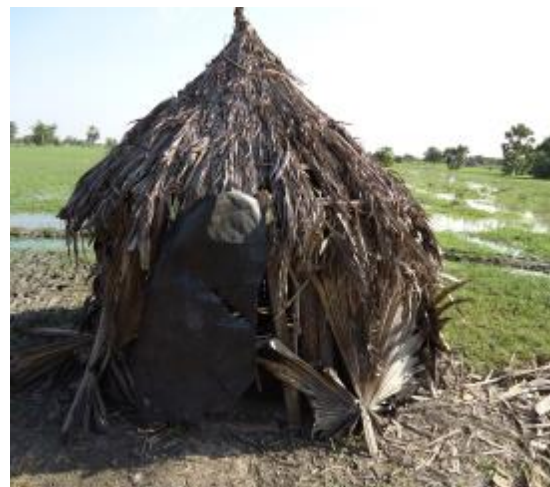
Once completed it was being used showing that the community is eager to end OD but need sensitization on construction of latrines. Challenge would be getting adequate space since most of the area is flooded with most high areas used for settlement.

Figure 6 Complete local latrine

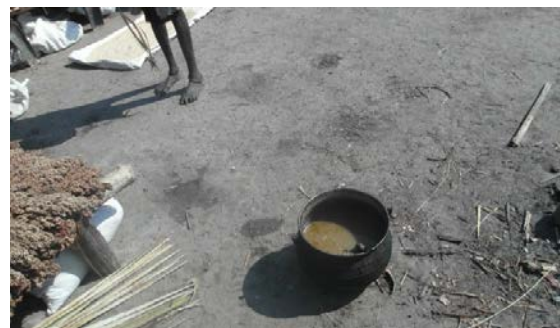
Figure 7 Photo of Shared Cooking pot

Most of the community have been displaced by floods with houses observed abandoned in the areas visited. The market in Haat is completely submerged and inaccessible. Most displaced host community has been forced to share limited high places sharing local shelters with incoming IDPs. Families including IDPs were observed to share housing, utensils, water collection jerricans and buckets.

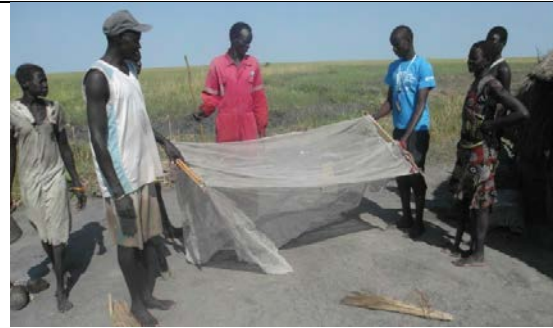
Figure 8 IDP from bentiu showing old shared mosquito net

- Training of CHP to help in to conduct sensitization about Hygienic practices in the community
- Training of local communities and monitoring their use of Pur incase distribution is done.
- Distribute PHCU kits for treatment of common diseases
- Distribution of soap and handwashing facilities for the PHCC
- Distribution of Mosquito nets to Pregnant and lactating mothers

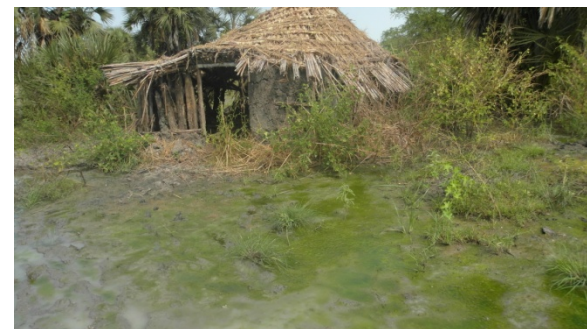
Figure 9 Abandoned settlement due to flooding

- Distribution of Shelter materials; plastic sheeting and encouraging use of local poles to construct temporary shelters.

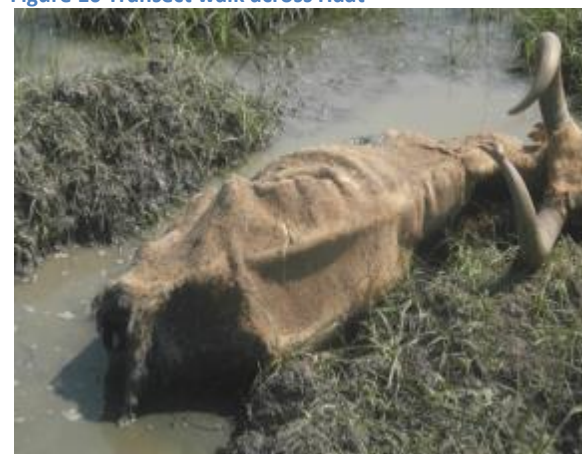
Figure 11 Dead Livestock
