Site and Shelter Assessment: UNMISS Compound Bentiu

The aim of the mission was to undertake the Inter Agency rapid Assessment of the IDP camp in UNMISS Bentiu. The site was developed for POC in response to the displacement due to the fighting. This report is primarily focused on site density, infrastructure and facilities, and shelter in the site.

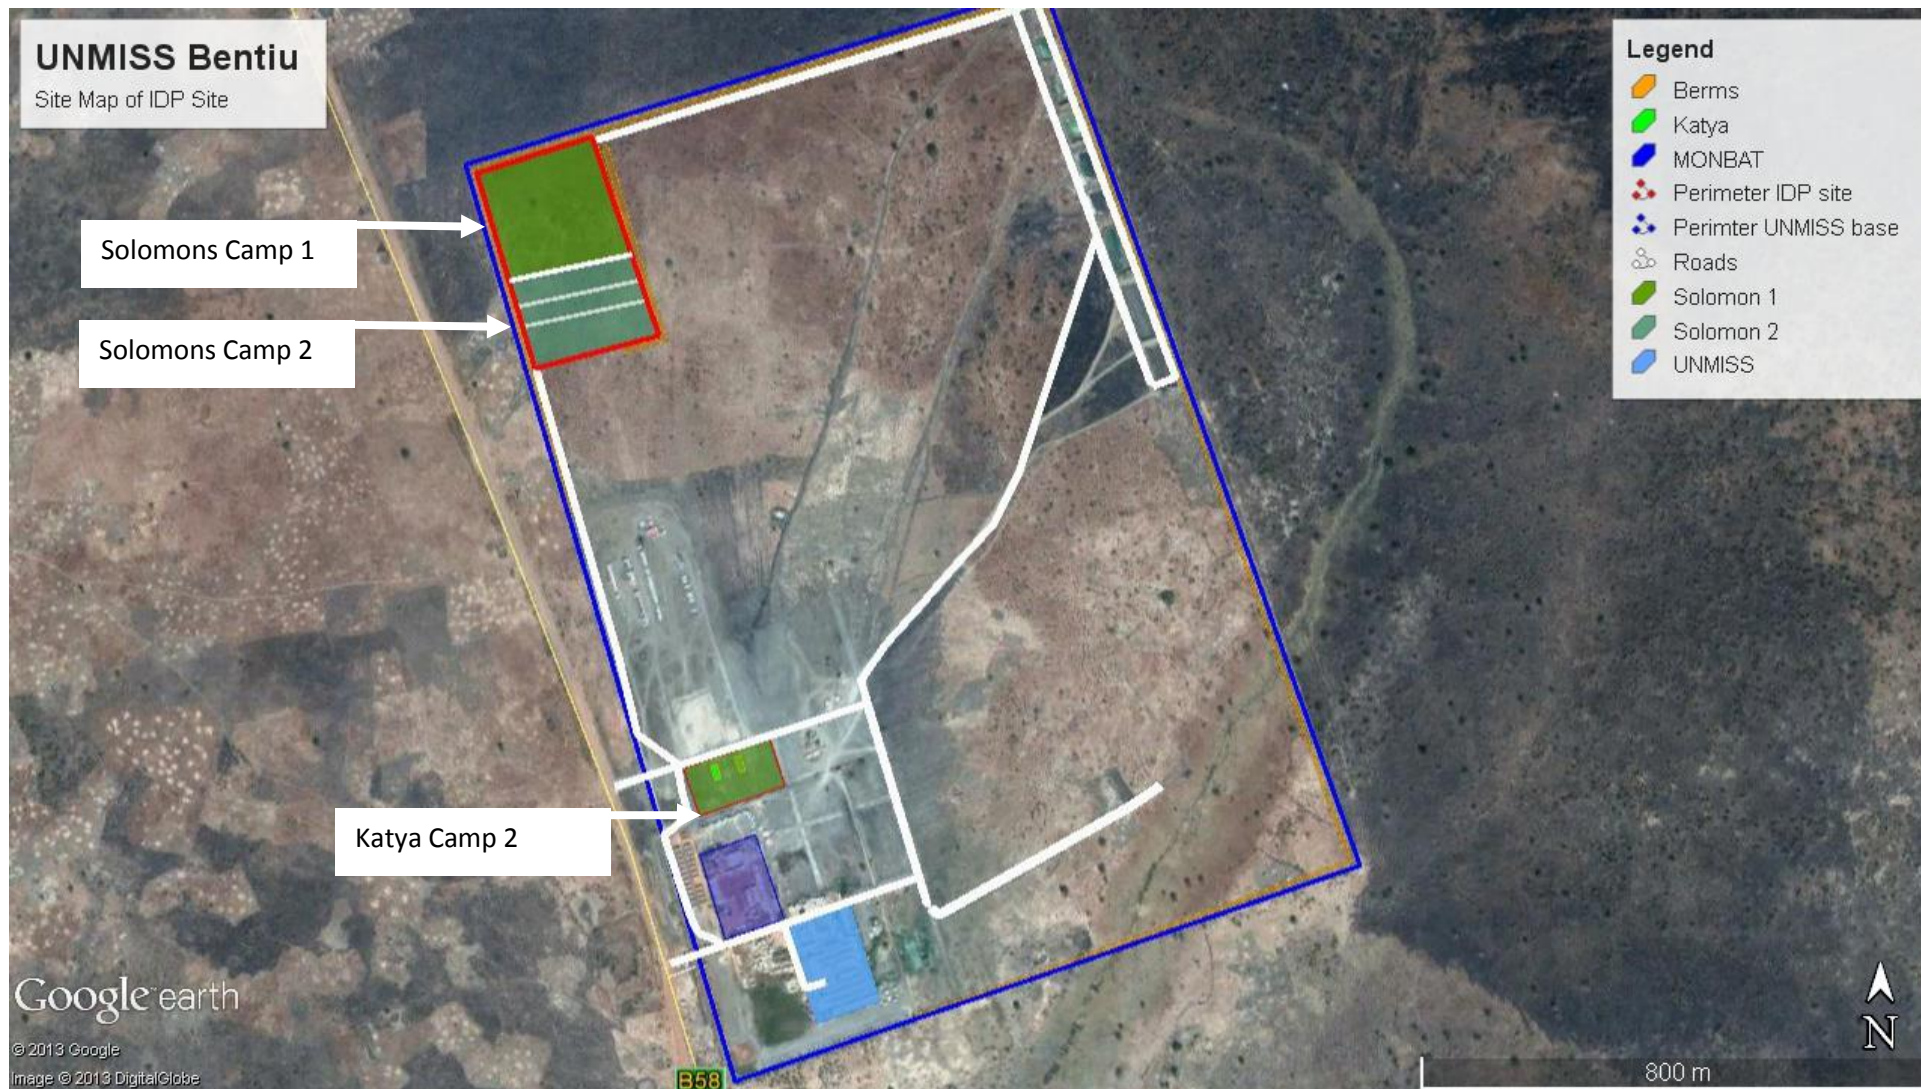
Aerial Photo of site with IDP Camp illustrated:

Site area 7.24 ha (rough perimeter approximately 204m x 354m) in total, within the site boundary which is formed out of large berm approximately 2m high. A water-filled moat lines the north and west boundaries. Newly created trenches line the east and south boundaries, the soil taken for berms.

The site has been levelled. A perimeter road runs on the inside of the bunds, a main intersecting road divides the site almost at mid point.

The NORTH sector (named SOLOMON 1 = 4.15 ha) of the site is occupied by all the IDPs, approximately **7,500 IDPs (UNMISS estimate, pending confirmation)**. **Current density is 5,5m² / person.**

The SOUTH sector of the site (named SOLOMON 2 = 3.08 ha) has just been completed with levelling. Two interim roads run laterally. Some spontaneous settlement has already begun in this section.

The site is due to be decongested by relocating some IDPs to Solomon 2. **The density of the site will reduce to 9.6m²/person.** While this is severely below Sphere standards it should be noted that:

- Comprehensive site planning is needed to ensure that all sectors are adequately provided for and that the density of the site does not compromise the safety and dignity of the IDPs.

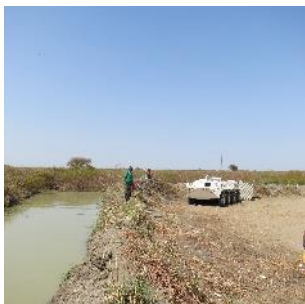
Berm and water filled 'moat' along west and north boundary edge.

- Additional materials may be required to enhance the durability of the traditional shelters.
- Household items are needed, including blankets and nets. The temperature was noted to drop severely at night and the presence of the water-filled berms increases the mosquito presence and malarial risk.

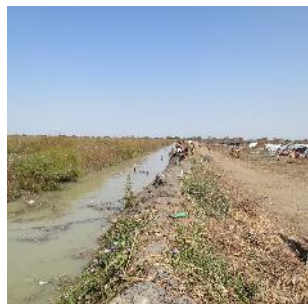
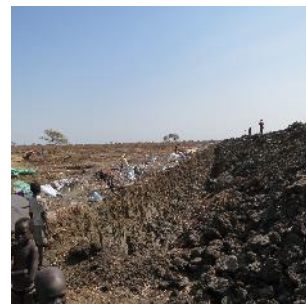
The defensive berms are almost completed around the site perimeter.

Berm along east boundary newly constructed

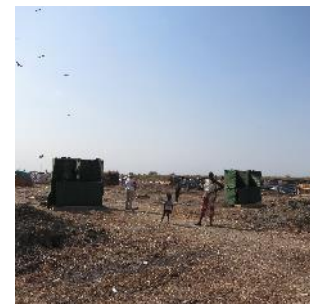
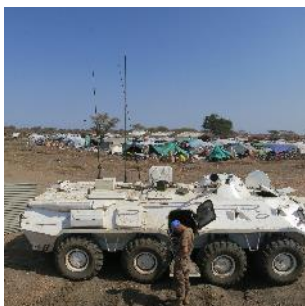
Shelter sizes vary, some are as little as 4m², average 12m². Occupancy could not be established on this mission. Spacing between shelters is as little as 10cm in some cases, but average 1.5 m in Solomon¹.

View of site from NW corner

- Spacing between shelters must be increased to meet minimum fire safety requirements with appropriate fire breaks established.
- Sanitation lines and refuse pits are required.

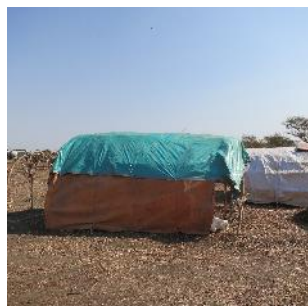
The shelters in the site are predominantly self-built using a combination of local materials salvaged from the area, namely small timber poles and long grasses, and what people had carried in, such as sheets. 600 plastic sheets have been distributed, allowing beneficiaries to construct traditional shelters that mirror the local vernacular. However, this represents approximately one third of the households.

Examples of traditional shelter construction out of the long grasses growing locally

- A comprehensive shelter strategy is required to ensure adequate shelter for the displaced people. This should take into account the local vernacular and available materials, while also planning for the possibility of protracted displacement into the rainy season. The local market of readily available

materials (grasses) should be encouraged with advocacy for the provision shelter construction and a robust environmental management campaign to protect the areas resources.

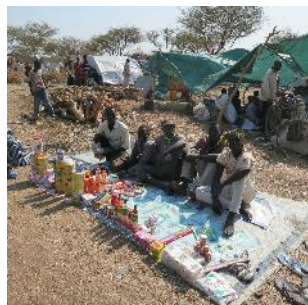
Informal market
