Post-Cyclone Sidr Family Shelter Construction in Bangladesh

Documentation of Plans and Processes

Shelter Working Group Bangladesh 2007-2009

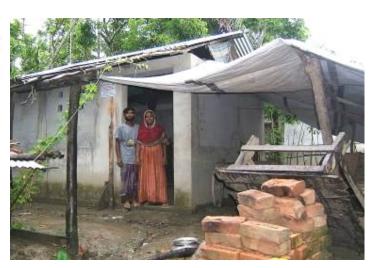
Photo 14: Tarpaulin used to store rainwater Photo 15: House owner bought bricks to fill up the core-house walls.

One agency built 172 permanent core houses in three months. Although they could not complete these houses nor provide water sanitation facilities, the important feature of these houses is that they are permanent structures with reinforced concrete columns and brick infill. The houses visited in Poshchim Shorailia where initially the agency planned to build 45 houses showed that 75 houses had been built, almost double than originally planned.

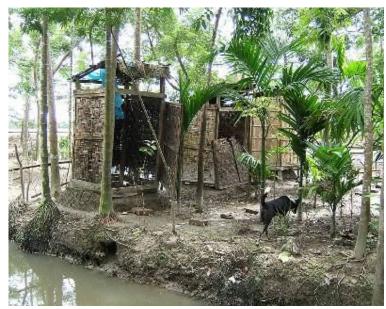
Photo 42: Latrines built without planning Morelganj 2009

Maintenance of water sanitation facilities can only be ensured if ongoing promotional activities are widespread and community committees are tasked to do so. Some agencies are working on hygiene promotion activities with local partners, while other's who built latrines with their emergency funds have left or stopped funding their partners. For example, toilets built next to each other, due to lack of space and lack of proper planning, are now neither being used maintained. Lack of land resulted in building more than one latrine in same place. This clearly shows the importance of community mobilisation and participation in health promotion to reduce waste of resources. Therefore agencies need to follow up to assess the performance of their delivered products, which can be done through case-by-case analysis together with the house owner.

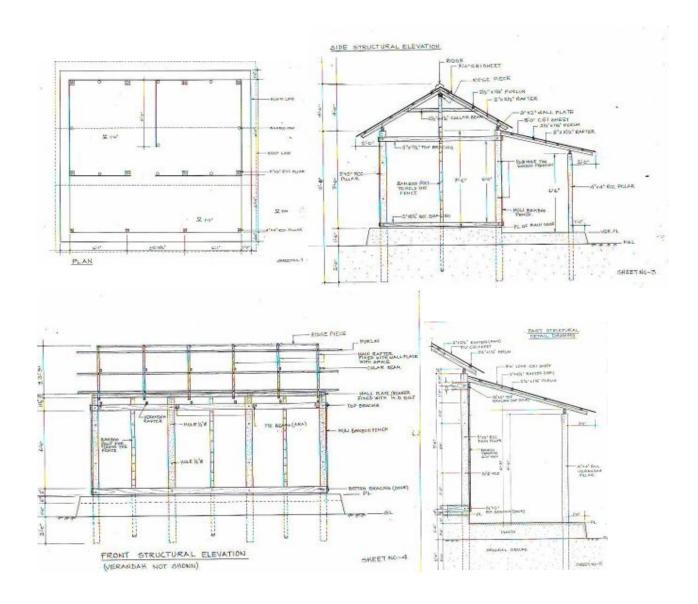
Structure: RCC pillars with bamboo posts and timber beams

Roof: **Timber frame with CI sheet Designed by:** CRS, Caritas
