Transitional to What?

Prepared as a technical document to assess a portion of the transitional shelters dispersed and discuss proposed methods for extending their expected lifespan if applicable to the shelter & site.

Architecture for Humanity / Habitat for Humanity

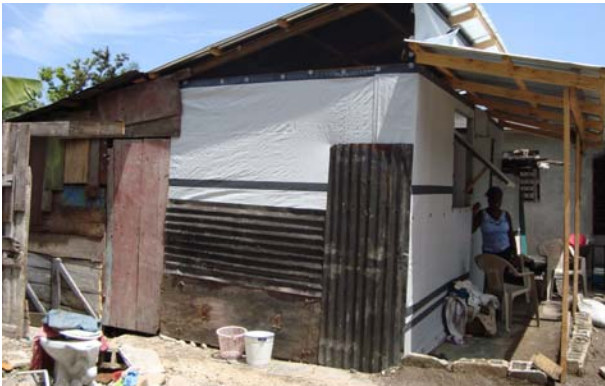
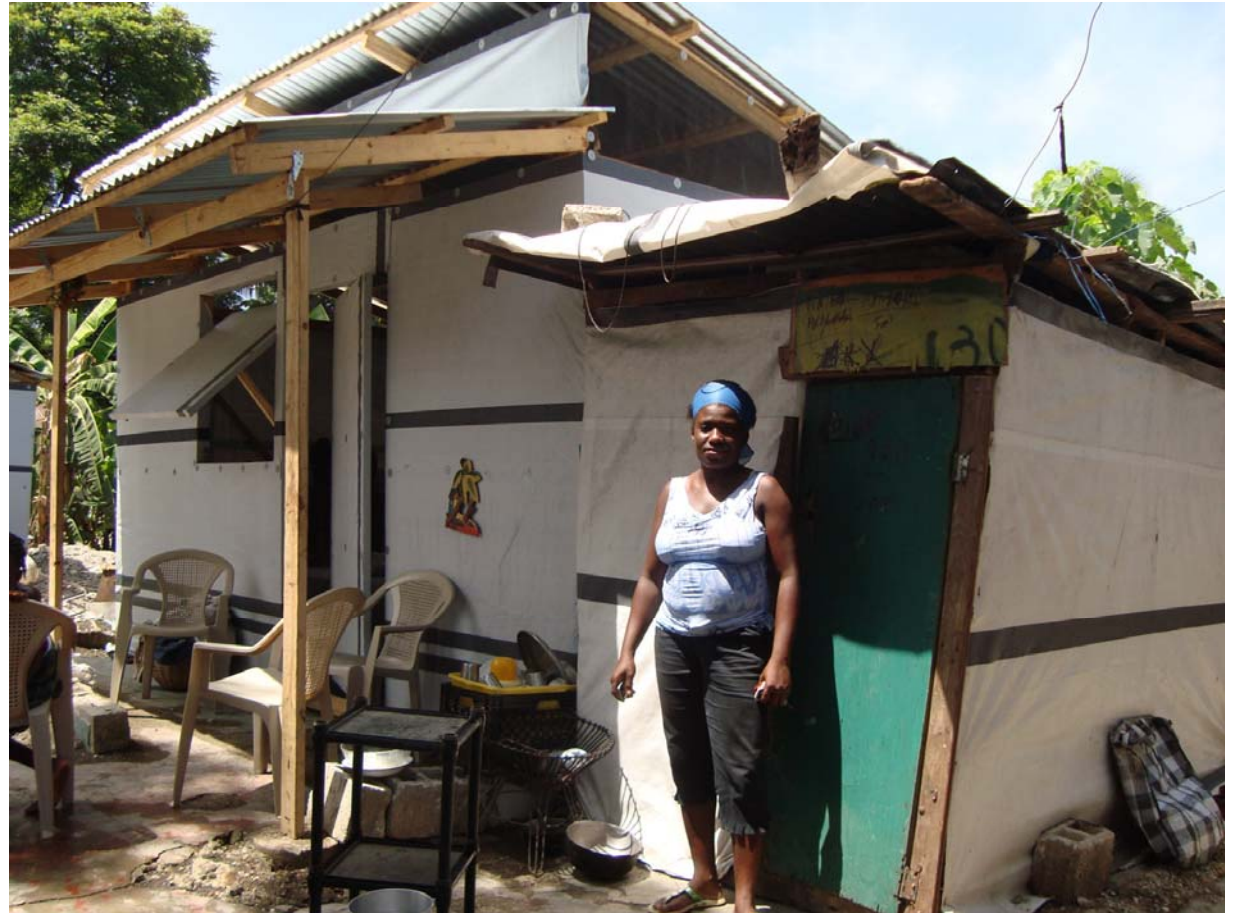
Site Survey-Habitat for Humanity

- Lack of Security with Tarp, Adding piece-meal siding
- Second Door Preferred
- Additional Covered Outdoor Area Needed
- Rain Blows in Gable End

- Safety/Siding
- Size
- Flooding Hazard; Water Infiltration @ Base
- Hurricane Hazard; Metal Roofing Nailed

- 1-3 years Extended Lifespan Potential

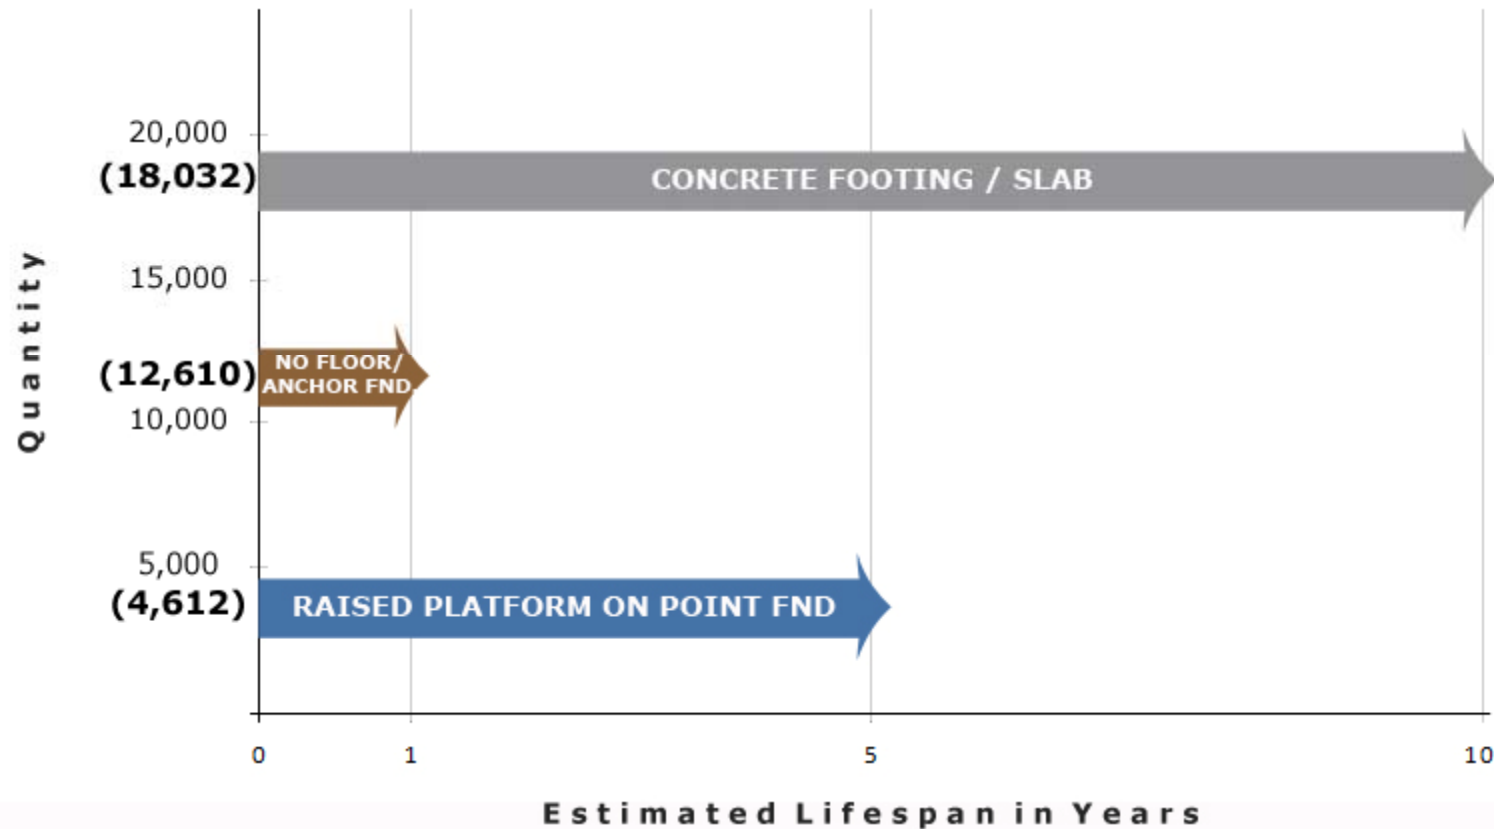
Case Study Review: 100-Concerns & Modifications

- Water Hazard
 - Ground Water Infiltration at Base
 - Wash out potential at shallow Footings
- Hurricane Hazard
 - Inconsistent methods w/ Hurricane Tie-Down / Strength of Footings

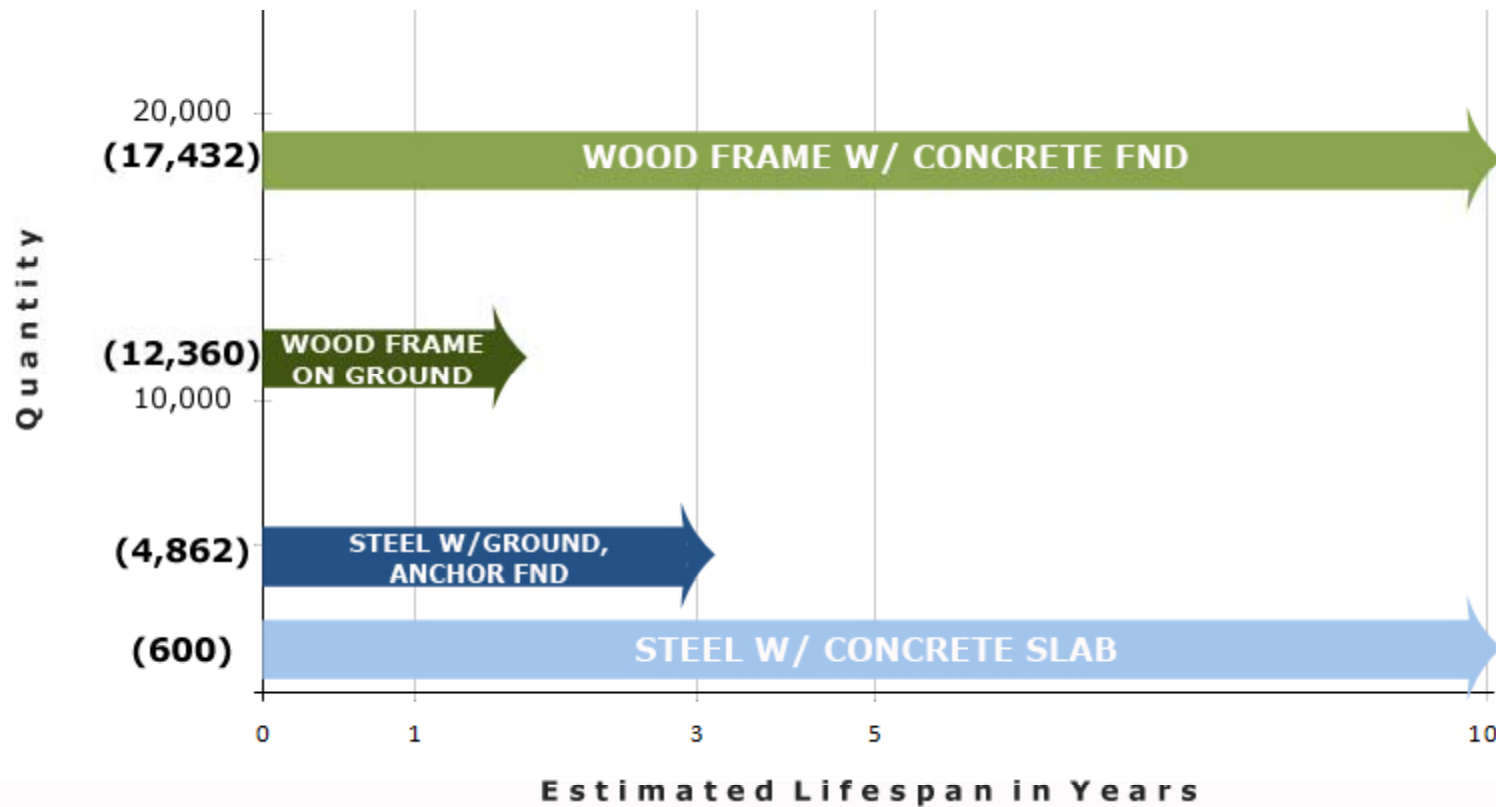
Case Study Review: 200-Concerns & Modifications

- Water Hazard - Contact with Moisture/Ground
- Hurricane Hazard - Inconsistent installation of Hurricane Straps (with-in companies & types)

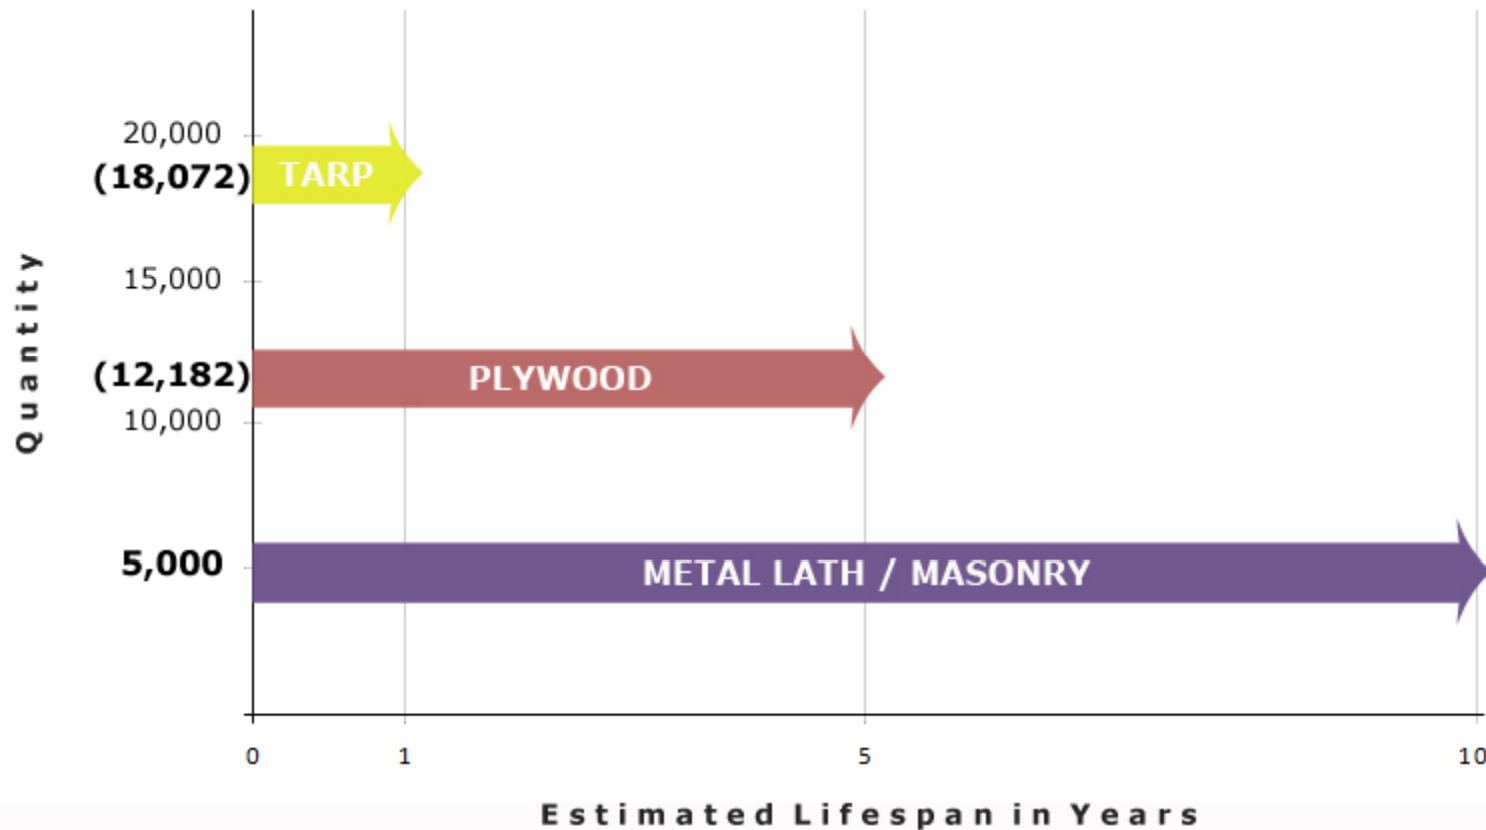
Case Study Review: 300-Concerns & Modifications

- Water Hazard
 - Roofing Leaks w/ Metal Frame
 - Durability of Tarp Siding, Tearing through at conn.
- Hurricane Hazard
 - Low Durability to High Winds w/ Tarps & Metal Roofing Installation Methods (nails not bent over, no screws)
- Other Concerns
 - Heat / Lack of Ventilation
 - Safety / Security of Tarps

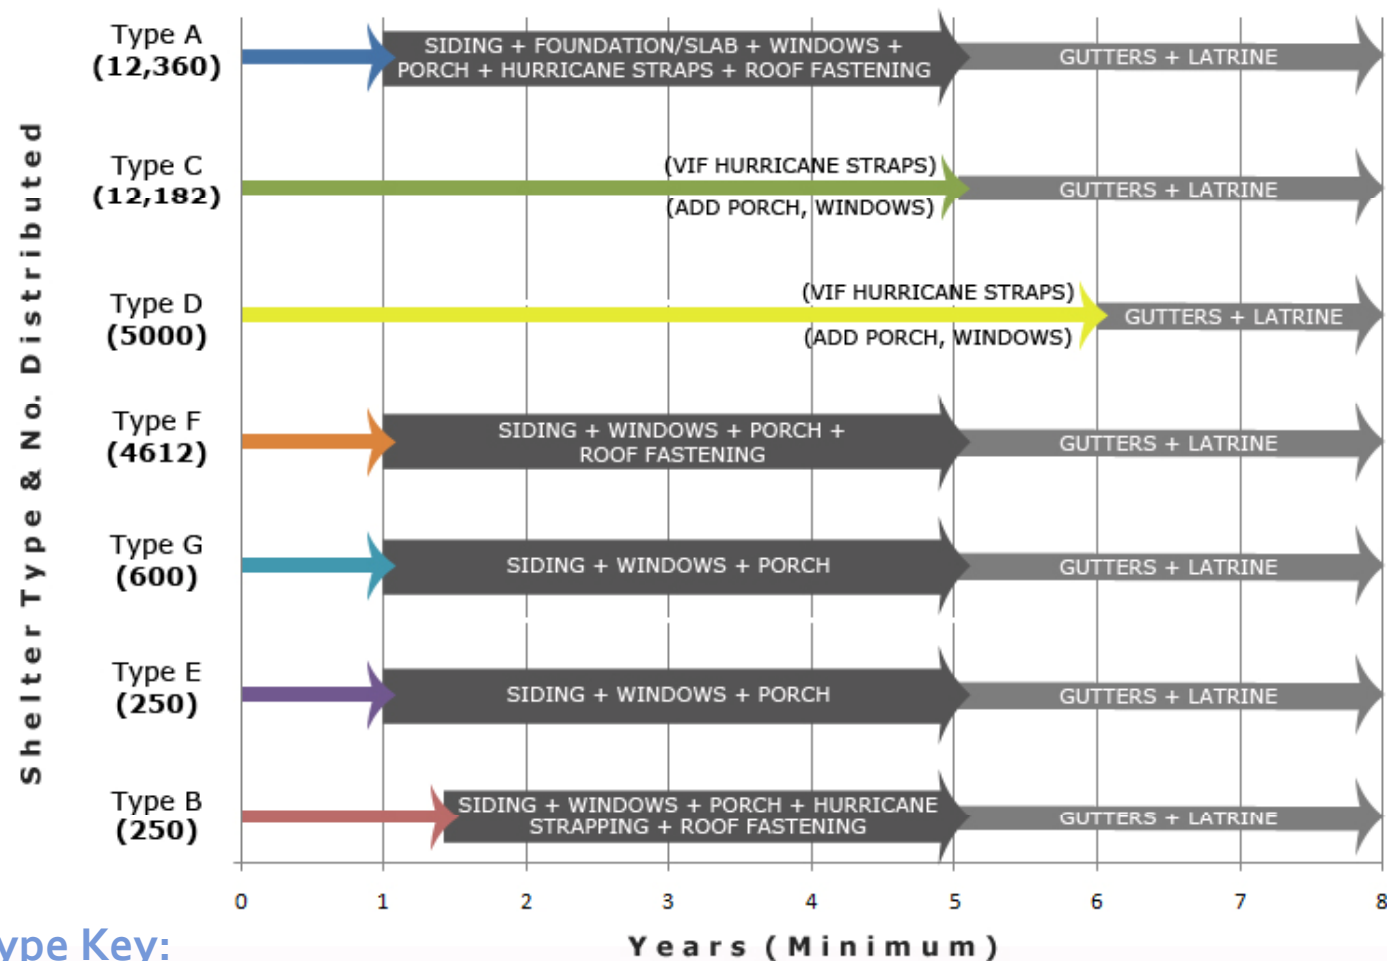
Case Study Review: Concerns & Modifications

- Insufficient Outdoor Covered Space
- Few windows for Light & Ventilation
- Additional Door Preferred
- Latrine Not always Provided
- Water Collection Systems Needed (Gutters & Barrel)

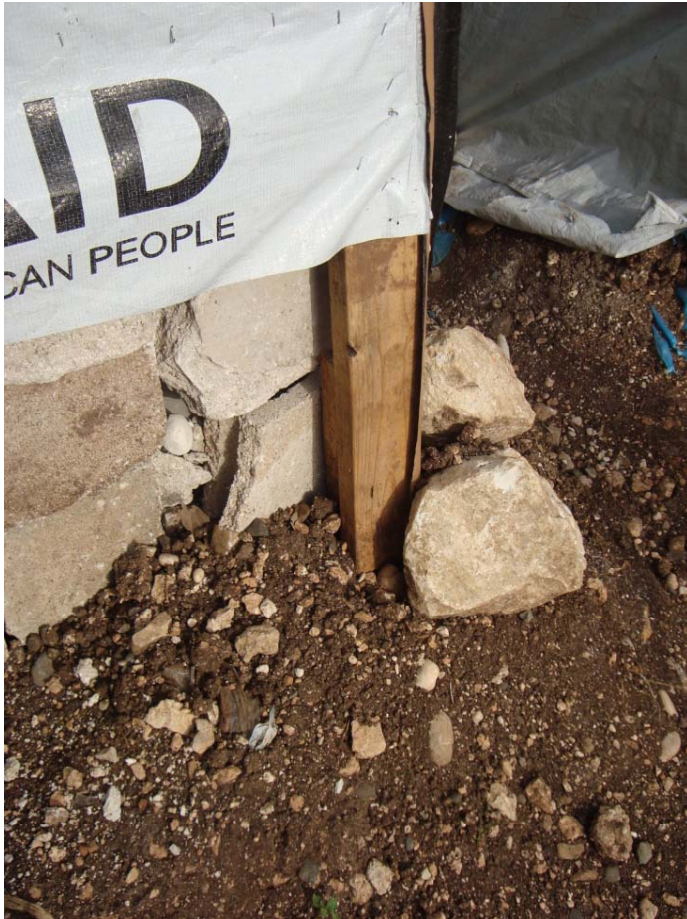
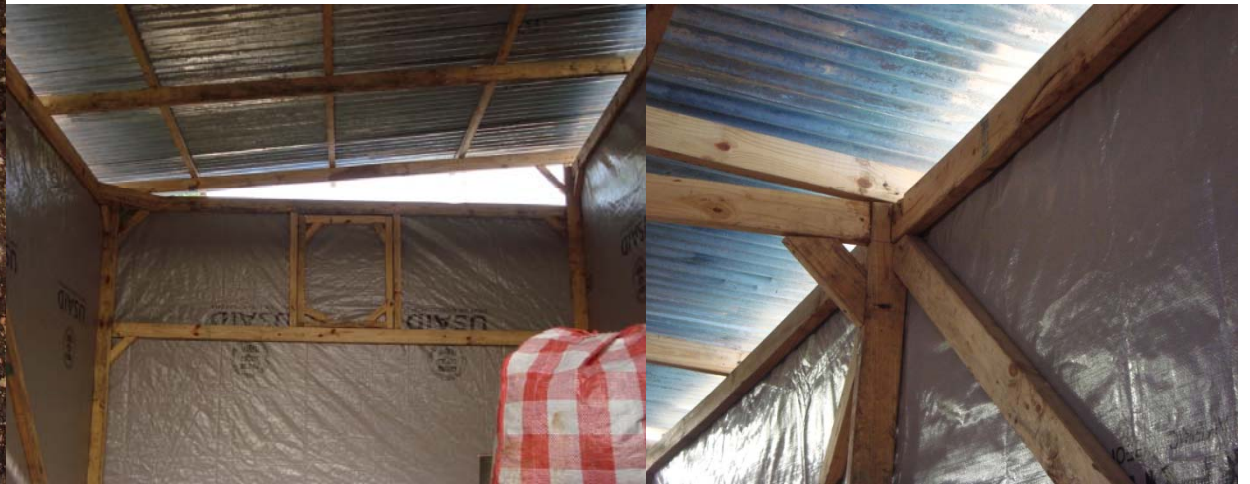
CHF-Type 1 Port-au-Prince

Beneficiary Feedback / Modifications:

- Lack of Security -Tarp
- Poor Ventilation
- Second Door Preferred
- Additional Covered Outdoor Area Needed
- Rain Blows in Gable End

- Security
- Heat/Ventilation
- Flooding Hazard; Water Infiltration @ Base
- Hurricane Hazard; Metal Roofing Nailed, no straps at roof/wall or posts/foundation

- 1-3 years

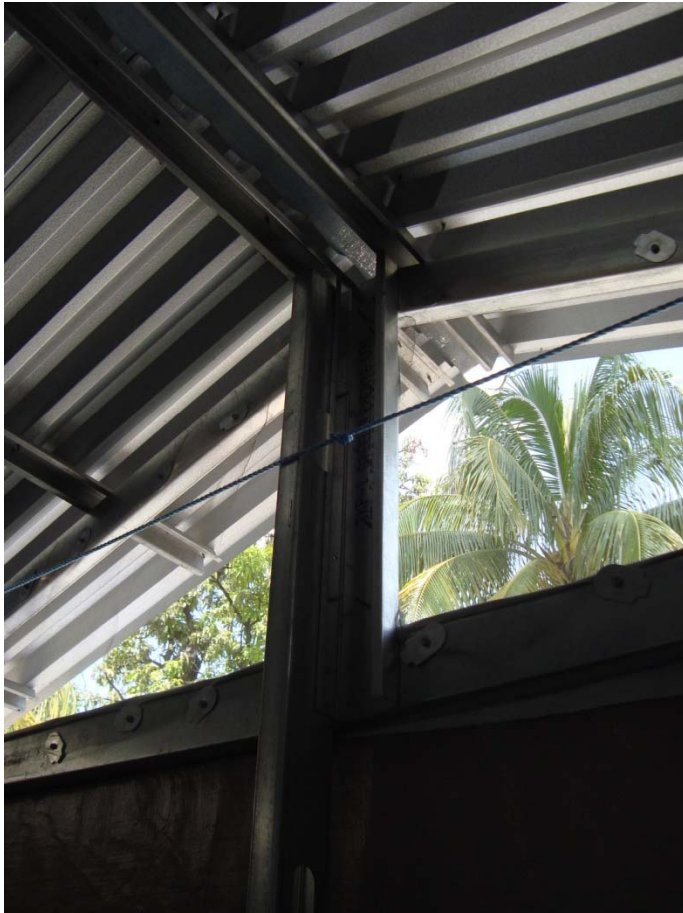
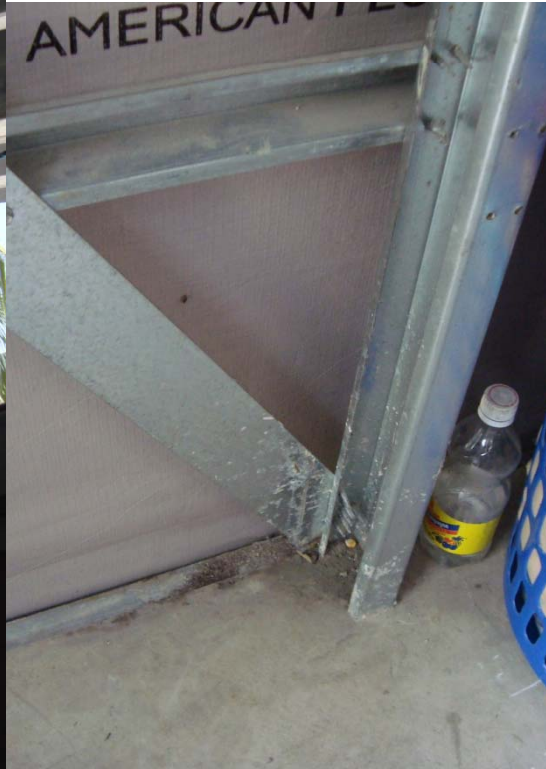
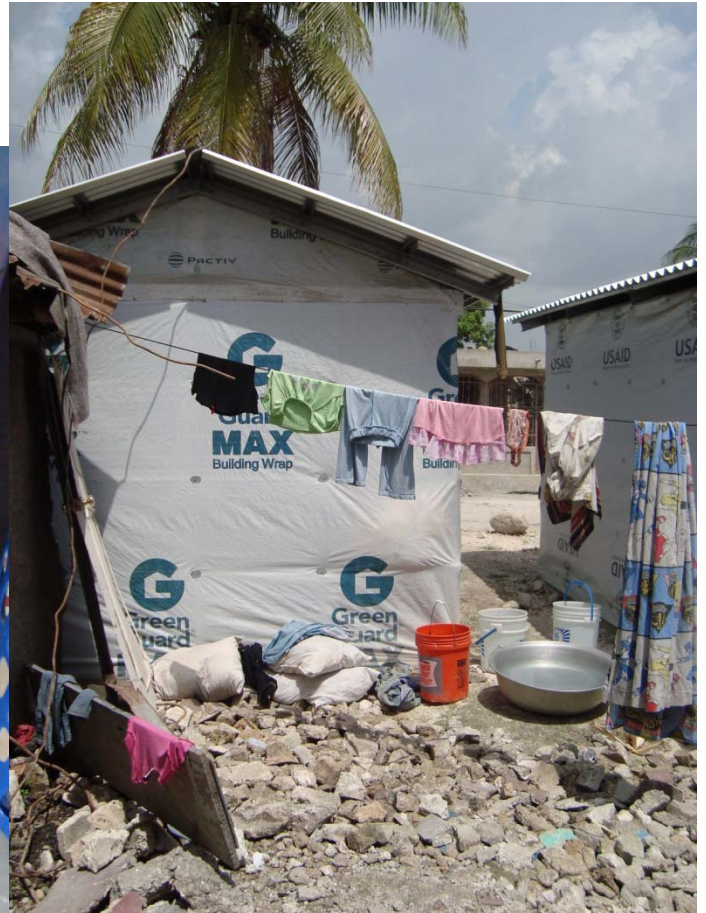
CHF-Type 2 Leogane

Beneficiary Feedback / Modifications:

- Lack of Security -Tarp
- Poor Ventilation
- Second Door Preferred
- Additional Covered Outdoor Area Needed
- Durability of Tarps
- Sharp Edges at Interior

- 1-8 years (extended lifespan potential)

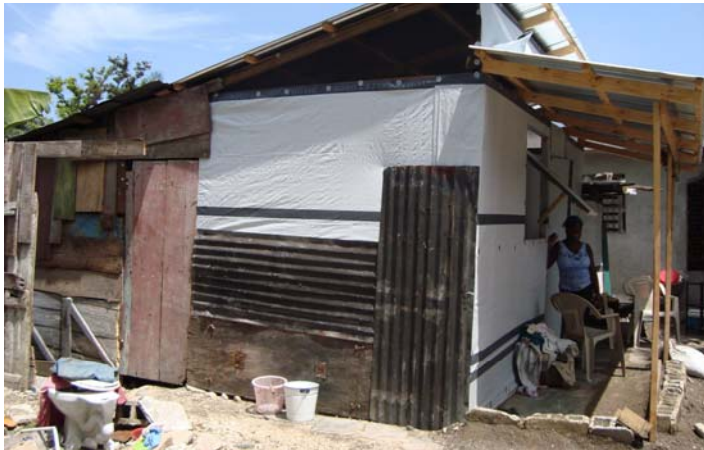
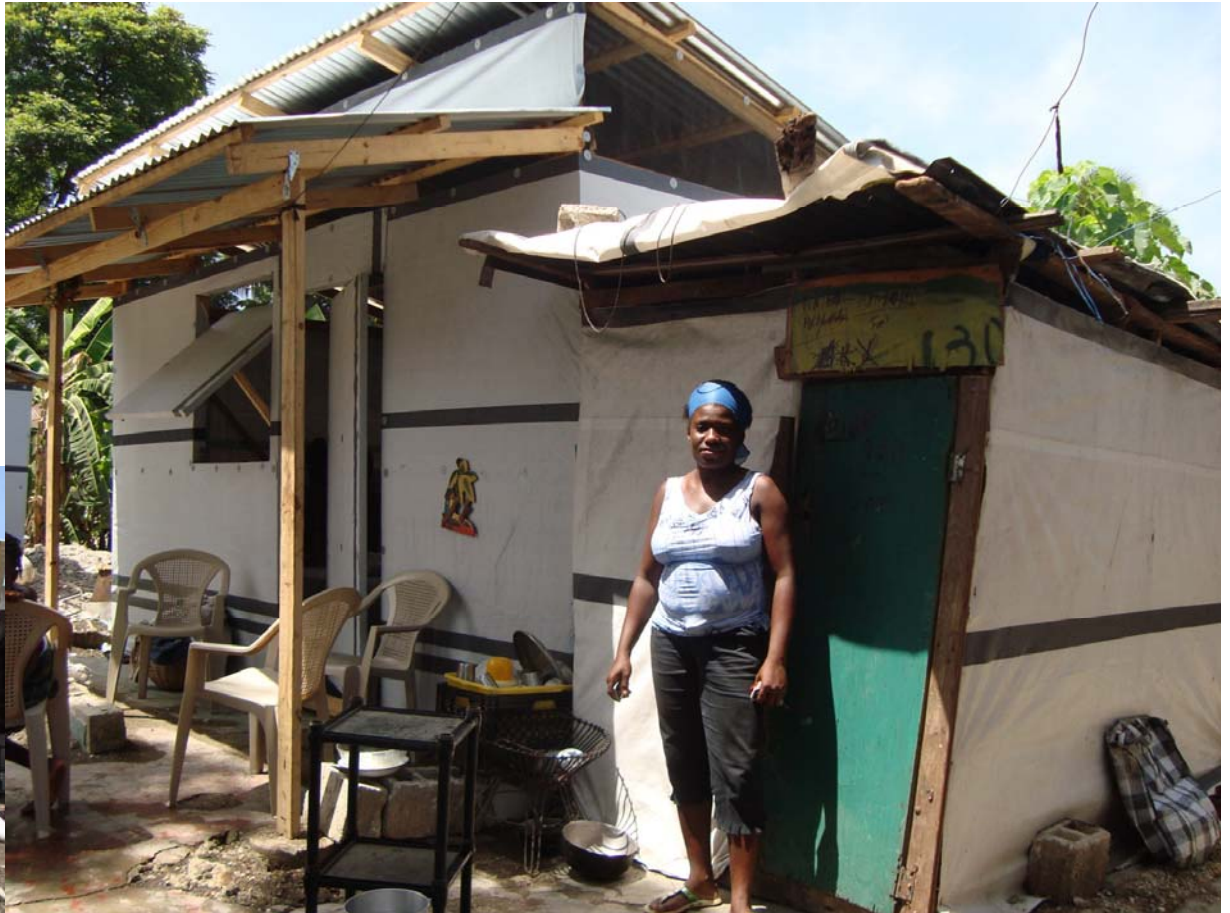
Habitat for Humanity

Beneficiary Feedback / Modifications:

- Lack of Security with Tarp, Adding piece-meal siding
- Second Door Preferred
- Additional Covered Outdoor Area Needed
- Rain Blows in Gable End

- Safety/Siding
- Size
- Flooding Hazard; Water Infiltration @ Base
- Hurricane Hazard; Metal Roofing Nailed

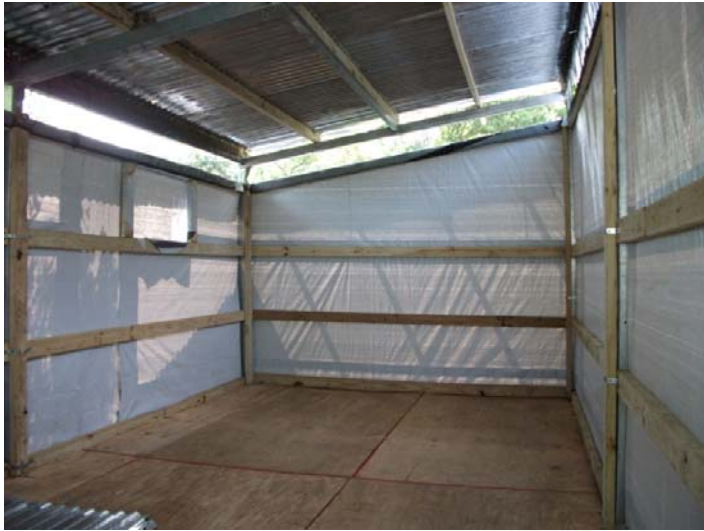
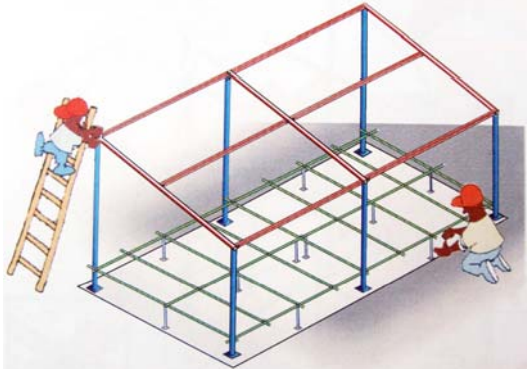
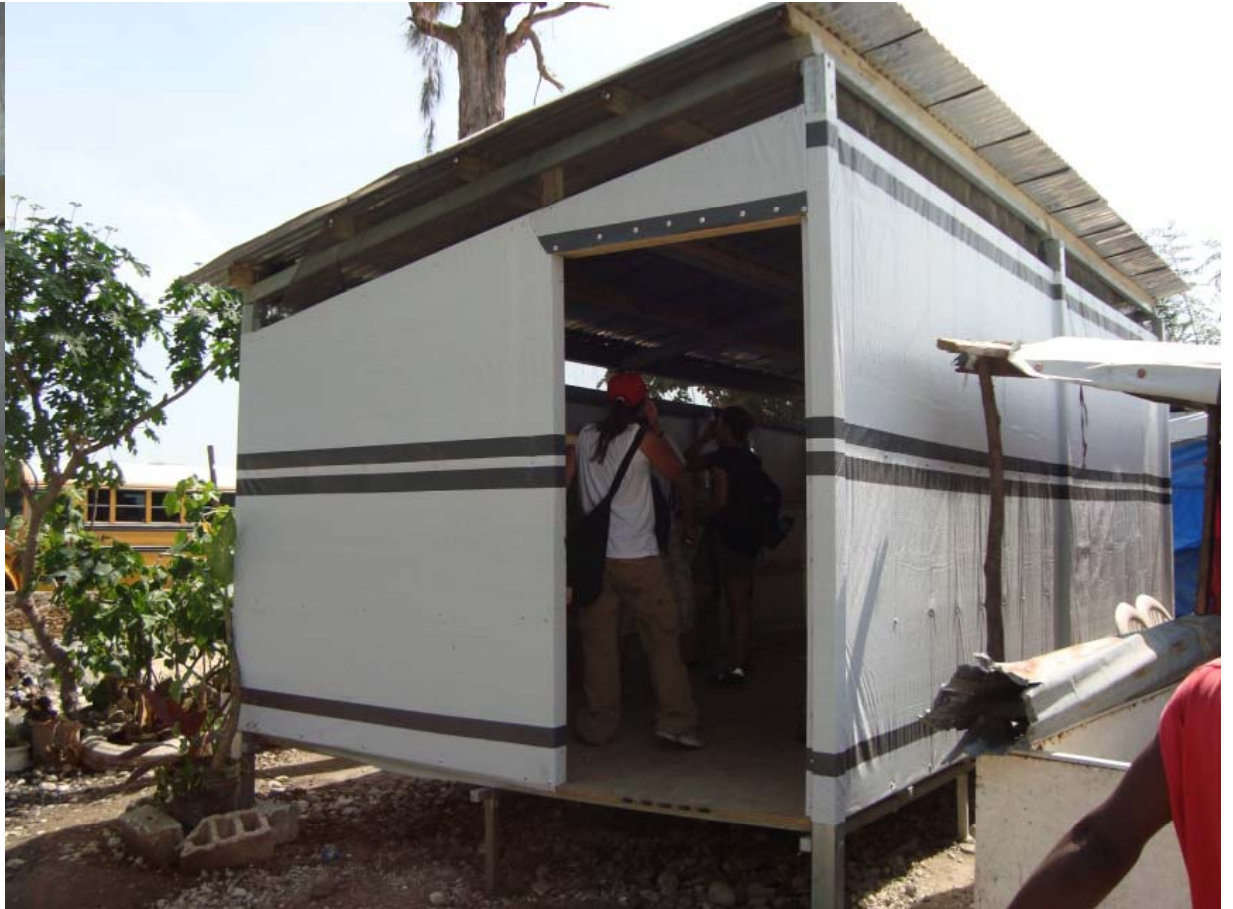
Samaritan's Purse

- Lack of Security -Tarp
- Poor Ventilation
- Second Door Preferred
- Additional Covered Outdoor Area Needed
- Ground Water Infiltration

- Security
- Heat/Ventilation Size - Add. Covered Area
- Flooding Hazard; Water Infiltration @ Base
- Hurricane Hazard; better tie to foundation

- 1-3 years

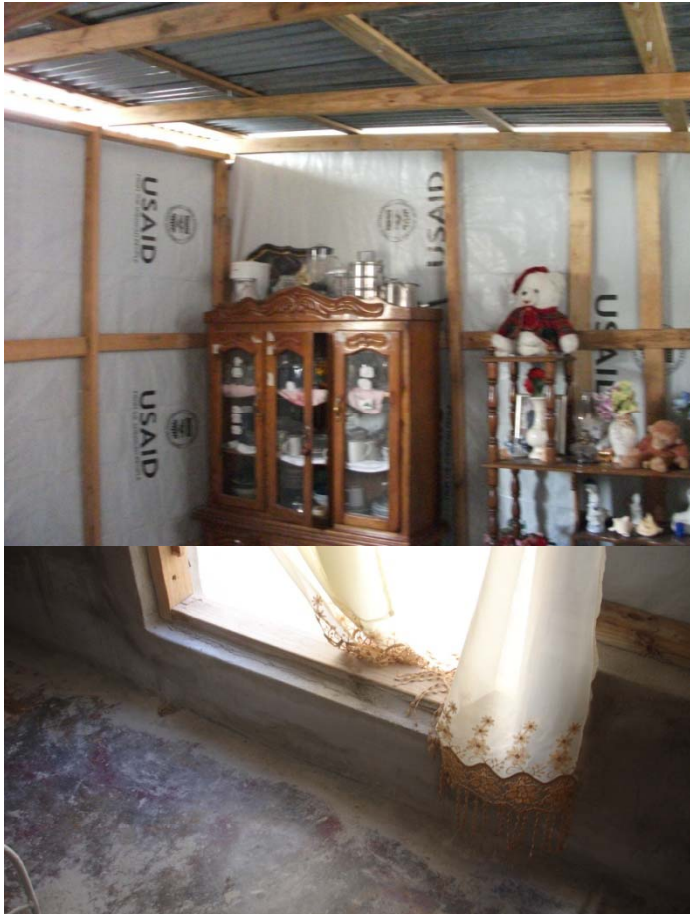
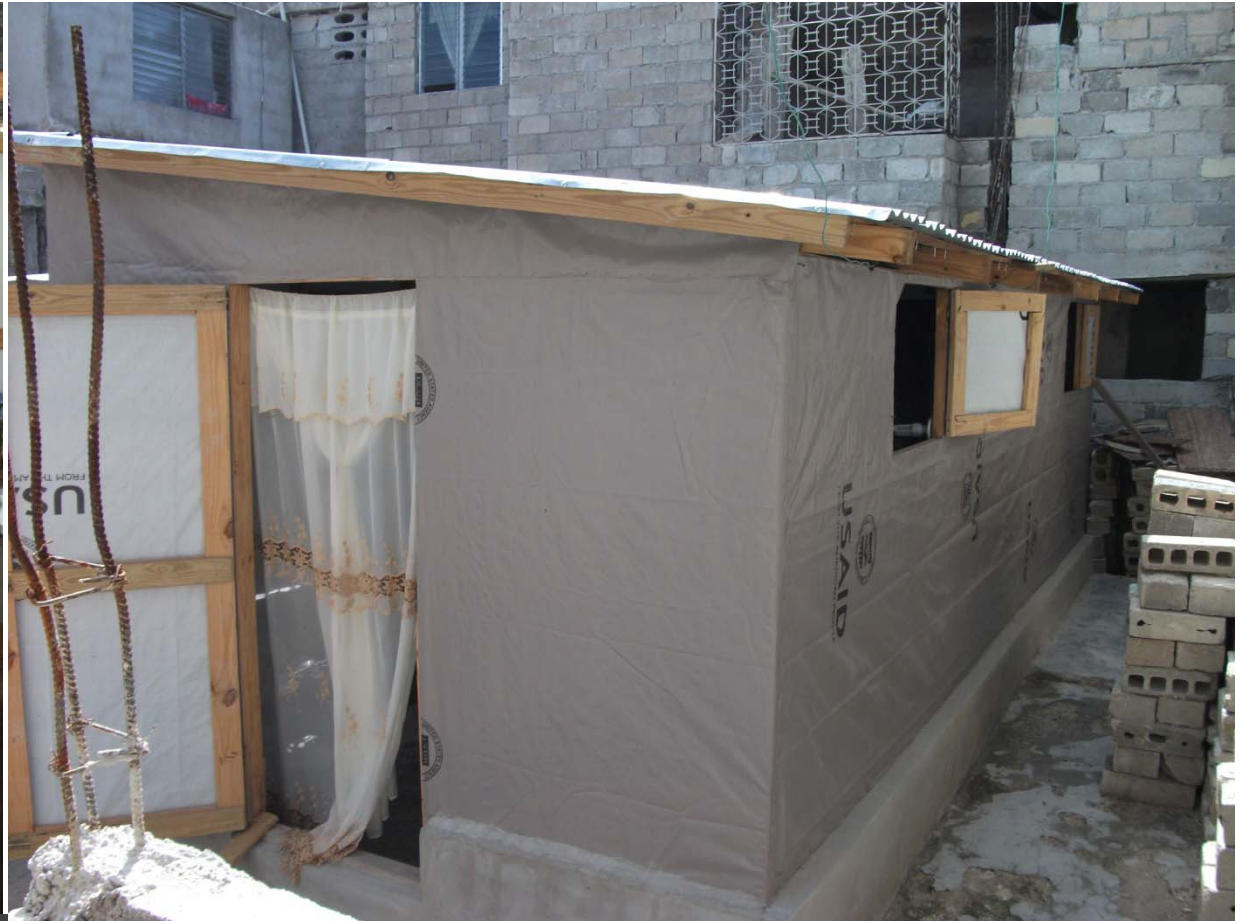
Spanish Red Cross

- Security
- Heat/Ventilation
- Size -Additional Covered Area
- Hurricane Hazard; siding

- 1-8 years, Extended Lifespan Potential

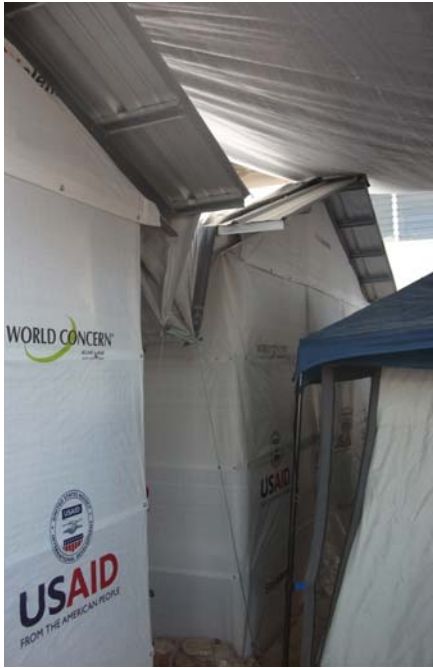
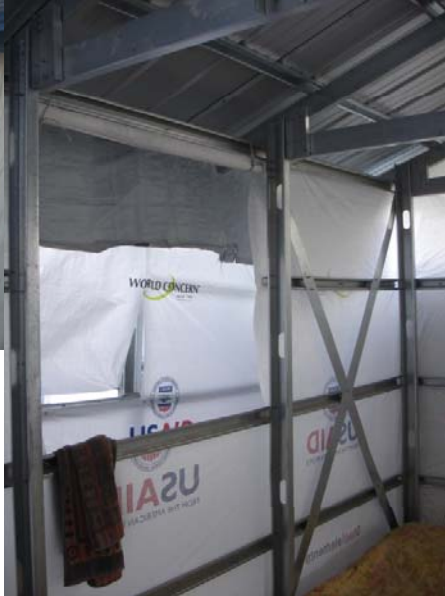
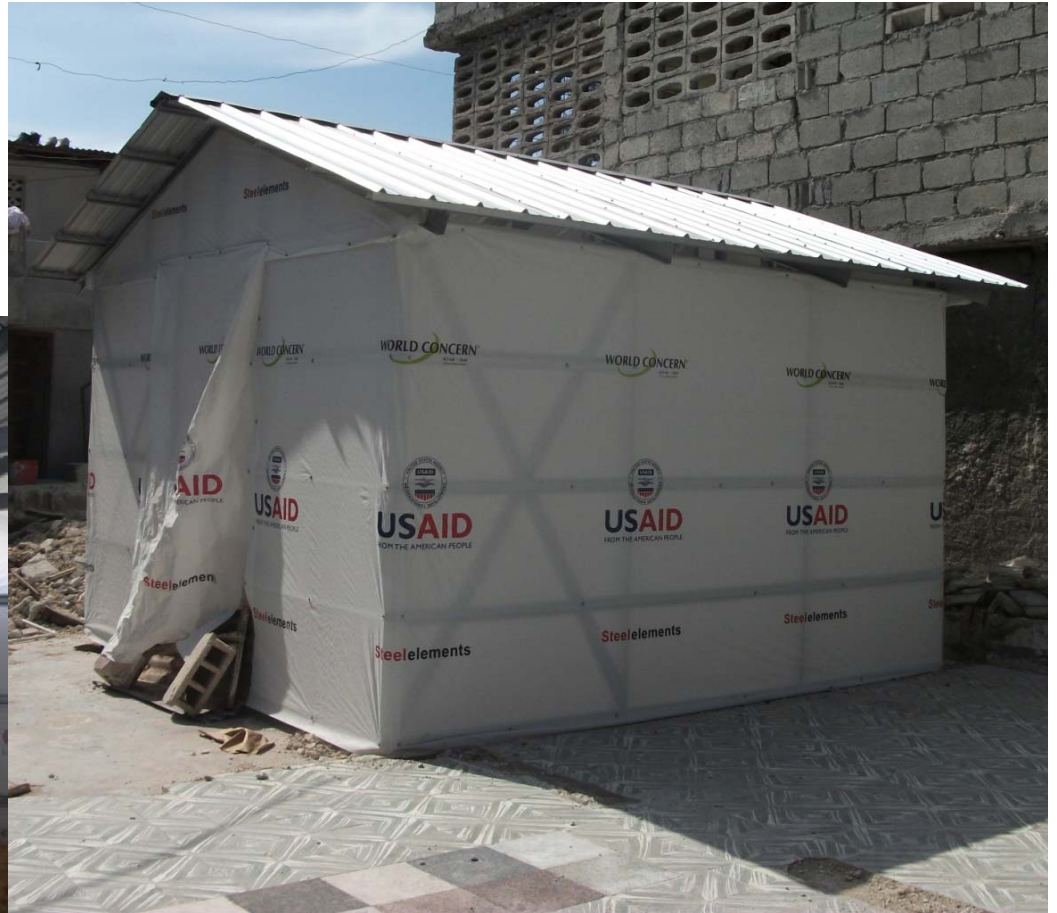
World Concern -Type 1

| ▪ # Dispersed: | ~250 | ▪ Foundation Type: | Concrete Point, Varies |

- Lack of Security -Tarp
- Poor Ventilation
- Second Door Preferred
- Additional Covered Outdoor Area Needed
- Roof Leaks at fastening points
- Water Infiltration @ Base

- Security & Durability of Tarp -pull through
- Heat/Ventilation
- Size
- Flooding Hazard - Water Infiltration @ Base
- Hurricane Hazard- Varying Found. Anchor Sys.
