**International
Hurricane Research
Center**

Shelter and Component Testing OFDA transitional shelters: materials, techniques and structures

Project Number: WOW12-2012-02

Shelter and Component Testing OFDA transitional shelters: materials, techniques and structures (Supplementary Test)

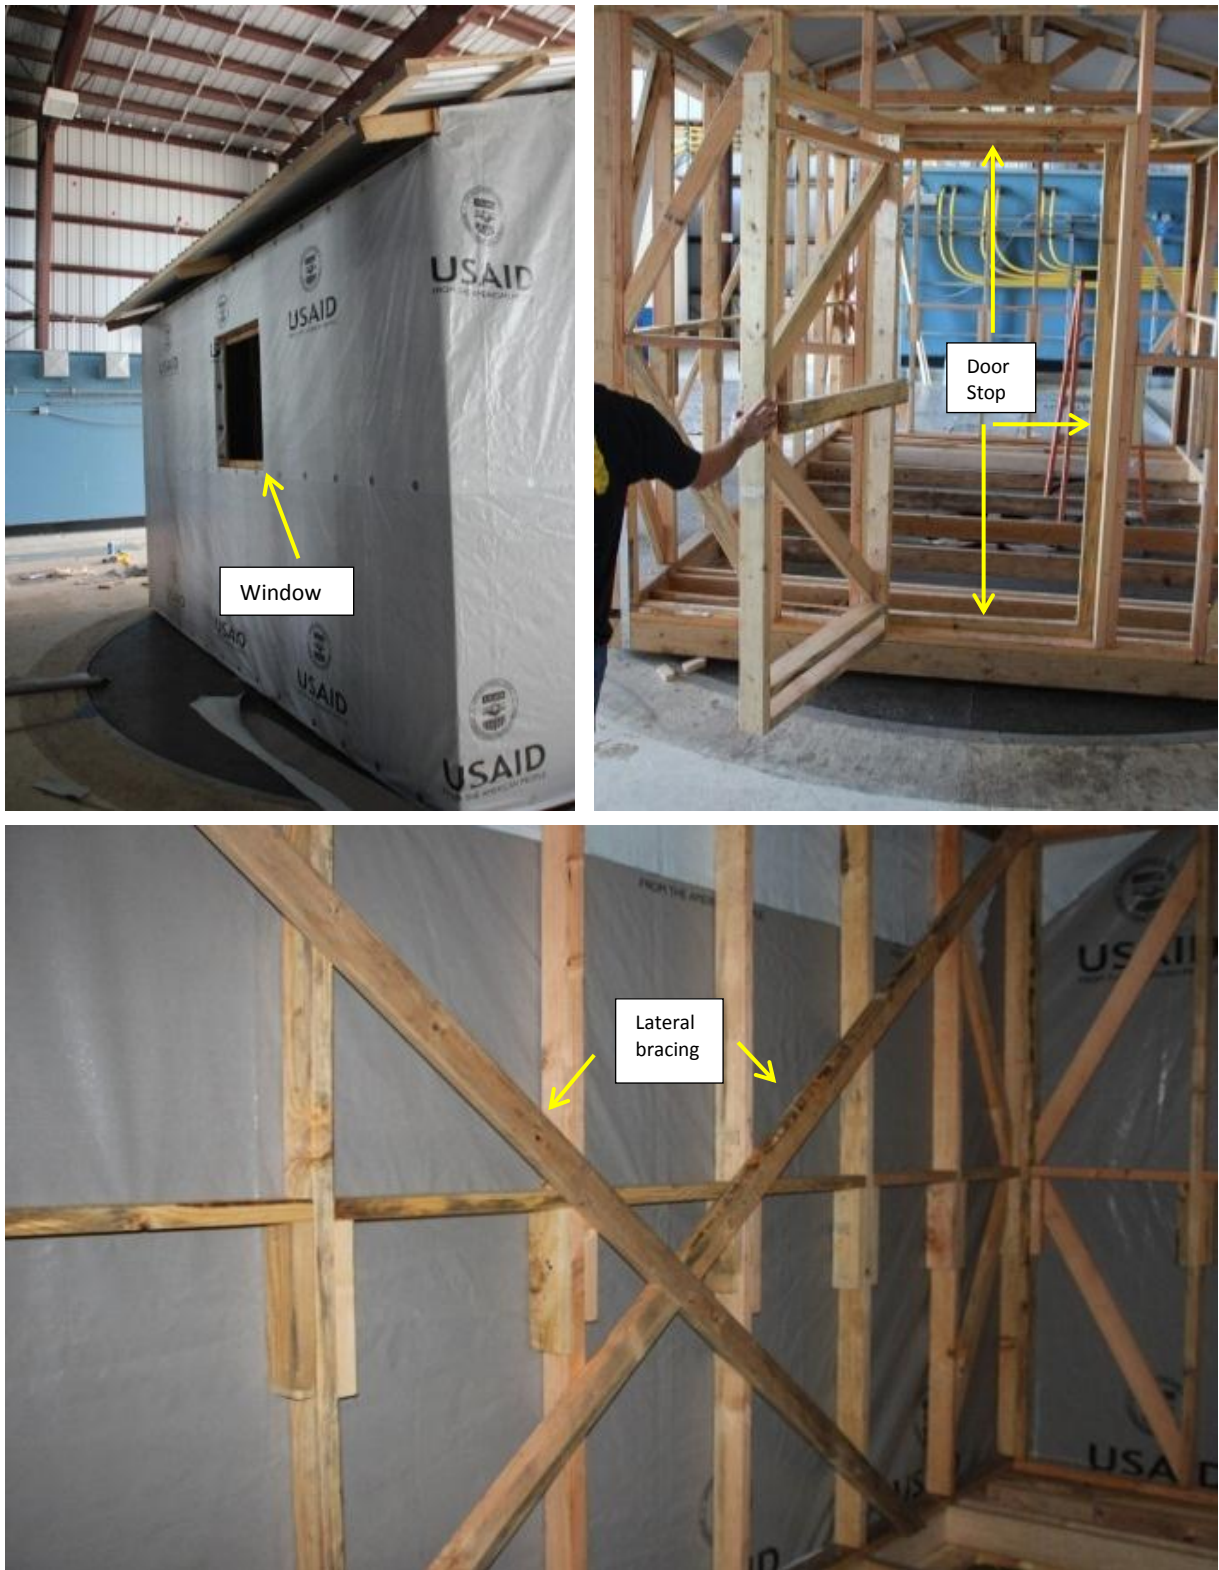
Figure 3 - T-Shelter model improvements for T-Shelter 3 testing

The following changes or additions were done to the T-shelter model as requested by OFDA (see Figure 3):

- Window on a non-gable end wall with a stop molding (built of 2-in x 4-in lumber) around the window frame.
- Provide continuous door stop molding all around the door opening and reinforce the hinge connections.
- Additional lateral bracing on non-gable end walls. A diagonal x-brace spanning the length of the walls was installed on both non-gable end walls.

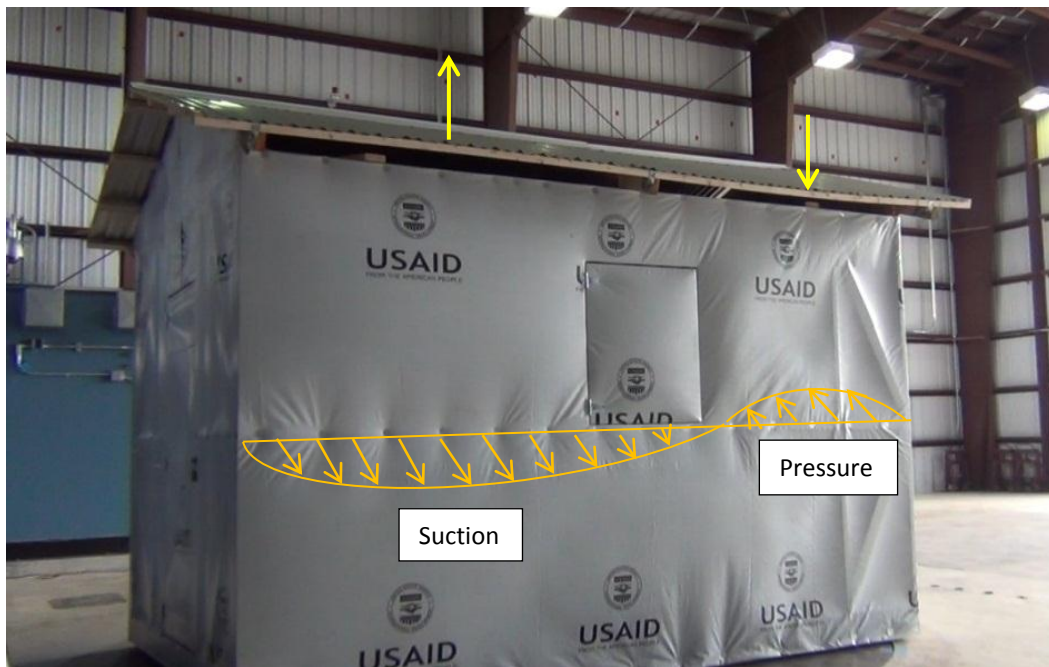
Figure 5 - T-Shelter 3 test at 85 mph and 90° angle of attack

The deformation of the plastic sheeting suggested that when the wind had a 90° angle of attack, the flow separated near the leading edges and reattached further downwind. This is shown on Figure 5: bloated plastic surfaces at the windward side (suction) and plastic being pushed against the frame on the back (pressure). The roof also seemed to be susceptible to this effect, particularly with the long unsupported spans of roof structure. The edge purlins can be seen deforming by the action of the wind-induced forces.

The goal was to prove that a stronger roof structure with the same spacing as T-Shelter 1 (weak construction T-Shelter from previous experiments) should be able to withstand hurricane force winds. Even with its stronger construction, large unsupported spans allow for greater deformations and flexibility. The vulnerability can be decreased by adding more trusses and reducing the clear spacing by half.

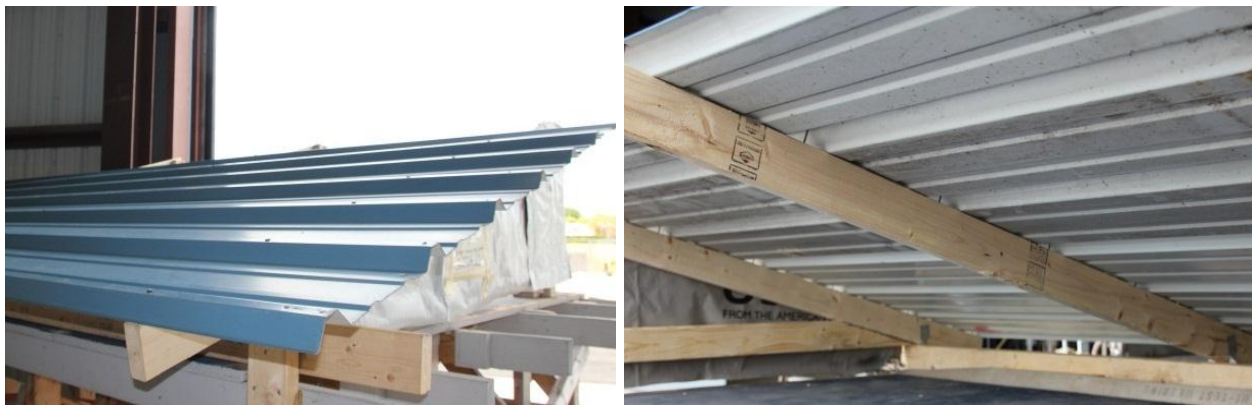
Figure 12 – 24-gauge PBR structural panel with no purlins or battens between rafters

A supplementary test not part of the original scope of work proved that 24-gauge purlin bearing rib (PBR) structural panels installed longitudinally on the roof rafters is an effective method of providing roof cladding (Figure 12). The test considered ring shank NEO roofing nails only. The purlins or battens were removed from the rafters and the sheets were directly nailed. It was observed that the ribs on the sheets provide enough structural rigidity to the roof system to sustain winds of up to 80 mph at angles of attack of 0 and 90 degrees.

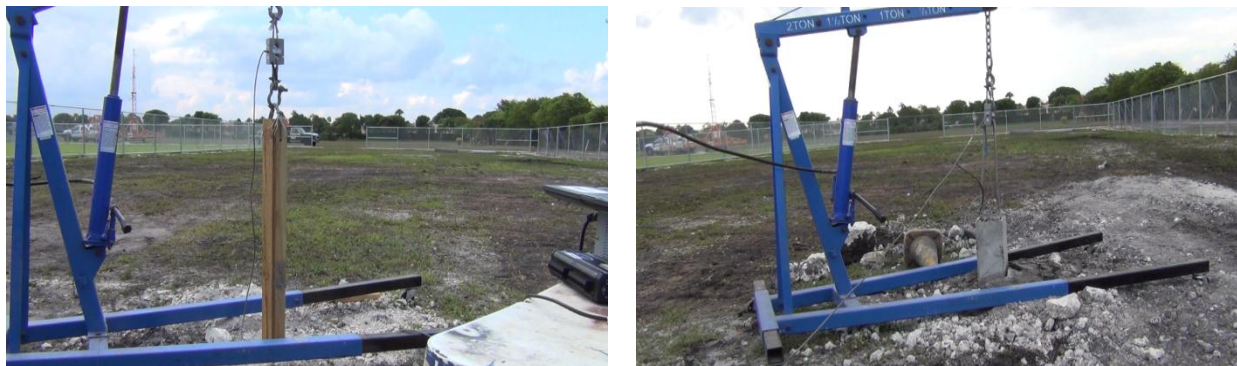
Figure 15 – Pull-out test of footings with hydraulic jack. Left: 4x4 embedded in concrete, right: precast concrete pier

The experimental data shows (Figure 16) that the precast concrete pier required the lowest amount of force to pull the footing out of the ground. It is evident that the characteristics of the ground surrounding the excavated hole affected the performance of the precast concrete pier. The effective preconsolidation ratio of the rock (gravelly soil) achieved by manually compacting the backfill is less than that achieved by mechanical compaction or in an undisturbed and cohesive soil. The ultimate tension load the precast concrete pier held is 1712 lbs...

With the concrete-embedded 4x4's and 4x4's with nails, the pull out forces measured were substantially larger. The steel wire rope connection between the hydraulic jack, load cell and specimen was the weak link of the setup. The 3/8-in steel cable snapped in one case and the clamp and thimble (wire rope connection) fractured in the second. The ultimate load recorded while pulling the cast-in-place foundations are 3089 lbs. and 2904 lbs. for the 4x4 with nails and 4x4 embedded in concrete, respectively. These forces represent the highest force achieved before the cable broke and not the ultimate strength of the footing. The footings did not visibly move, even at the highest tension load.

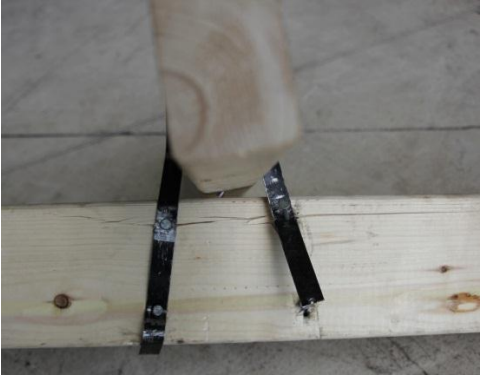
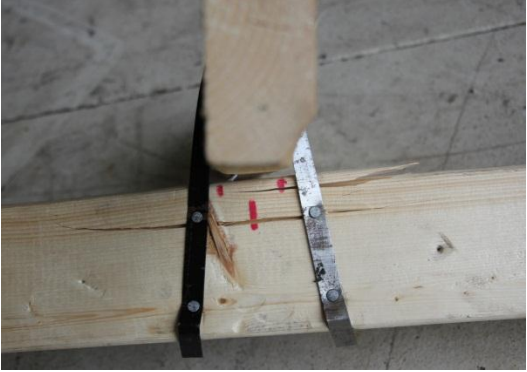
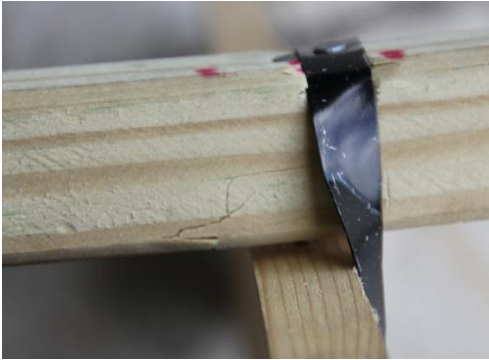
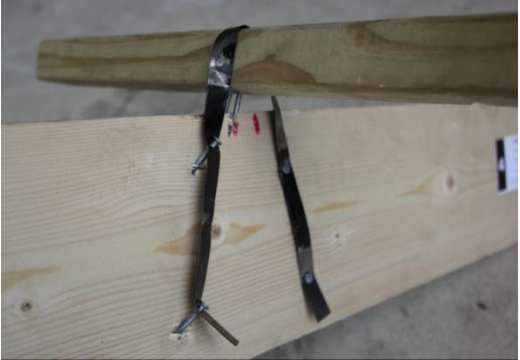
Most of the connection techniques done between 2x4 lumbers were able to reach loads close to 2000 lbs. before failing. The lumber would split at the points where a nail was driven into the wood before the connection material or fasteners failed. Weaker lumber members broke before any other components of the connection. It was evident that the 2x2's made the connection weaker, where none of the connections were able to take more than 1400 lbs... Most of these systems failed at loads less than 1000 lbs., except the ones with the wrapped steel wire. It is believed that the steel wire distributes the load around the slenderer lumber and also does not weaken it with multiple nail penetrations.

Observed failure	
Metal strap	<p>Specimen 1 Ultimate load: 1722 lbs.</p>

<p>Specimen 2 Ultimate load: 1806 lbs.</p>

<p>Specimen 3 Ultimate load: 904 lbs.</p>

<p>Specimen 4 Ultimate load: 912 lbs.</p>

The preferred method to strap the roof to be included in the full scale T-shelter model test is the metal strap. Even though the engineered tie provides good resistance to tension loads, the size and pattern of the nails create a fracture plane on the lumber. Also it requires the installer to follow the correct instructions and application guidelines. Otherwise connections might be ineffective due to incorrectly sized lumber members and fasteners that might cause a connection or component failure.

The metal strap does not provide a predetermined nailing pattern and does not require a highly technical knowledge to install it. It also gives flexibility as to the installation location and number of fasteners to use. Also it was preferred over the steel wire because it is made of galvanized metal (corrosion resistant) and did not allow displacement of the members at the connection.

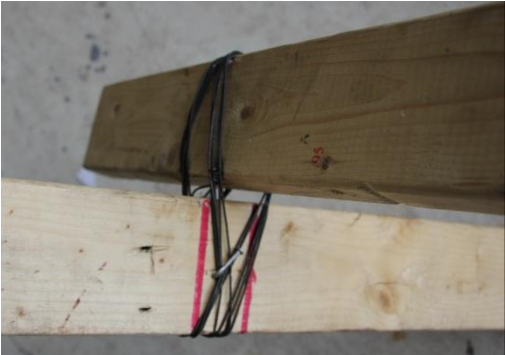
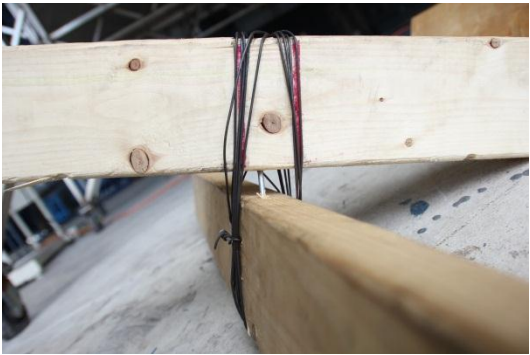
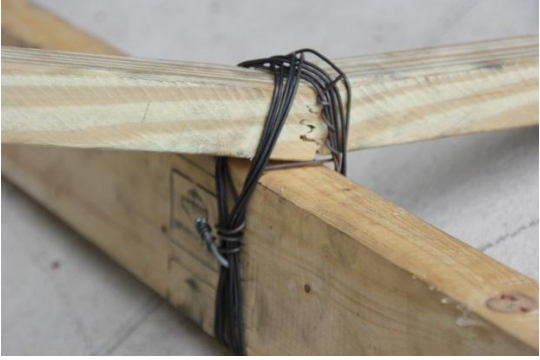
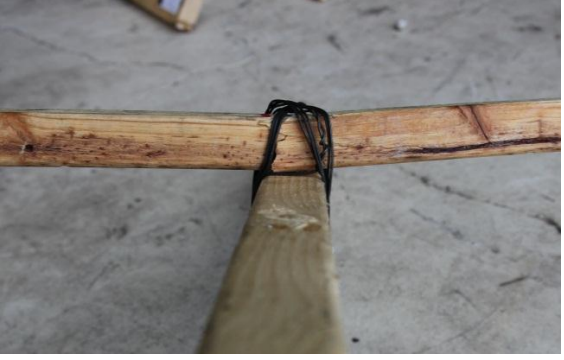
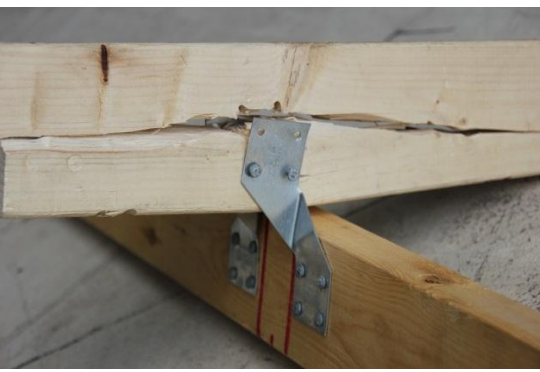
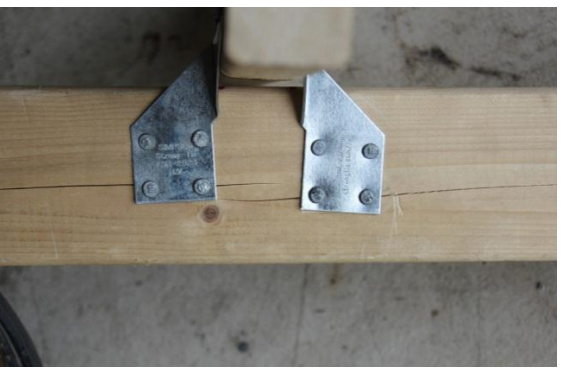
The different strapping methods yielded resistance to tension forces from as low as 462 lbs. up to 3000 lb. The highest resistance was achieved by a nontraditional technique: steel wire wrapped around the 2x4 members 8 times. This technique does not penetrate the lumber with nails and weaken the member. The engineered hurricane ties and the metal strap do penetrate the wood members, predetermining a fracture point in the wood. The steel wire connection was able to reach 3014 lbs. of

Even though the steel wire provided the best tension resistance, its performance depends on the number of wraps around the lumber and the method used to secure the loose ends. This factor will vary depending on the quality of the installation and the number of wire strands securing the connection. It will be contingent to the consistency of the wire wrap and its tightness around the lumber. This technique showed the biggest deformation presenting a big gap between the members before the wire started to break. This deformation may allow the members to slide within the connection if additional forces are present before the strapping can be fixed. Table 3 shows the ultimate strength in pounds achieved by each of the connections and the type of failure observed on the different hurricane strapping connections.

Steel wire	<p>Specimen 5 Ultimate load: 2608 lbs.</p>

<p>Specimen 6 Ultimate load: 3014 lbs.</p>

Observed failure	
Steel wire	<p>Specimen 7 Ultimate load: 1484 lbs.</p>

<p>Specimen 8 Ultimate load: 1121 lbs.</p>

<p>Specimen 9 Ultimate load: 1999 lbs.</p>

<p>Specimen 10 Ultimate load: 1561 lbs.</p>

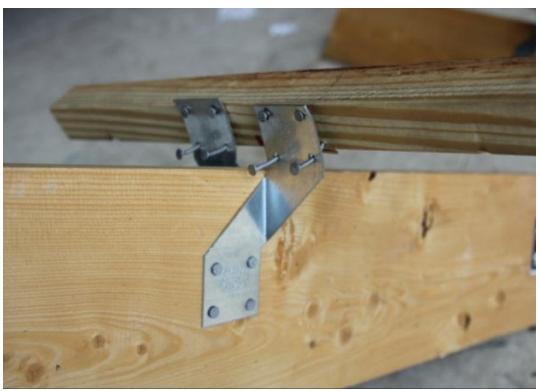
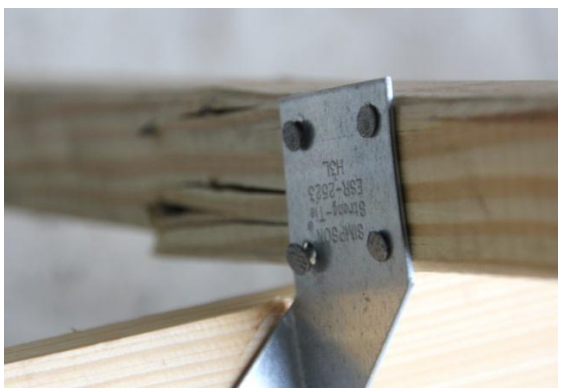
Engineered tie	<p>Specimen 11 Ultimate load: 462 lbs.</p>

<p>Specimen 12 Ultimate load: 1027 lbs.</p>
