Shelter Cluster Typhoon Mangkhut Response Planning

Northern Luzon Rapid Market Assessment Report

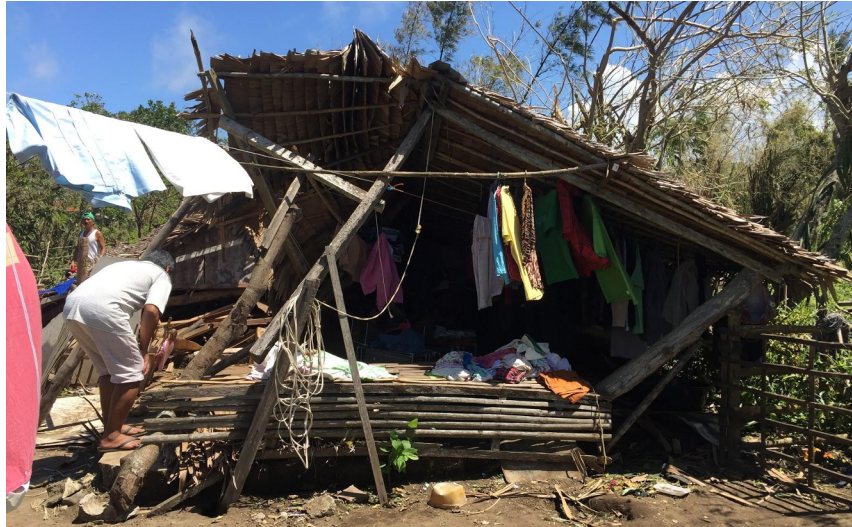
Collapsed or partially collapsed timber shelters should receive the maximum cash amount possible. **Timber homes typically lack all of the critical components (foundations, walls/bracing, vertical framing, roofing, connections) needed for a disaster-resistant home and will be able to fully utilize amounts of 50,000PHP or more.**

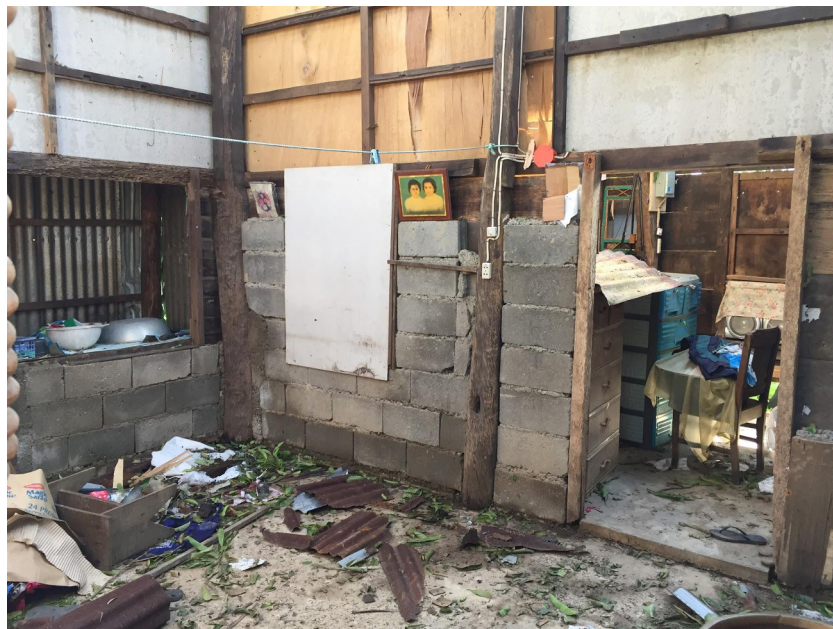
Mixed material homes (typical half height masonry walls with timber upper walls and timber roofs) may have existing foundation elements and existing bracings elements due to the presence of the masonry wall construction. **Preliminary minimum cash assistance recommendation for mixed material homes is 35,000PHP.**

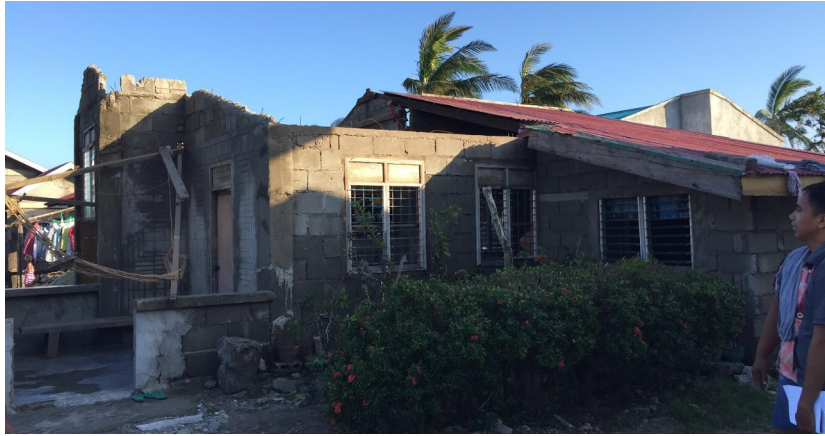
Concrete and masonry homes with damaged roofs typically will require repair or reconstruction of the roof, which will require less funding than a full home repair depending on the size and square meter area of the roof. Particular attention needs to be made to the connections of the roof members to the concrete support structure below. If proper connections are not constructed, any new roofs constructed will be at risk of damage in future events, resulting in a poor investment of funding. **Preliminary minimum cash assistance recommendation for concrete and masonry homes with damaged roofs is 21,000PHP, and it is recommended to allocate more funding for larger houses.**
