Field report:

Location: Korong Batu Gadang, Nagari Kurangi Hulu, Pariaman

Purpose of Visit: to have a clearer picture of self-recovery effort being carried out, the quality of self-built transitional shelters, and those still living in host families or community buildings.

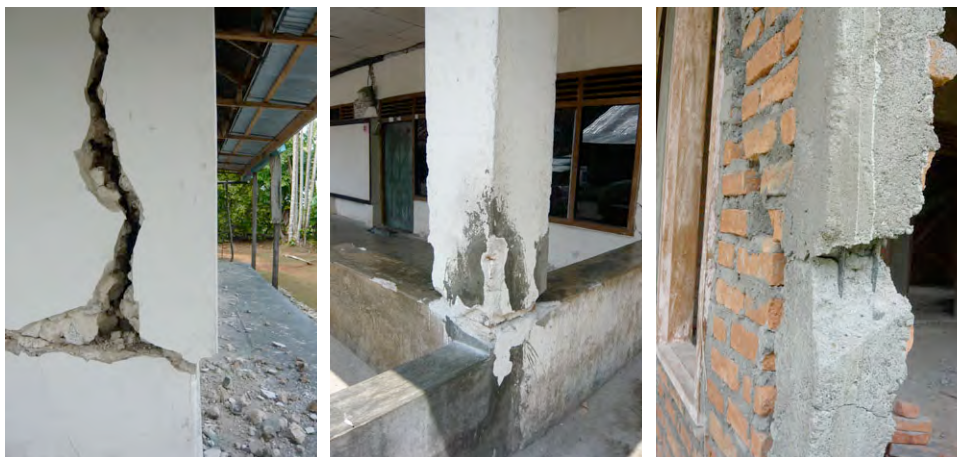
As many have witnessed, severe damages are seen in full masonry houses without frame structure, 'columns' are often built of bricks, concrete frames use rebar with no threads.

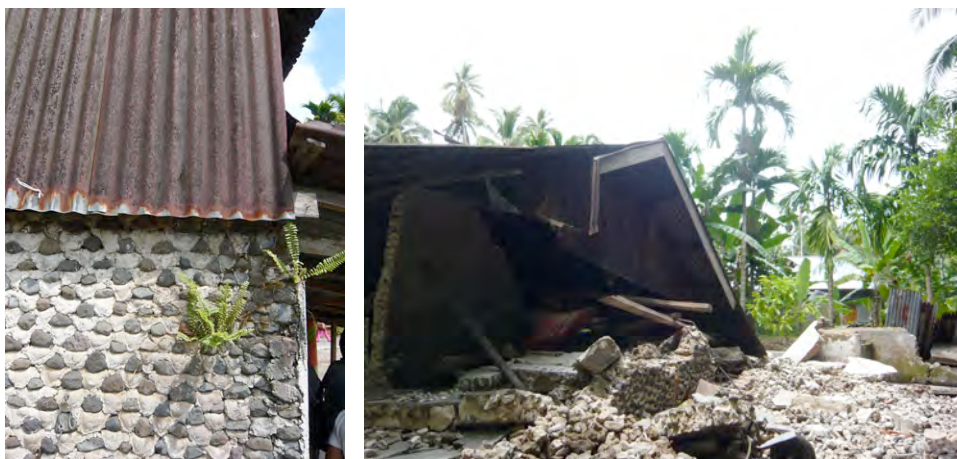
Local practice of using stones with lime-and-clay mortar appear to have withstood the earthquake well when it's only waist high and topped with timber structure – full walls of the same material construction had often lean away from the rest of the building and collapsed.

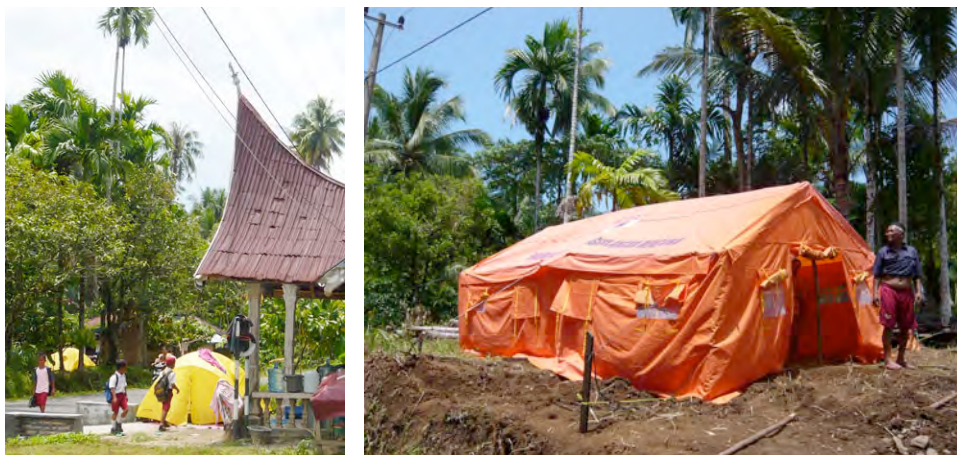
Individual family tents seen in the village were donated by a local hospital, most people lived in this tent (or similar) for around a week, some of them still use it for sleeping at night.

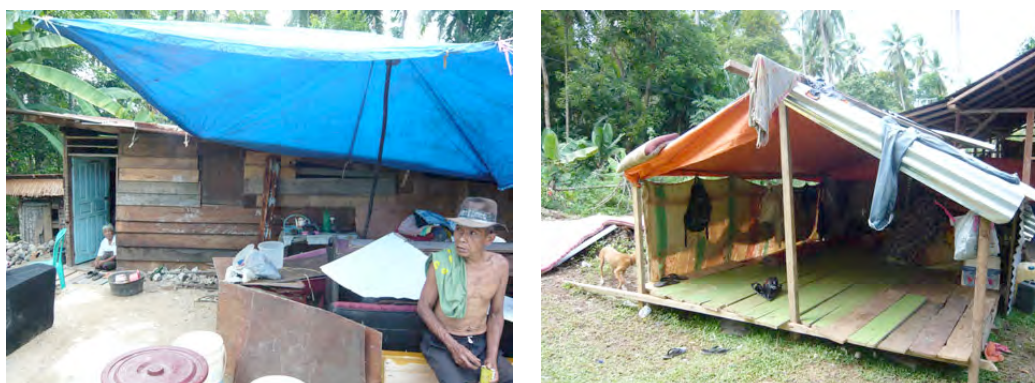
A majority have constructed their own T-shelter, often a small, enclosed structure built from collected material with covered space (plastic sheet) area out front. Roofing is reclaimed CGI sheeting from damaged houses. Most of these shelters are quite sturdy and well constructed, if somewhat small.

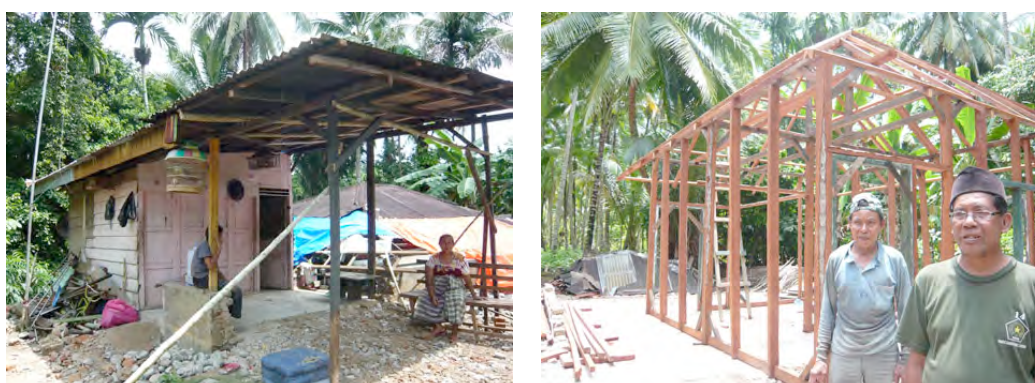
These temporary shelters are often built with support of friends and family, - the house below, left, was an exception, the owner paid builders IDR 500,000 to build it combined with salvaged material from the old house. On the right is an example of a house being built from coconut wood. It has so far taken 10 days – starting from coconut wood processing – they are now looking to collect enough money to buy roofing material.

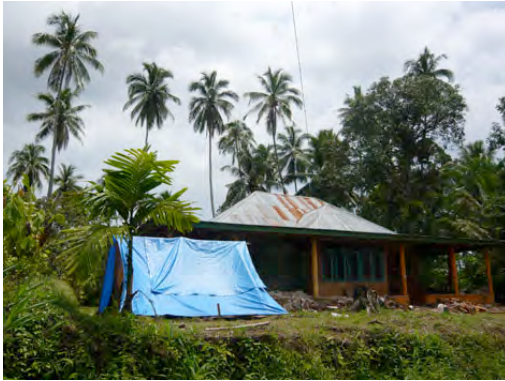
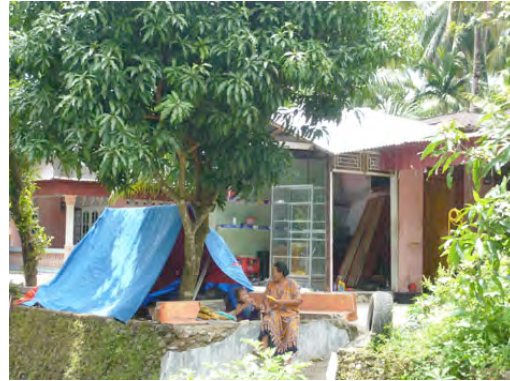
A small number were also seen living under plastic sheets, using the house during the day and sleeping in outside during the night.

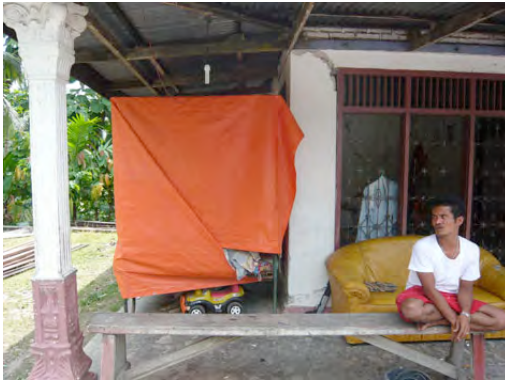
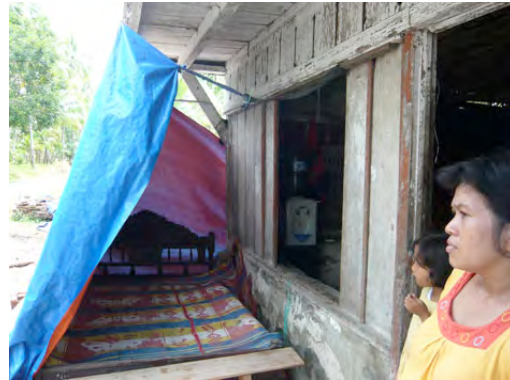
Of more concern are also those living attached to damaged structures, setting up ad hoc sleeping area with a bed and plastic sheeting.

Those still living under plastic sheet – especially attached to damaged houses, should become a priority in the up coming month.
