Shelter Cluster (Preparedness) meeting 4th November 2016

Typhoon Haima / Lawin update

Shelter Cluster Philippines (Preparedness)

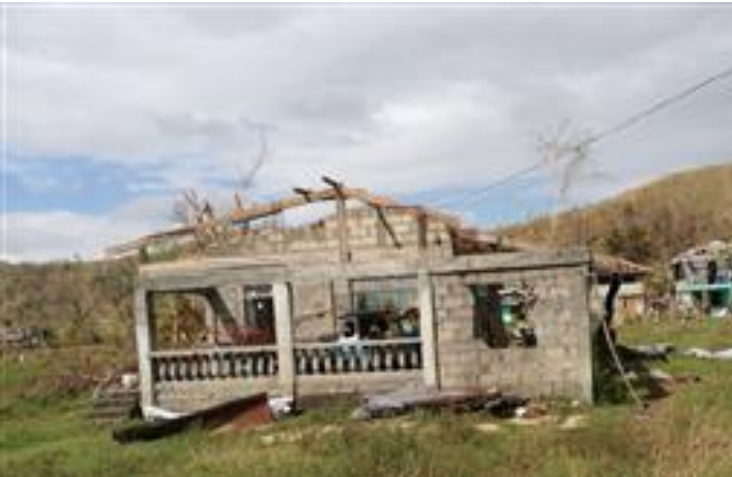
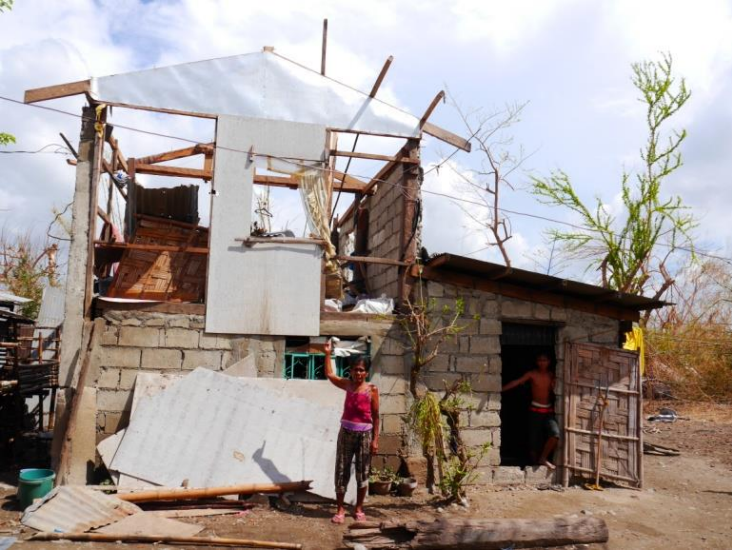
Update on field visits – damage

- Urban, semi-rural, rural – varying damage densities
- Totally and partially damaged – what does this mean?
- Self-recovery actions witnessed: salvage of materials, repair works, purchase of new materials (GGI) construction of temporary shelters, ‘adopt a neighbour’.

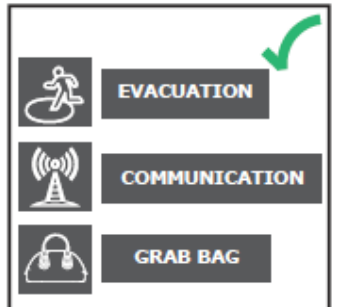
8 BE PREPARED

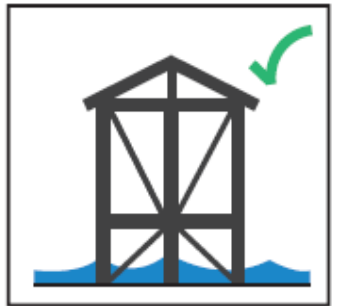
6 SITE YOUR HOUSE SAFELY
