Shelter Advisor Deployment Report

Strategy recommendations for the Shelter Cluster for Maewo, Penama Province, Vanuatu

Step Haiselden, CARE International Shelter Team Leader supporting Vanuatu Shelter Cluster

6th September 2018 (updated 27th September)

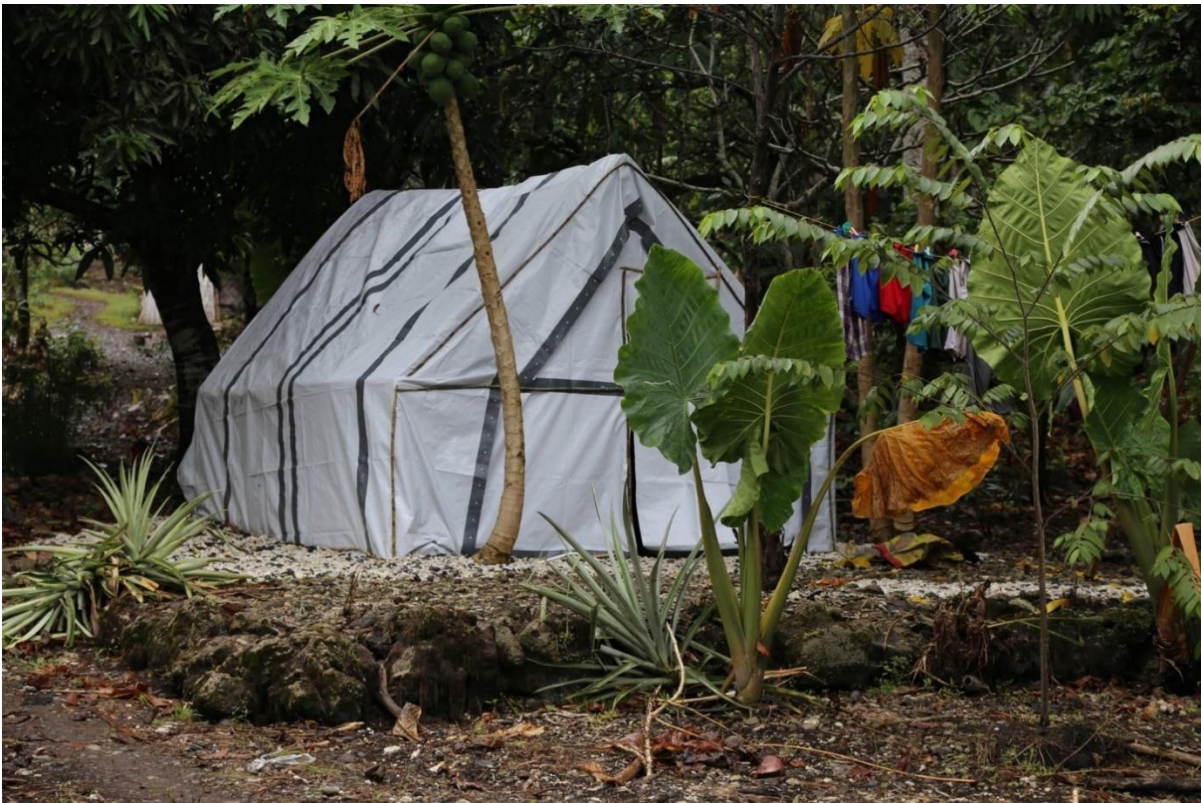
Typical bamboo and tarpaulin shelter, Nasawa

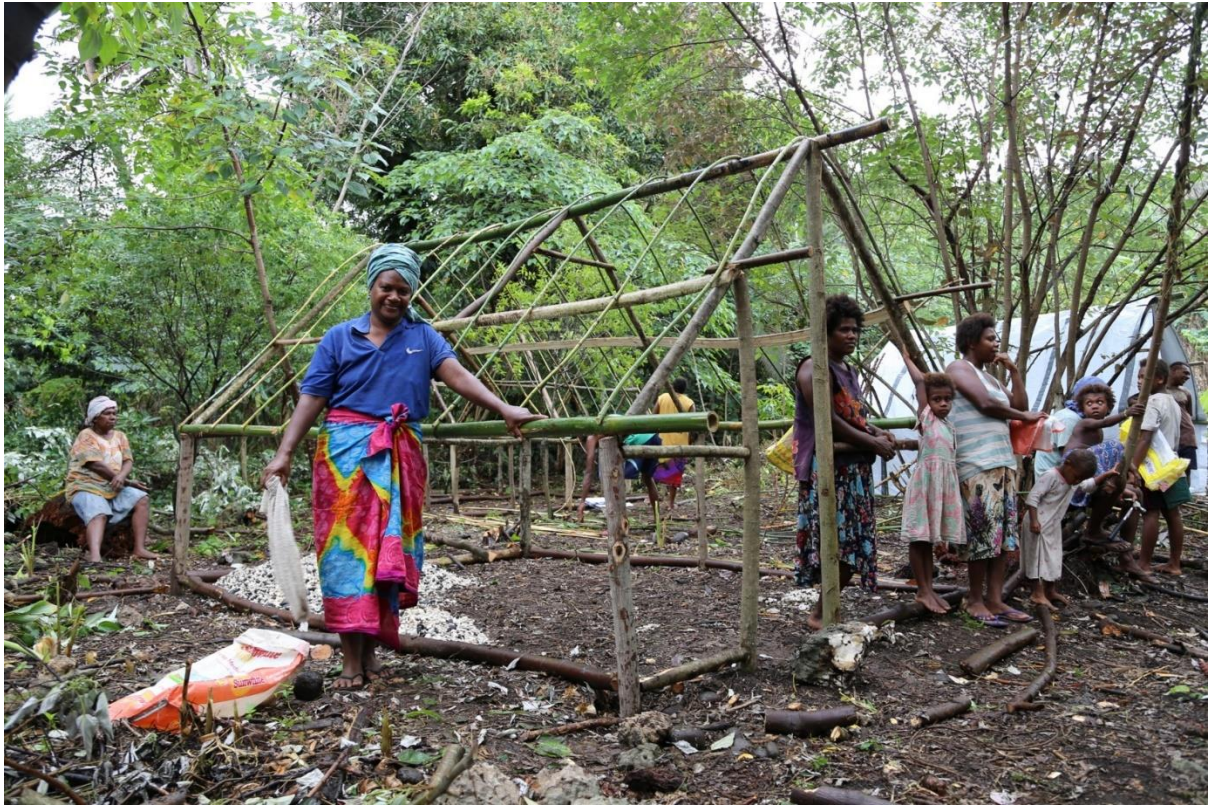
Bamboo frame under construction for a family displaced from a school at the start of the term, Nasawa

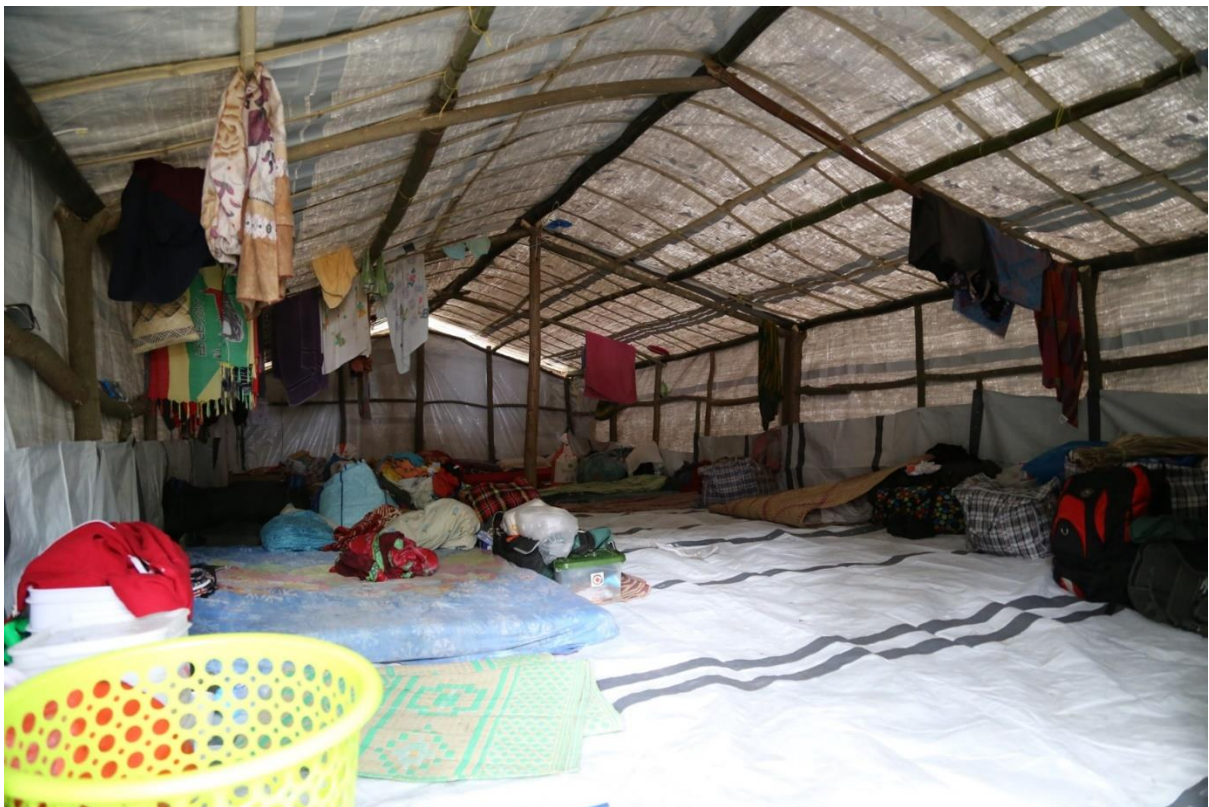
Lack of privacy is a problem in shelters where materials have been pooled to create shared spaces

- Rasa Ure has also repeatedly highlighted the importance of privacy in all new shelters.
- If appropriate, and based on the environmental impact assessment and availability of local timber, the hire of a mobile sawmill (of the kind that fits on the back of a pick-up) could be considered. The need for a communal chainsaw in each community should also be assessed and, if provided, should be accompanied by rigorous training on their use and maintenance, fuel and suitable safety equipment.

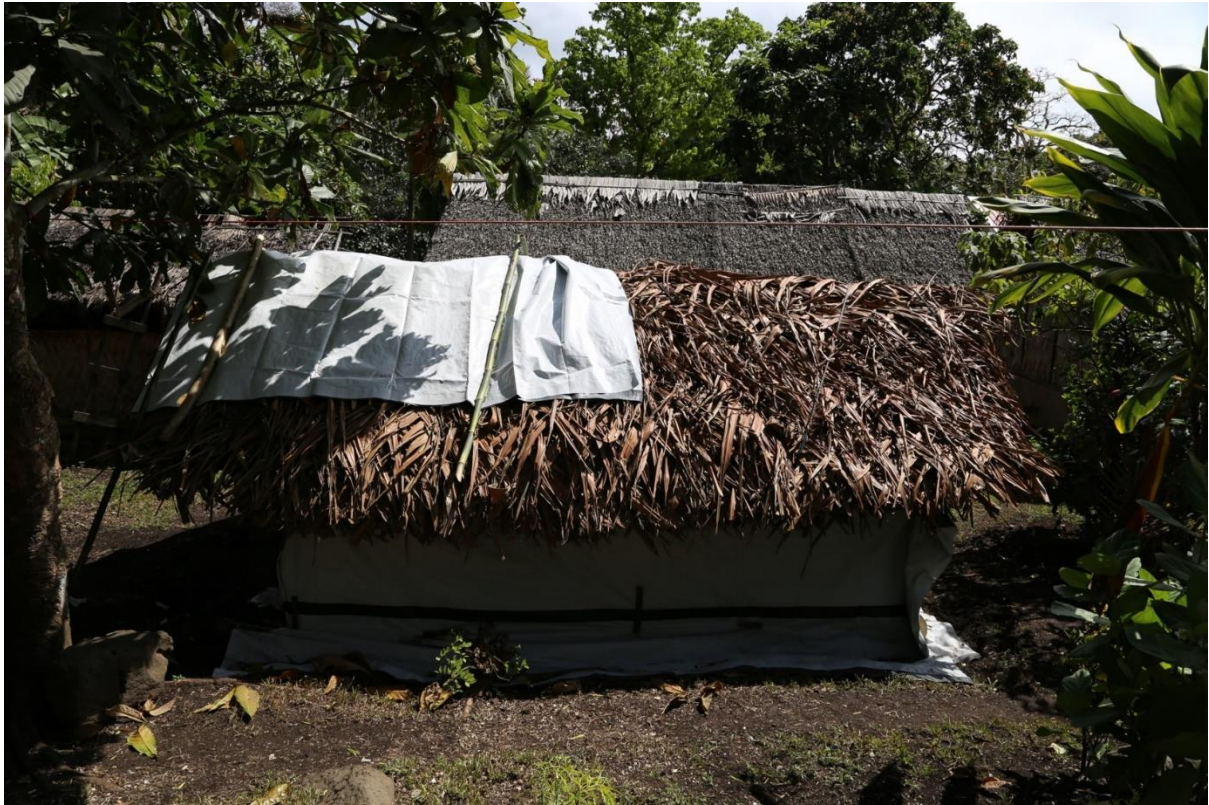
Shelters are starting to be upgraded using traditional materials from the bush

- Many evacuees have started to upgrade their emergency shelters using local materials from the bush. Some have requested more three-inch nails as there were insufficient nails in the toolkits that were shared by several families (and some of the toolkits were distributed on Ambae and left behind during the evacuation). A distribution of nails and galvanised tie wire would help with the shelter upgrades. This should be done as soon as possible and combined with the awareness training.

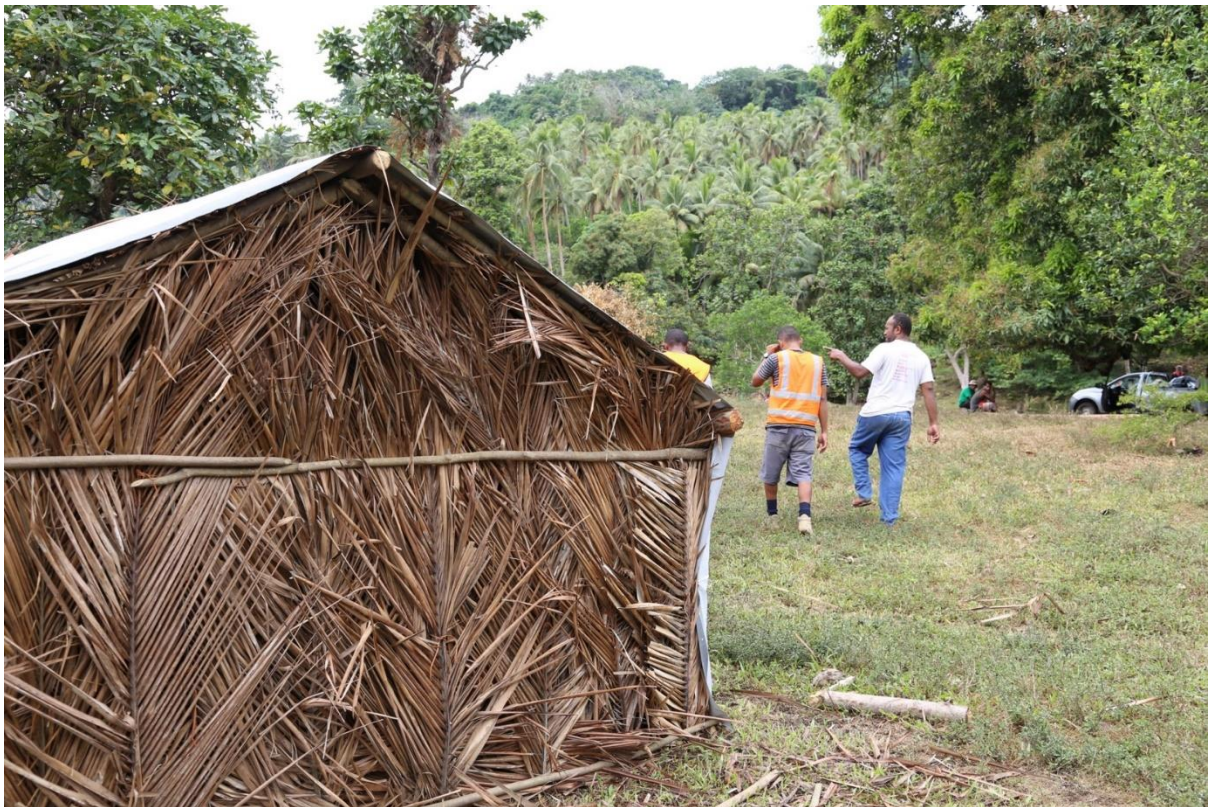
Upgraded shelters will still only offer limited protection from heavy rains and strong winds

6. It is possible, and urgently required, to strengthen the temporary shelters to increase their resistance to wind and rain through minor technical investments in improved foundations, bracing, connections and siting. This will help to protect communities' health, dignity and property during poor weather.
